**2016 ROUTINE
BRIDGE INSPECTION REPORT**

**BRIDGE # 2937
CP RAIL over CSAH 77(8TH AV NW)**

Date of Inspection: 09/20/2016

**Report Written By: Dan Bodelson
Report Reviewed By: Nicklaus Fischer
Final Report Date: 10/20/2016**

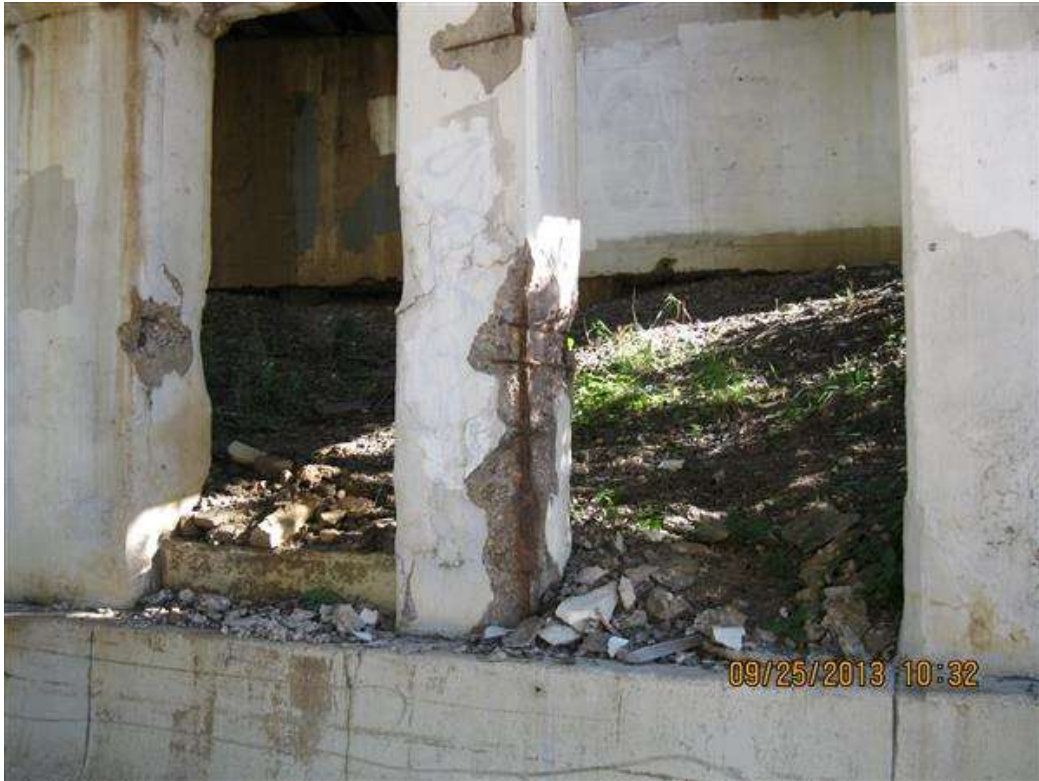
Photo 10 - Culumn 6 2013

Notes: [2014] RR filled in between the columns and created pier walls.
 [2009-2013] There is additional delamination to the east side of column #2. Column #6 has additional delamination under the concrete cap.
 [2006-2013] The north side of column#1 contains a major spall w/exposed rebar.
 [2011-2013] Columns #2, #4, #5, #6,#8 & #9 consists of delamination, major spalling & cracking with exposed rebar.
 [2009-2013] East side of column #4 & #6 have major delamination with exposed rebar & section loss.
 [2006-2013] 50% of columns in need of shot-crete rehabilitation.

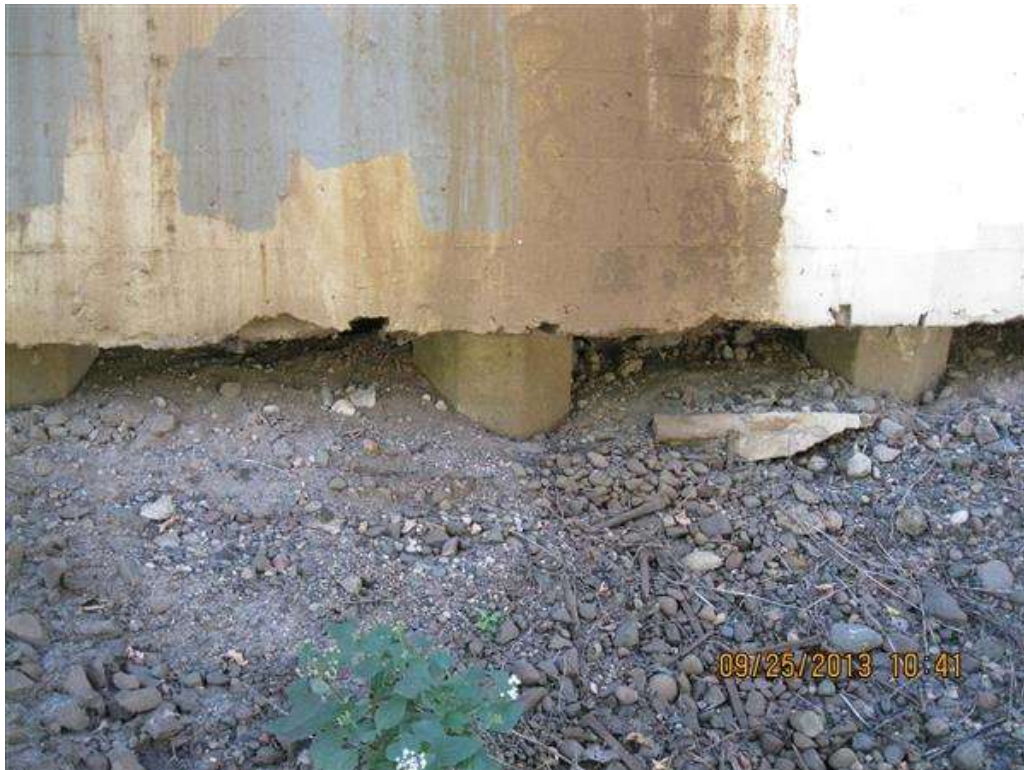
Photo 13 - East abutment 2013

[2013] Additional slope protection is needed at the east abutment due to exposed piling.

[2003-2013] Slope is undermining at the east abutment. Slope protection is recommended on the east side.

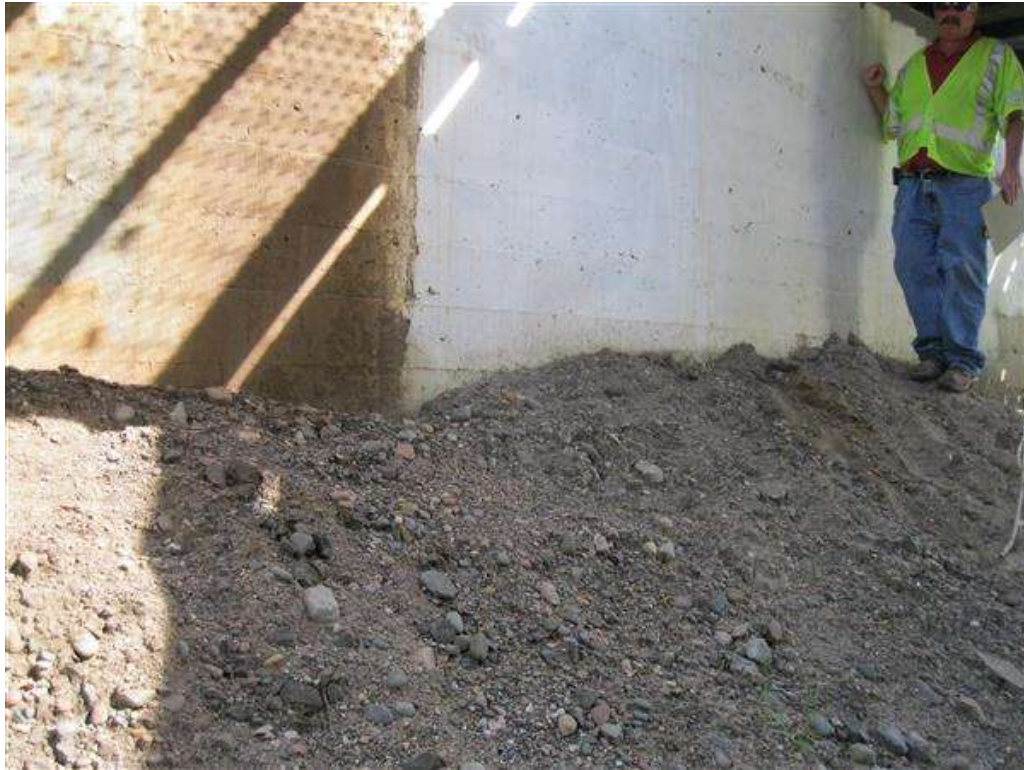
Photo 21 - East abutment 2014

[2014] East abutment has been repaired and has no exposed piling.

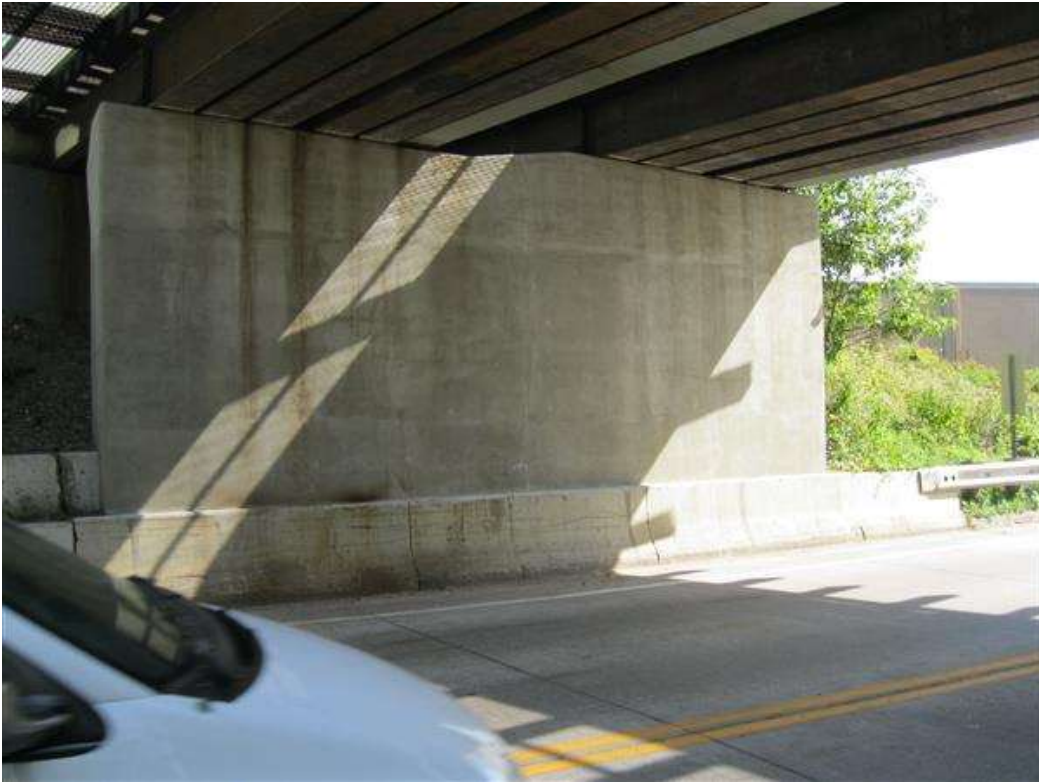
Photo 22 - east pier wall 2014

Notes: [2015] Minor shrinkage cracks on both piers with effervesce.
 [2014] Minor shrinkage cracks on both piers.
 [2014] RR filled in between the columns and created pier walls Condition state 2 due to being a repair.
