**2016 ROUTINE
BRIDGE INSPECTION REPORT**

**BRIDGE # 5583
CSAH 51(LEX PKWY) over BNSF RR**

Date of Inspection: 10/16/2016

Inspected By: Engel, Michael; Grau, Joe; Reimer, Dan

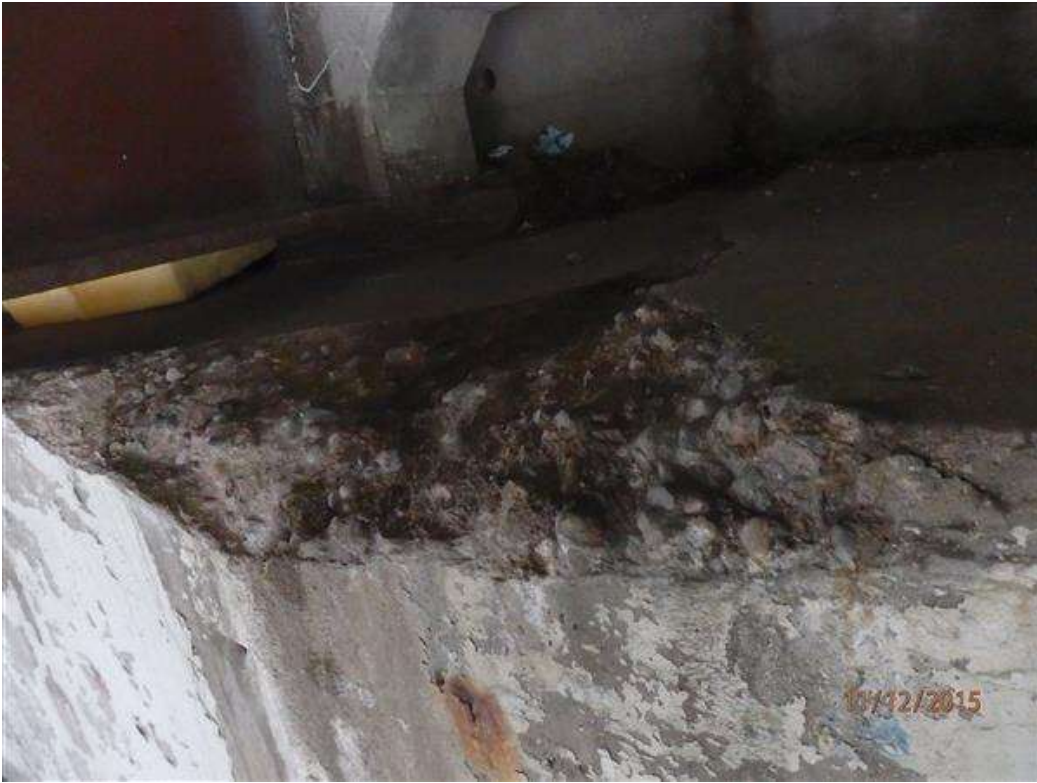
Photo 1 - abut seat SW - spalls - exposed rebar - leakage

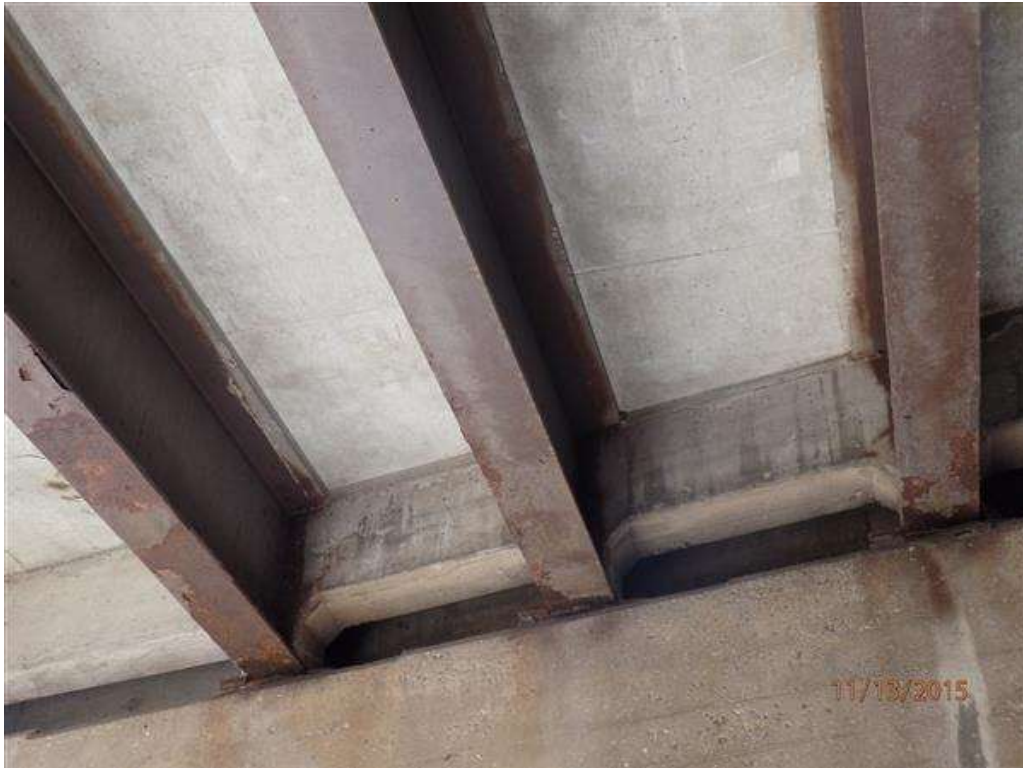
Photo 2 - beam ends pier 1 - rusty - north face

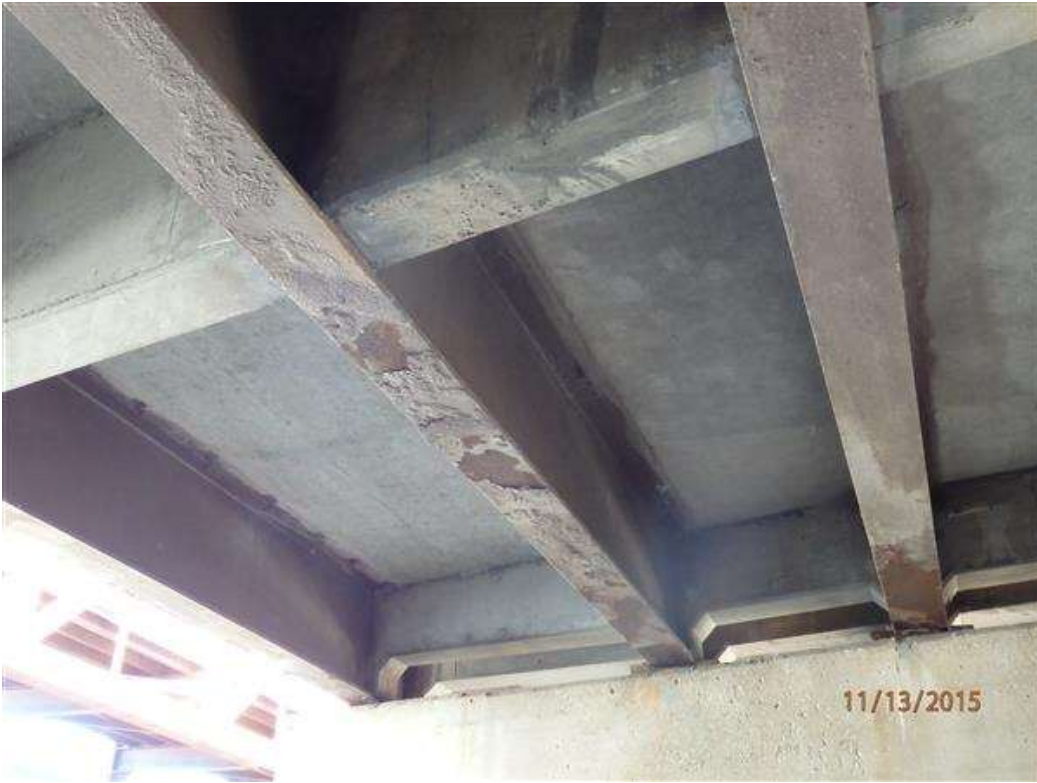
Photo 3 - beam ends pier 4 - rusty

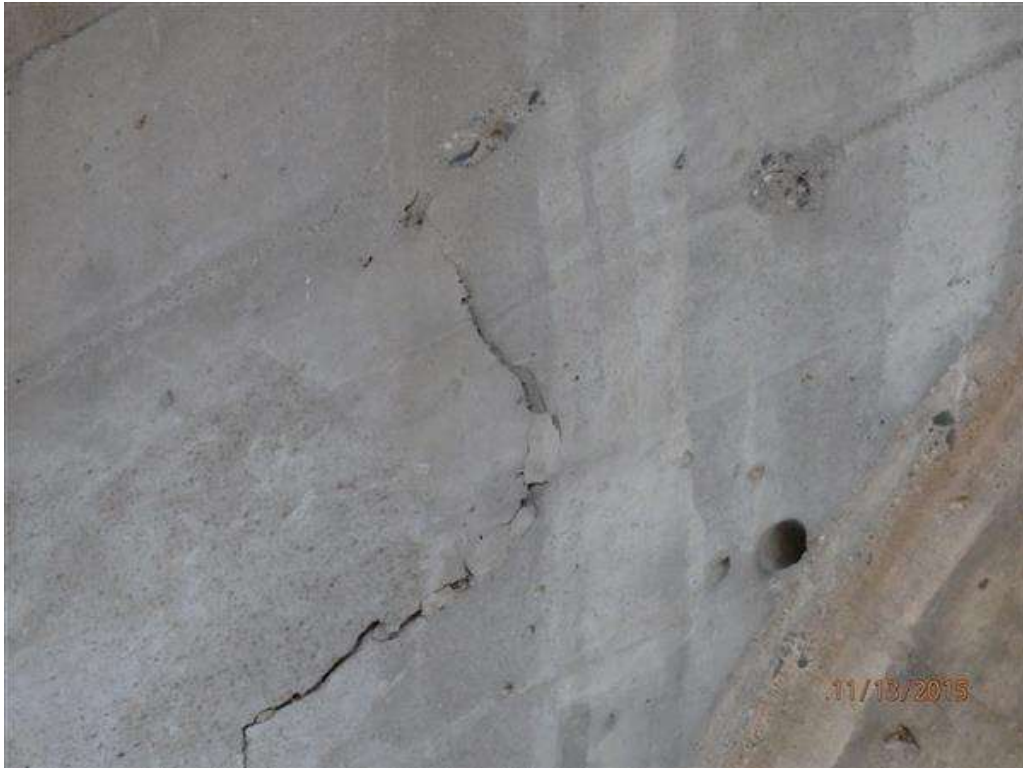
Photo 4 - center column pier 1 - delam south face

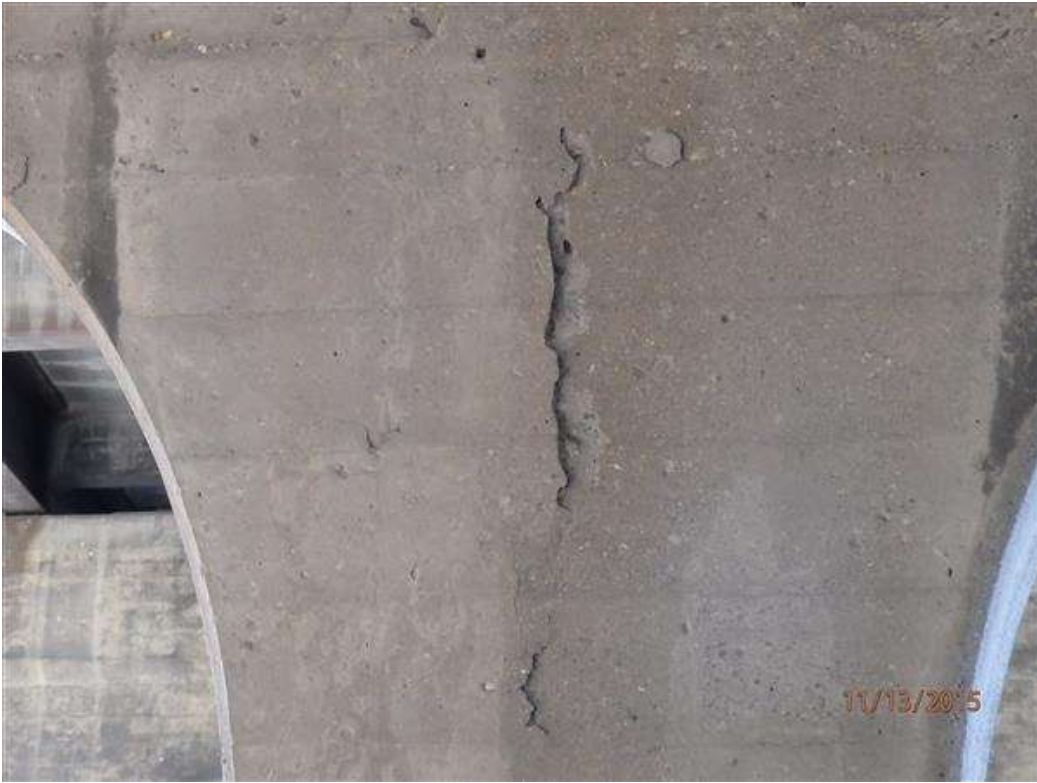
Photo 5 - center column pier 1 spalls north face

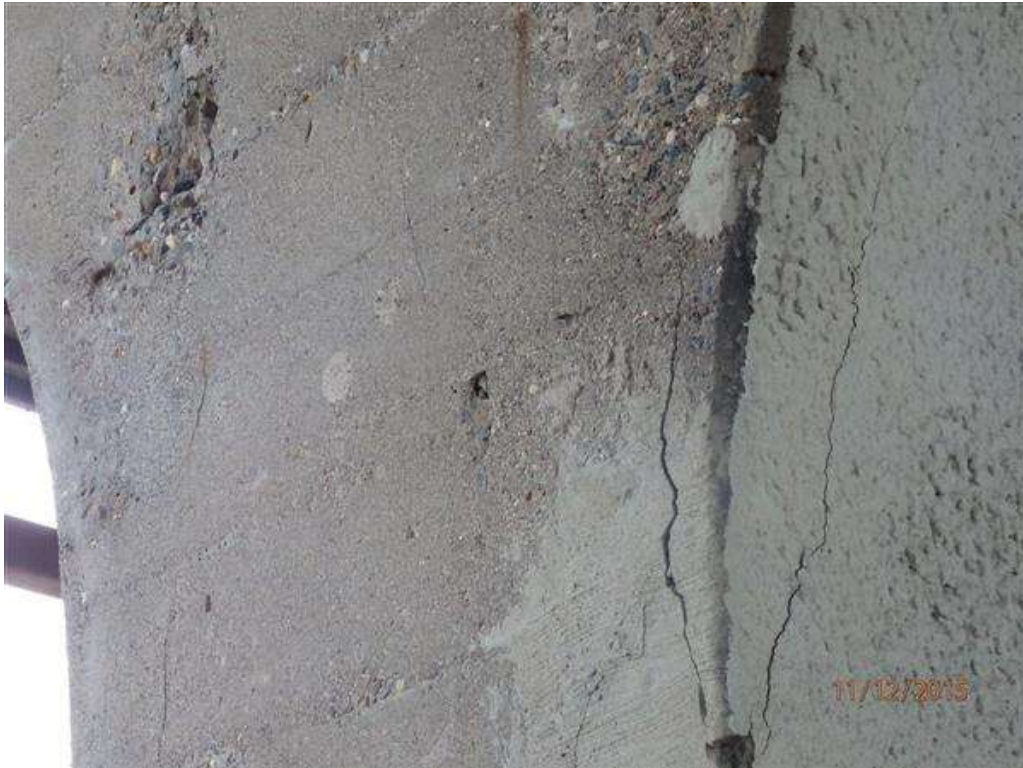
Photo 6 - column delam - spalls pier 4 south end

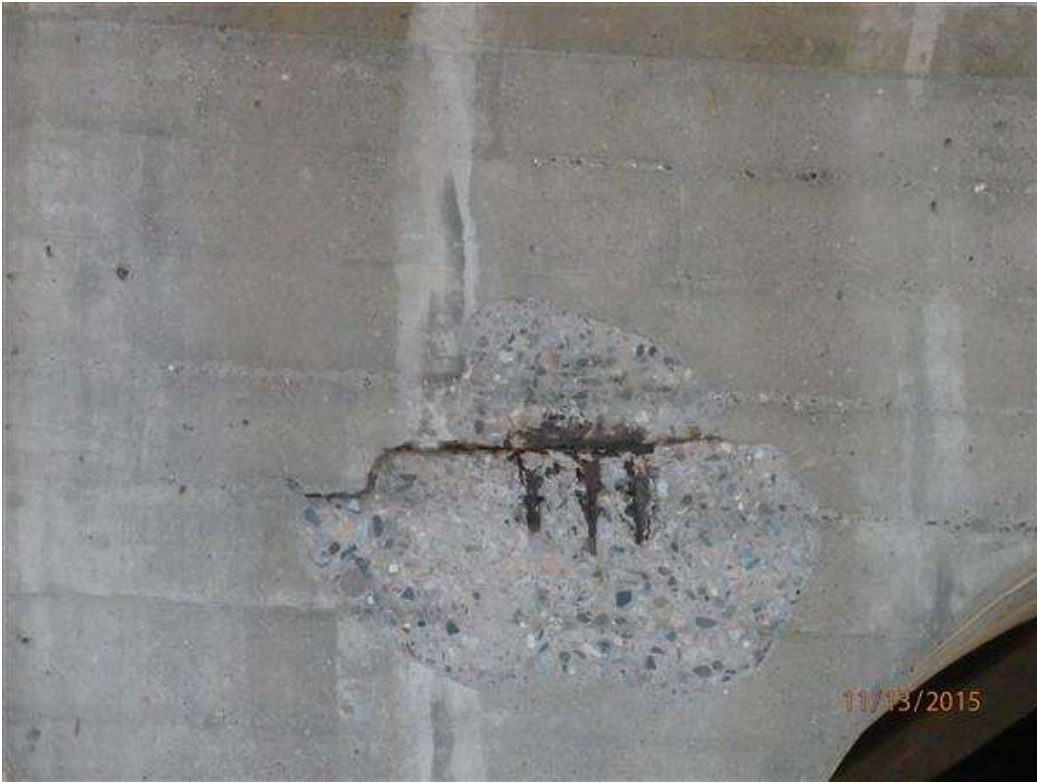
Photo 7 - column spall pier 1 south face

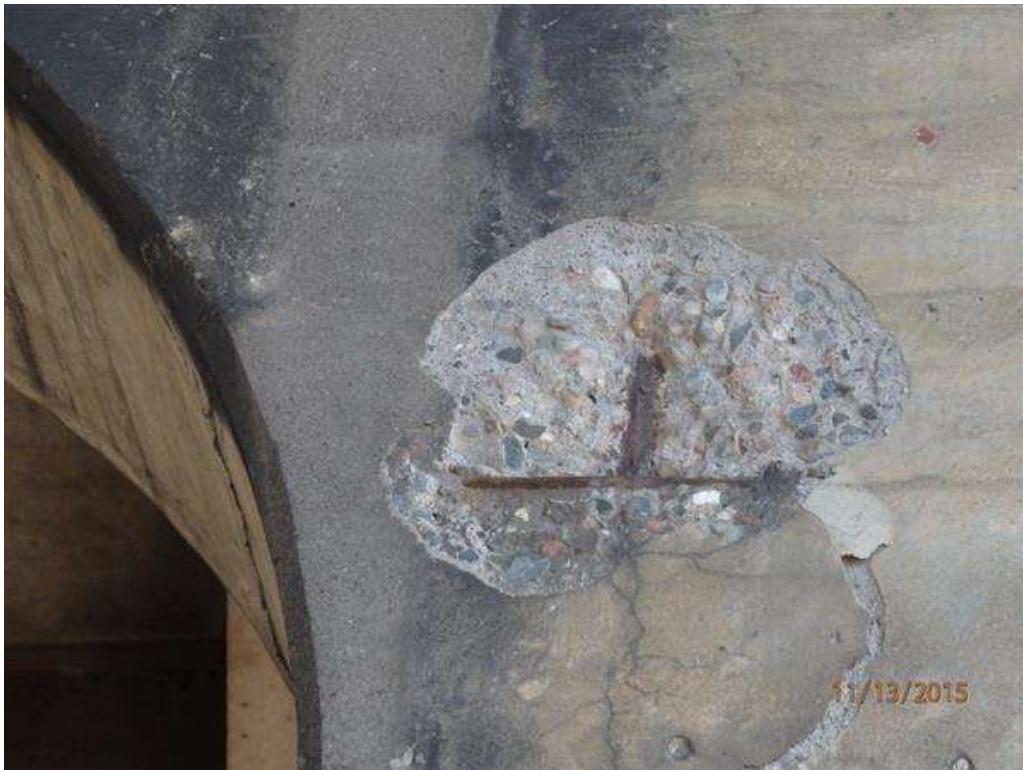
Photo 8 - column spall pier 2 south face

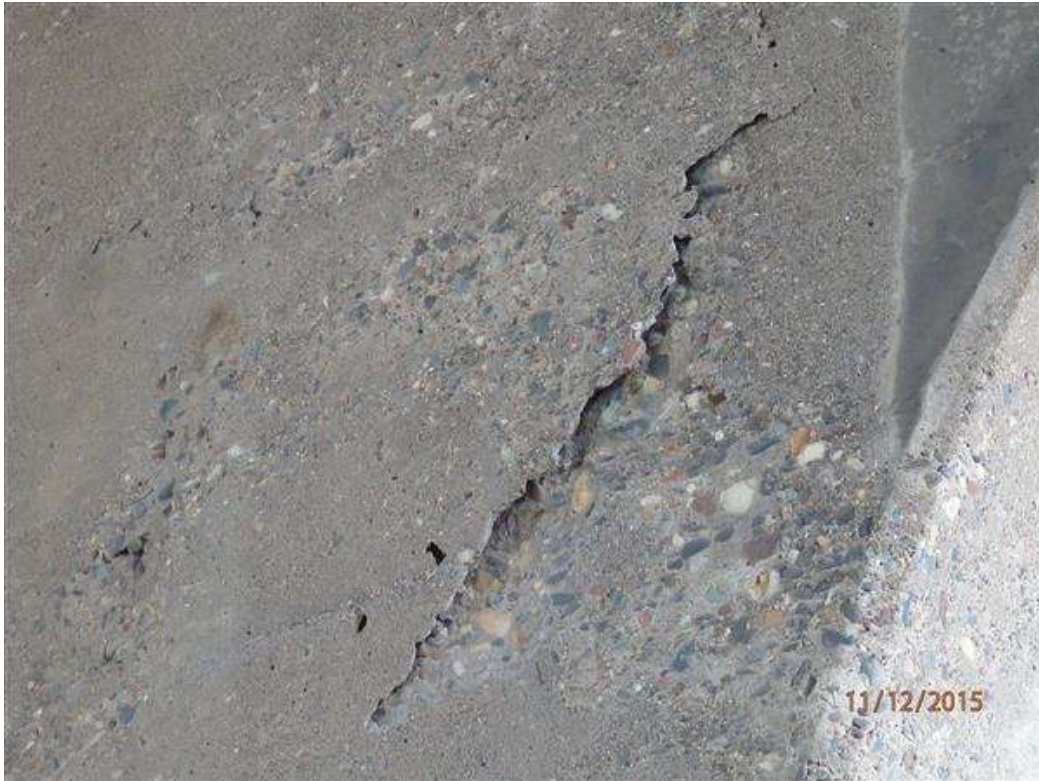
Photo 9 - column spall pier 4 south end

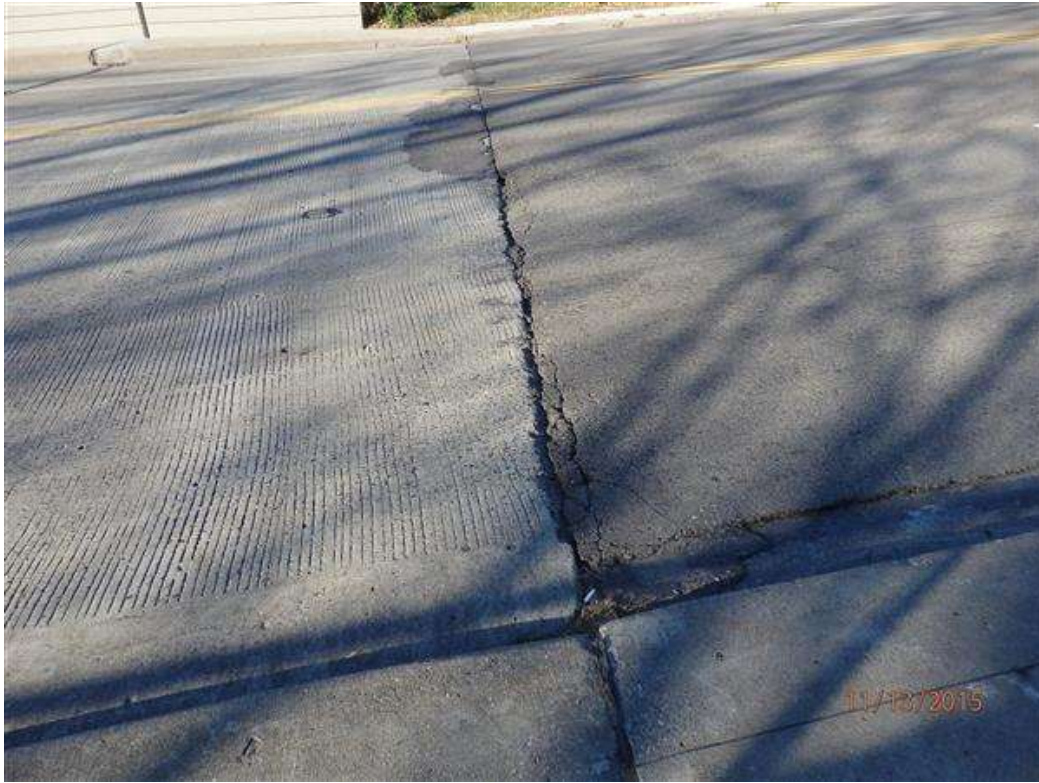
Notes: Poured sealant has loss of adhesion. 2015

Photo 11 - liquid poured joint north approach

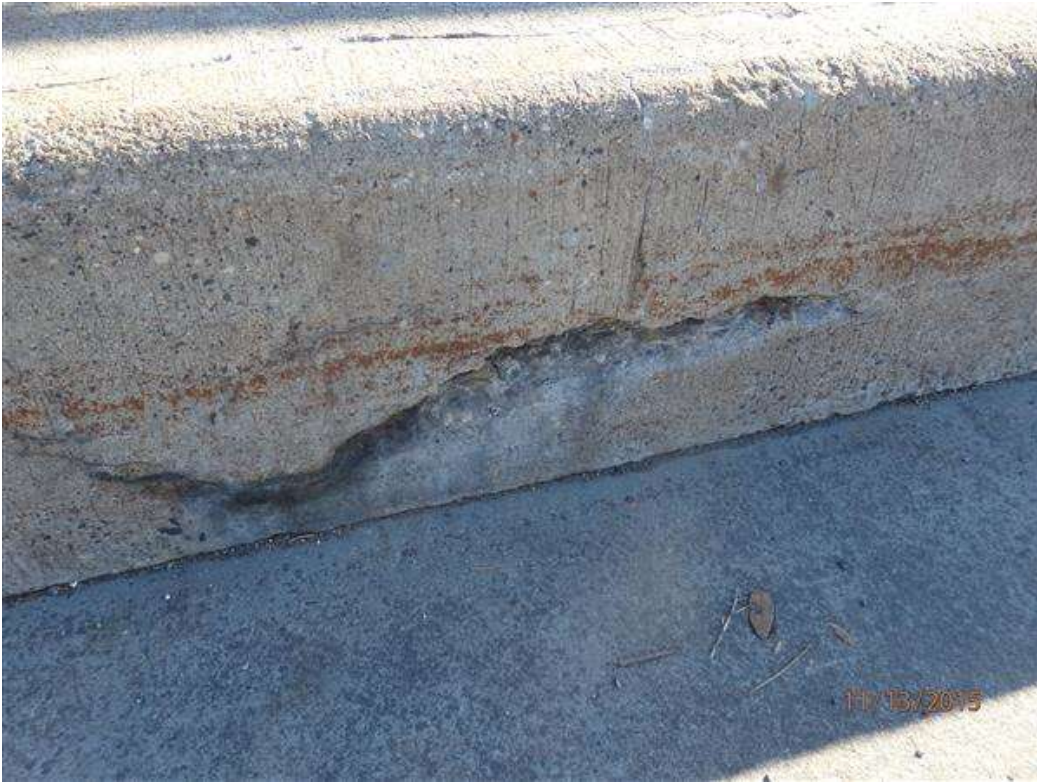
Photo 13 - longitudinal cracking at curb face east side mid span

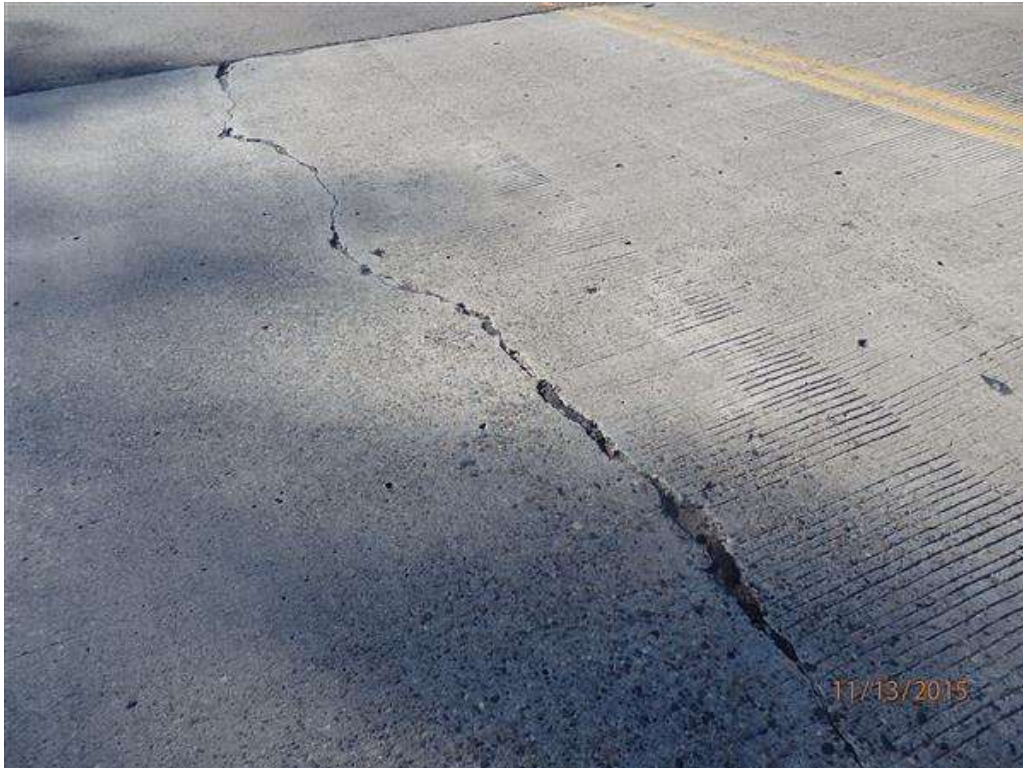
Photo 14 - longitudinal cracks south approach panel

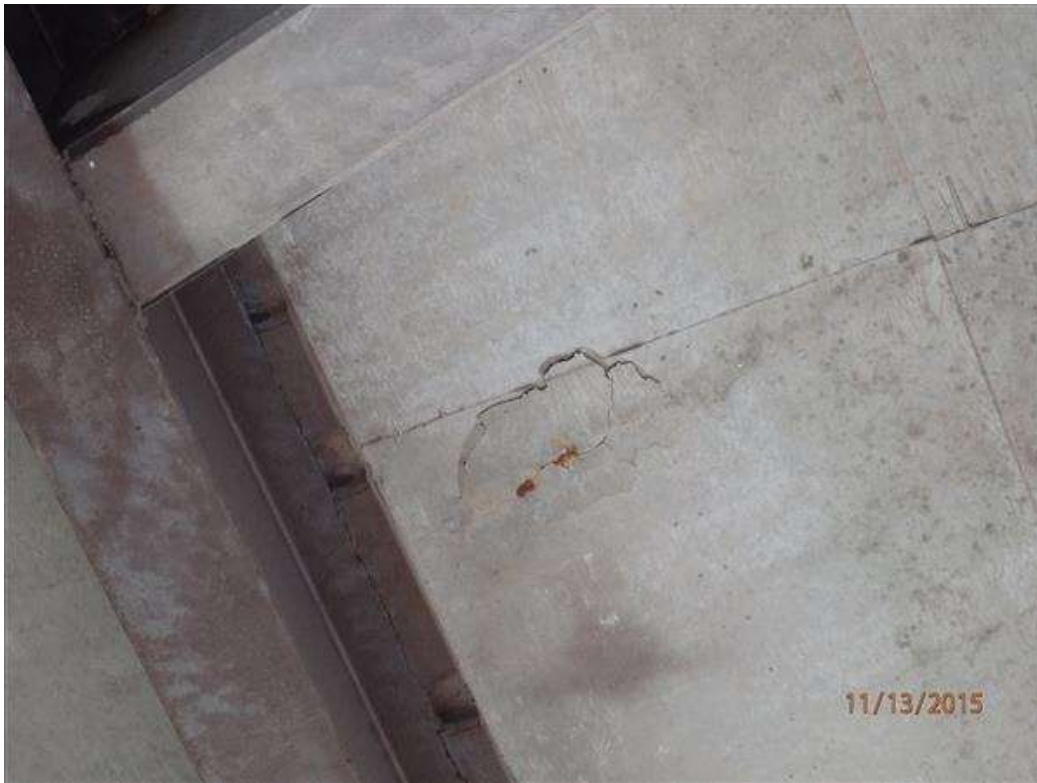
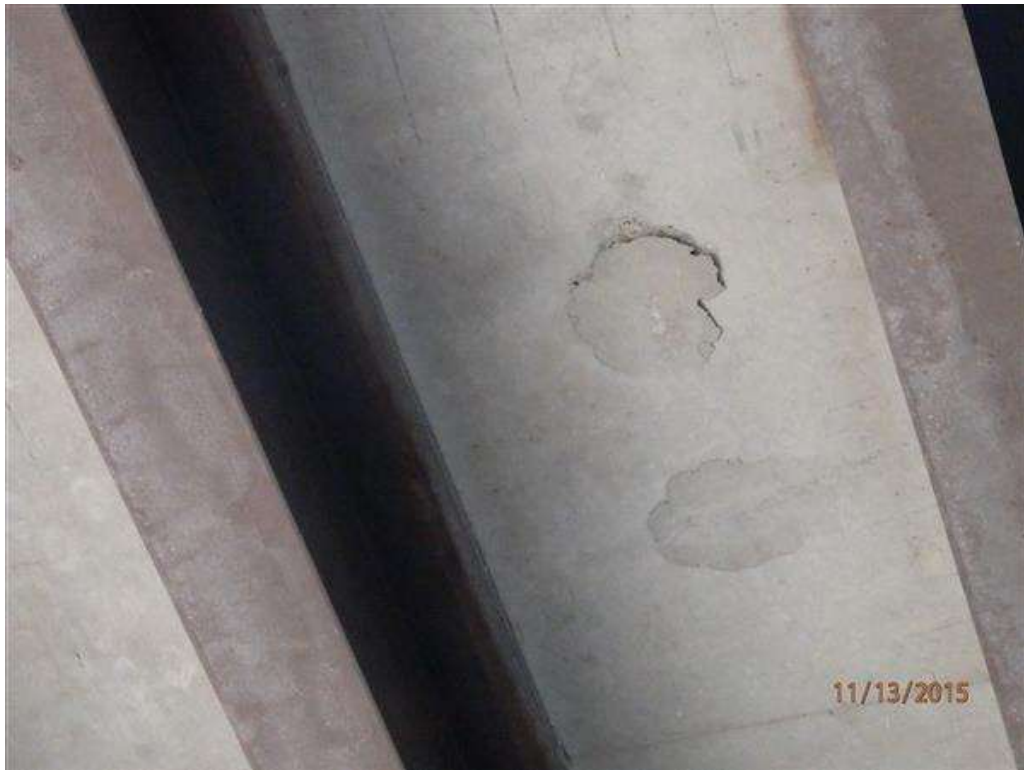
Photo 15 - underside of deck between pier 4 and pier 3 has delam

Photo 16 - underside of deck between pier four and pier three has delam

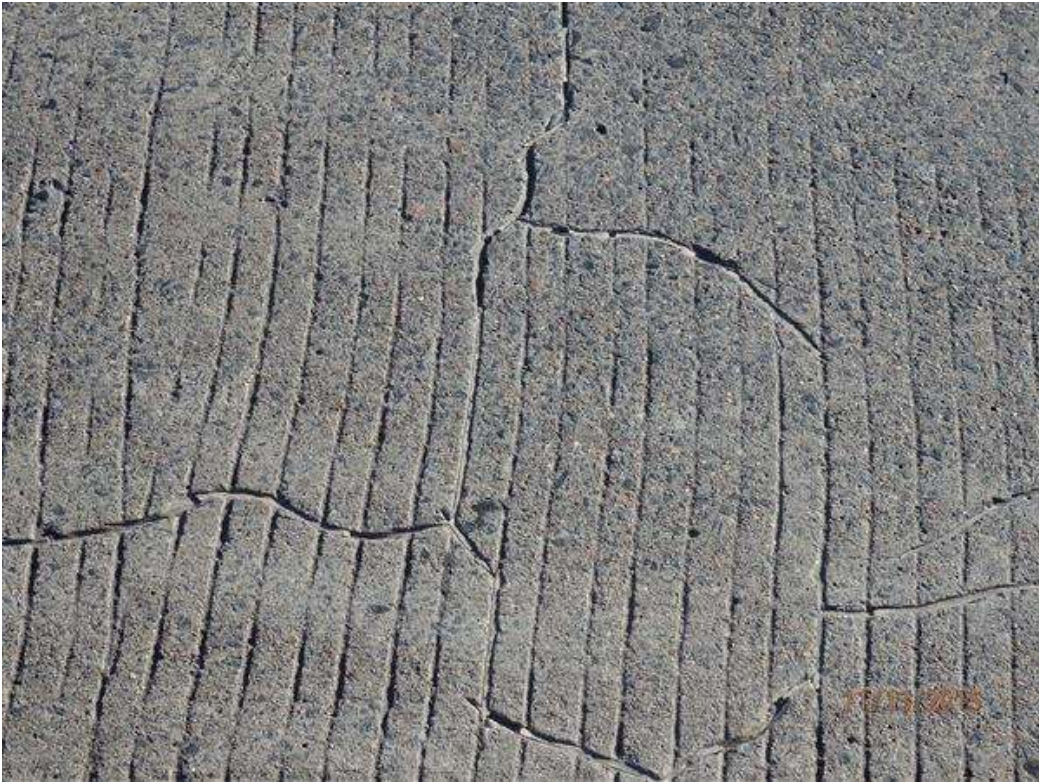
Photo 17 - unsealed cracks on deck - typical

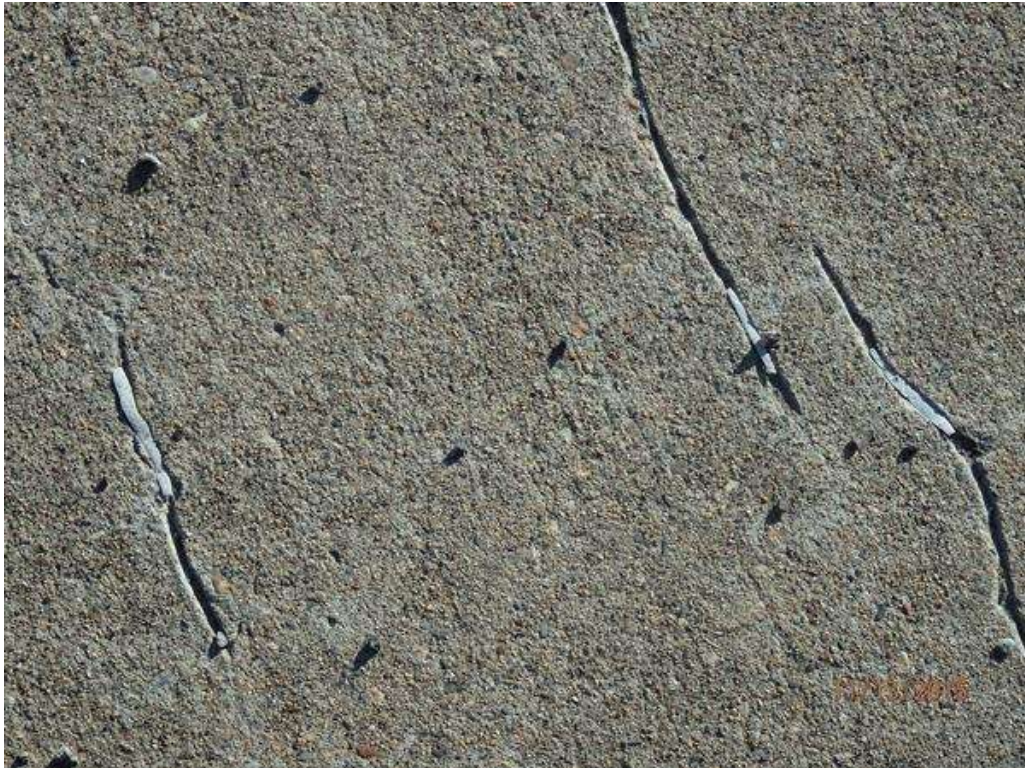
Photo 18 - unsealed cracks on sidewalk - typical

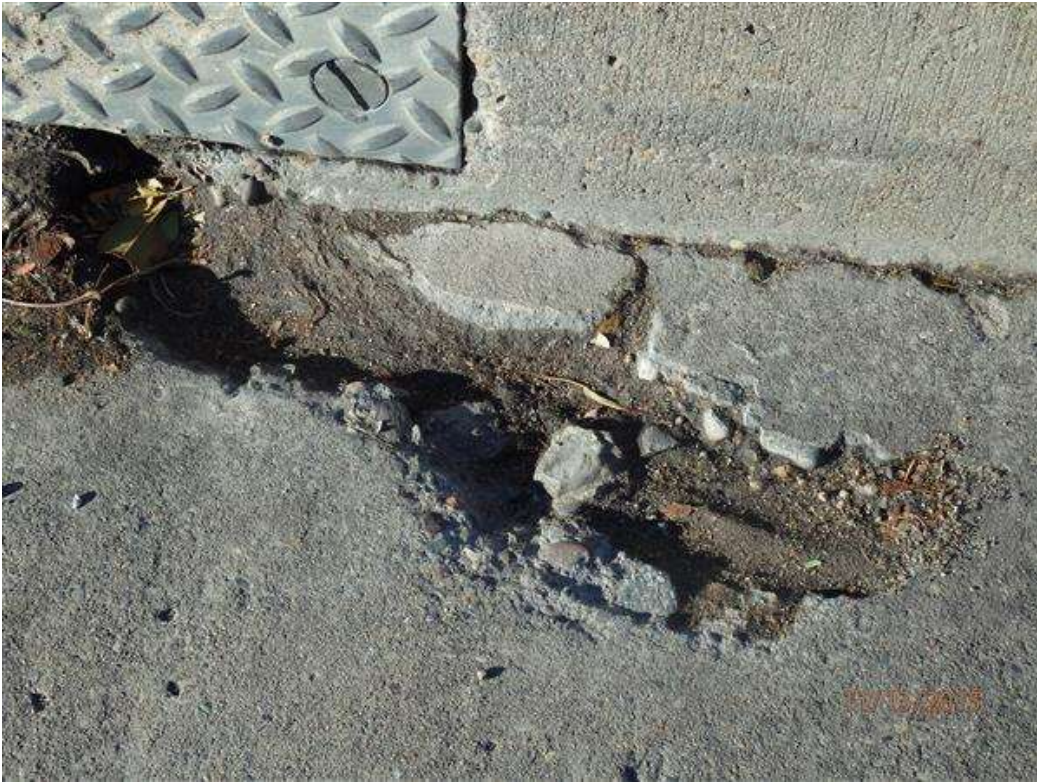
Photo 19 - unsound patch NW approach panel at gutter line

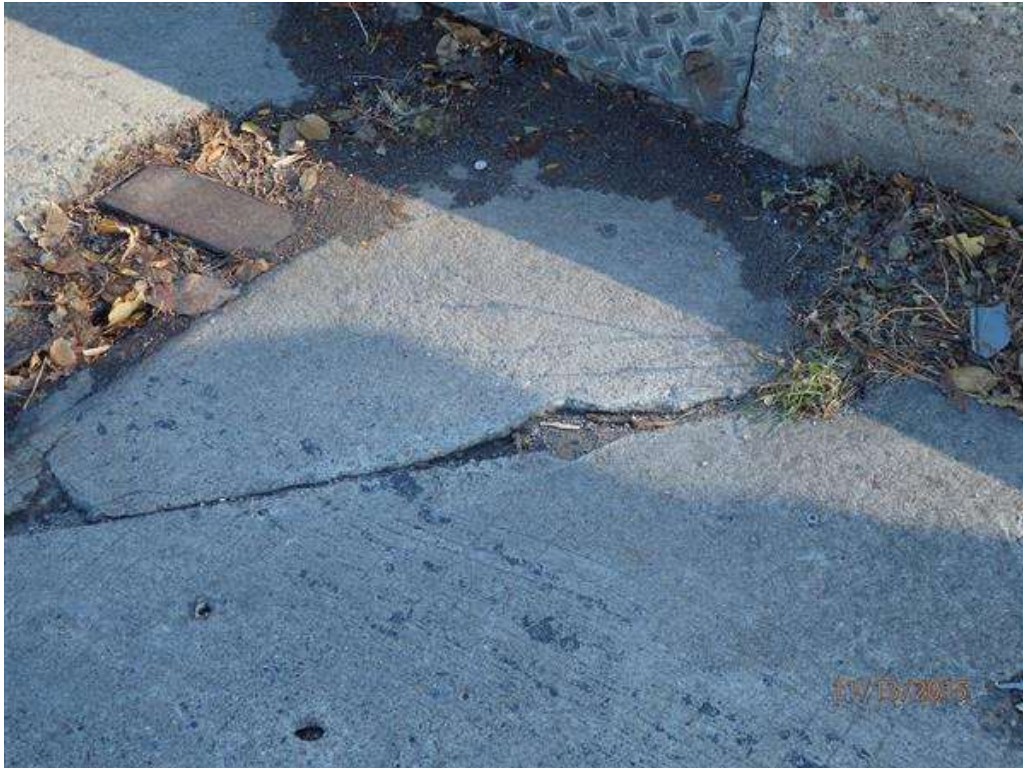
Photo 20 - unsound patch S. approach panel at gutter line

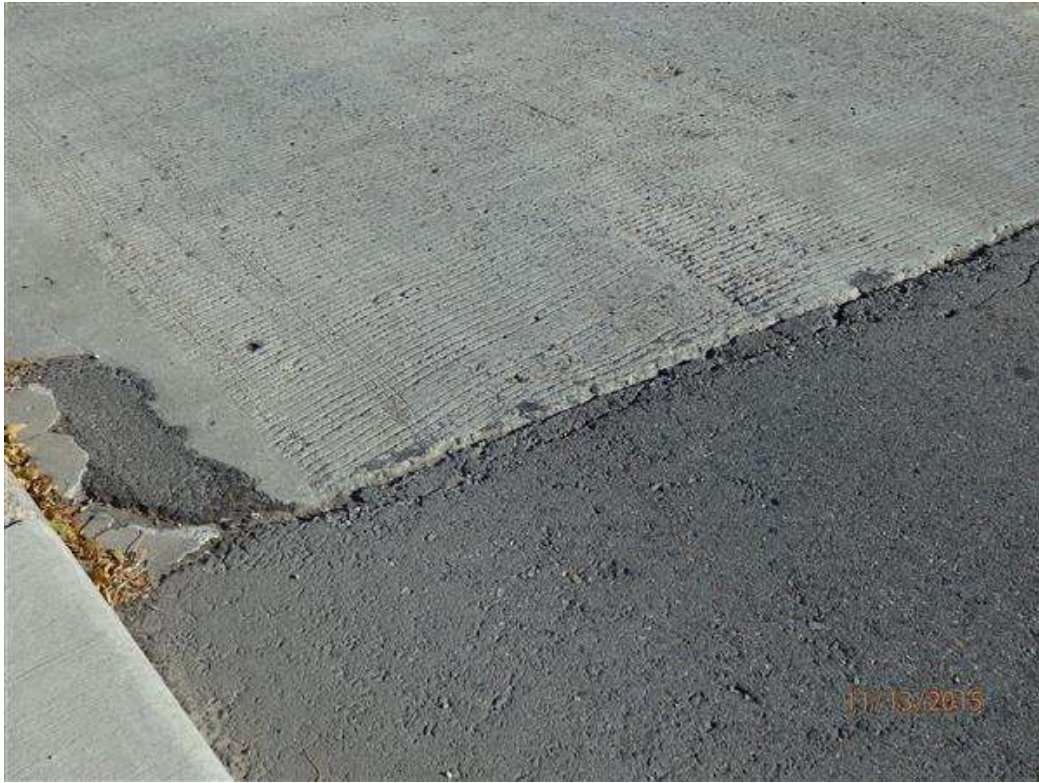
Photo 21 - unsound patch SW approach panel

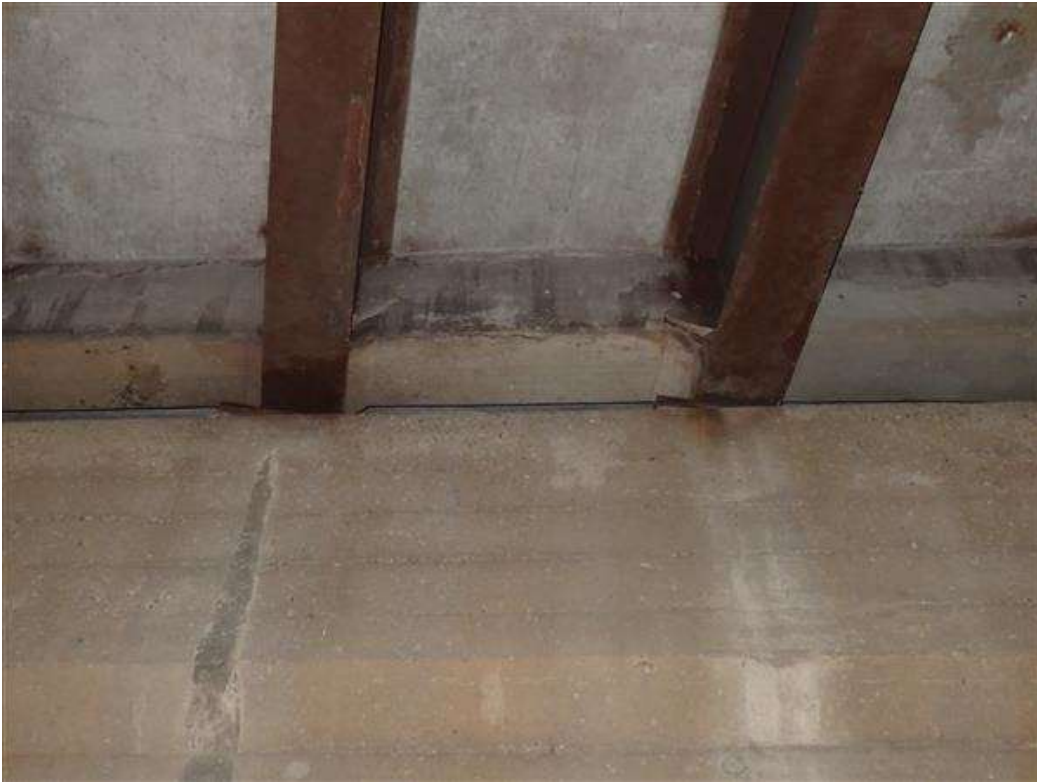
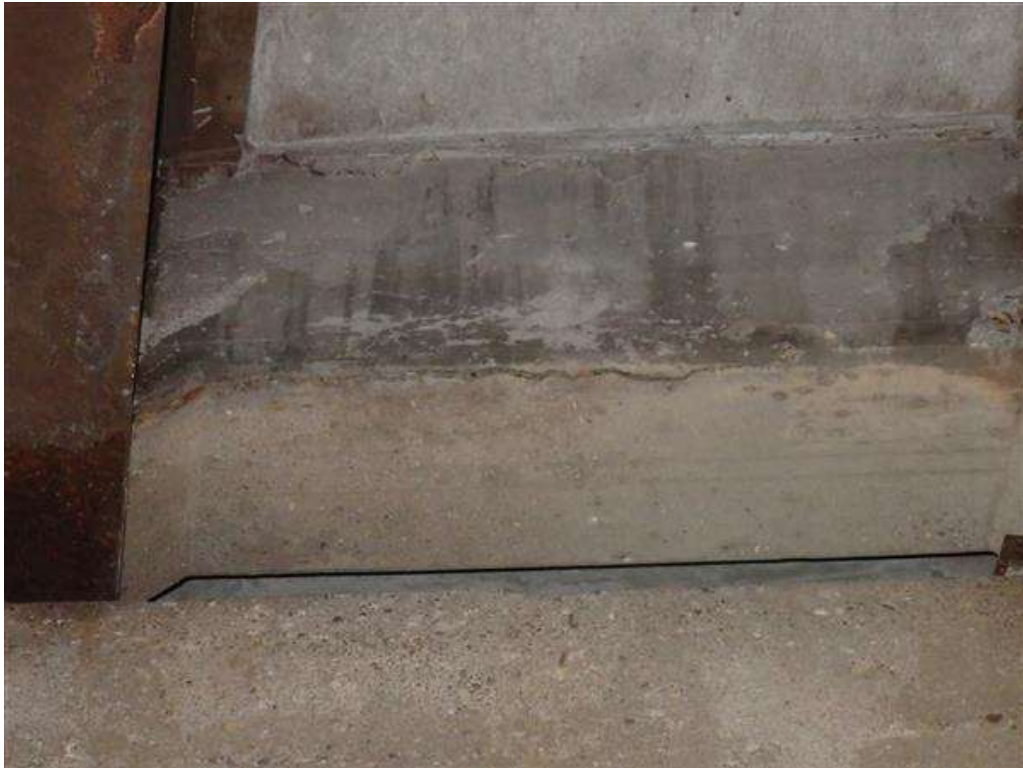
Photo 23 - Diaphragm at pier 4 (1)

Photo 24 - Diaphragm at pier 4 (2)

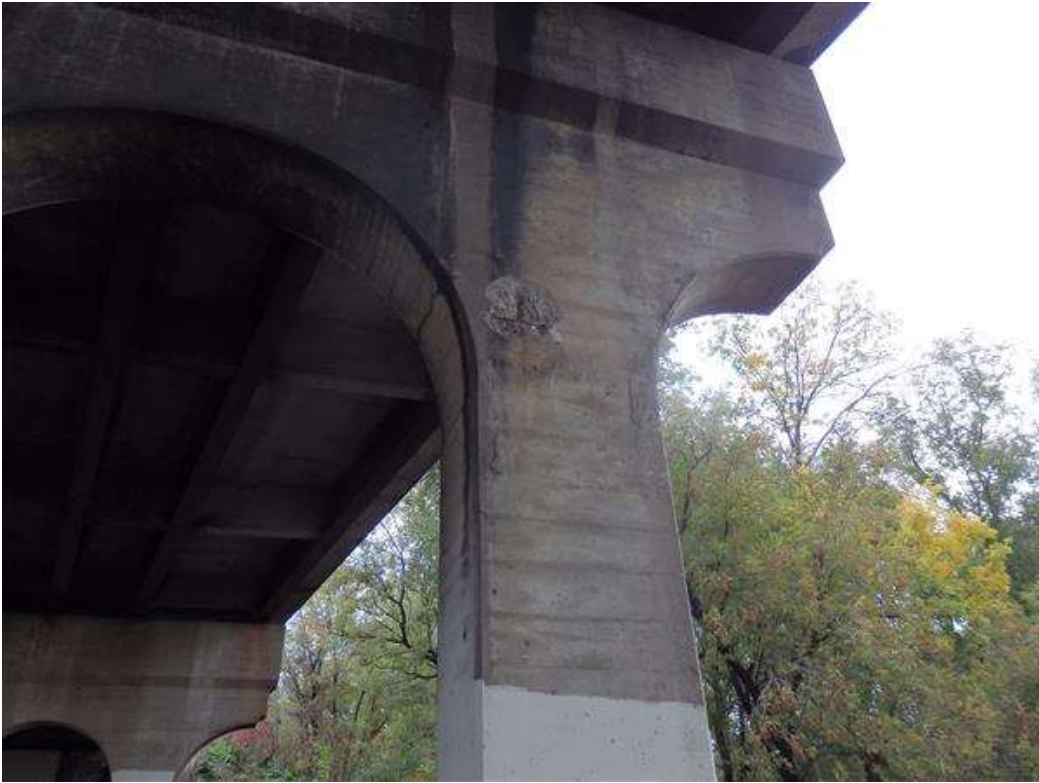
Photo 25 - Pier 3, S face

Notes: Gunite spalling off beams in span 3 over the RR. (TKDA 2012)							
	Pack rust distress at steel beam ends / bearing areas.			2011-16				
515	Steel Protective Coating	Routine	10/16/2016	21886 SF	0	20793	656	437
		Migrated Values		21886 SF	0	20793	656	437
	Notes: The paint system has extensive deterioration at the beam ends.			2015-16				
	Corrosion with flaking rust present at the beam ends.			2011-16				
	Prep. and paint recommended.			2011-16				
205	Reinforced Concrete Column	Routine	10/16/2016	20 EA	12	3	5	0
		Migrated Values		20 EA	12	3	5	0
	Notes: 4 sq. ft. +/- spalling concrete with exposed rebar on Pier #4 south face. (TKDA 2012) -16							
	Various column spalls / delams - see photos.			2014-15				
	1 SF spall at pier 3, S. face, delam is below.			2016

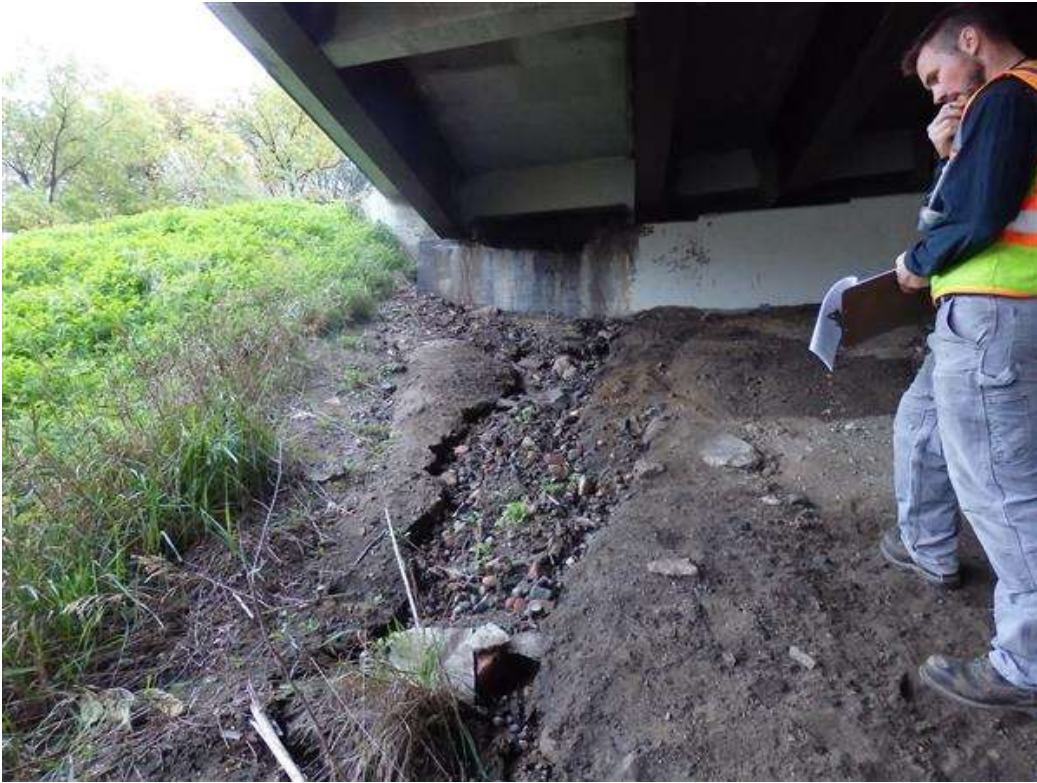
Photo 29 - Slope washout at SE end

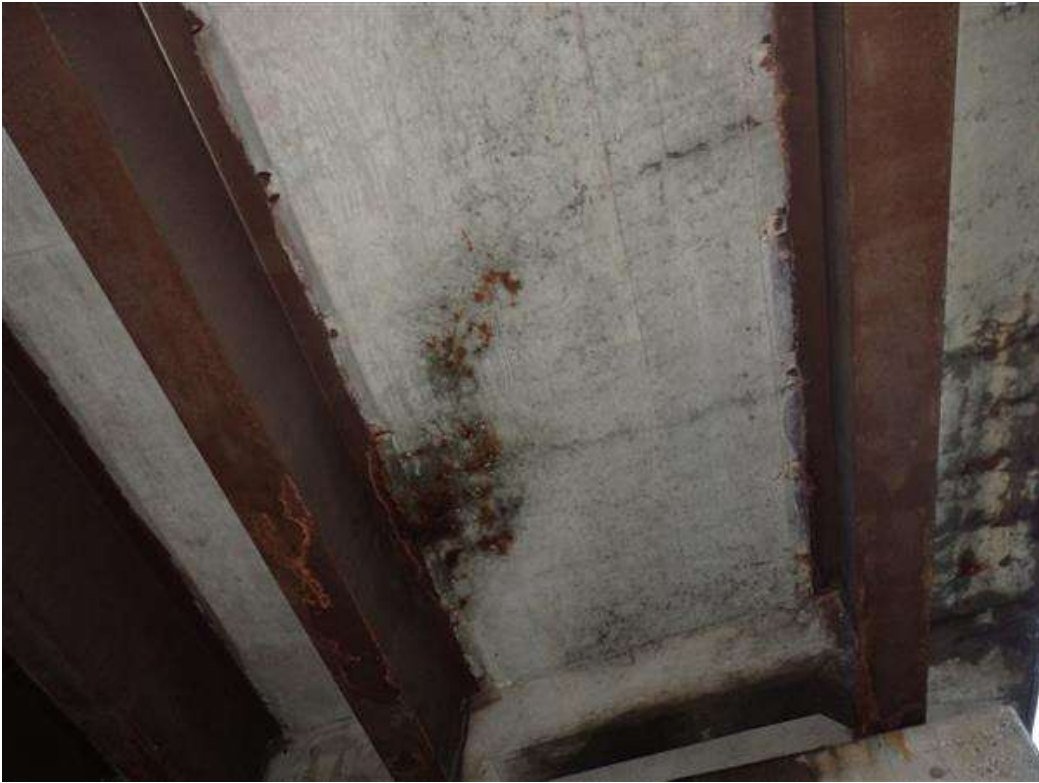
Photo 31 - Staining, E side near S abut
