**2016 ROUTINE
BRIDGE INSPECTION REPORT**

**BRIDGE # 5664
CSAH 55(JACKSON) over BNSF RR**

Date(s) of Inspection: 04/29/2016

**Report Written By: Ron Ekstrand
Report Reviewed By: Glenn Pagel
Final Report Date: 06/08/2016**

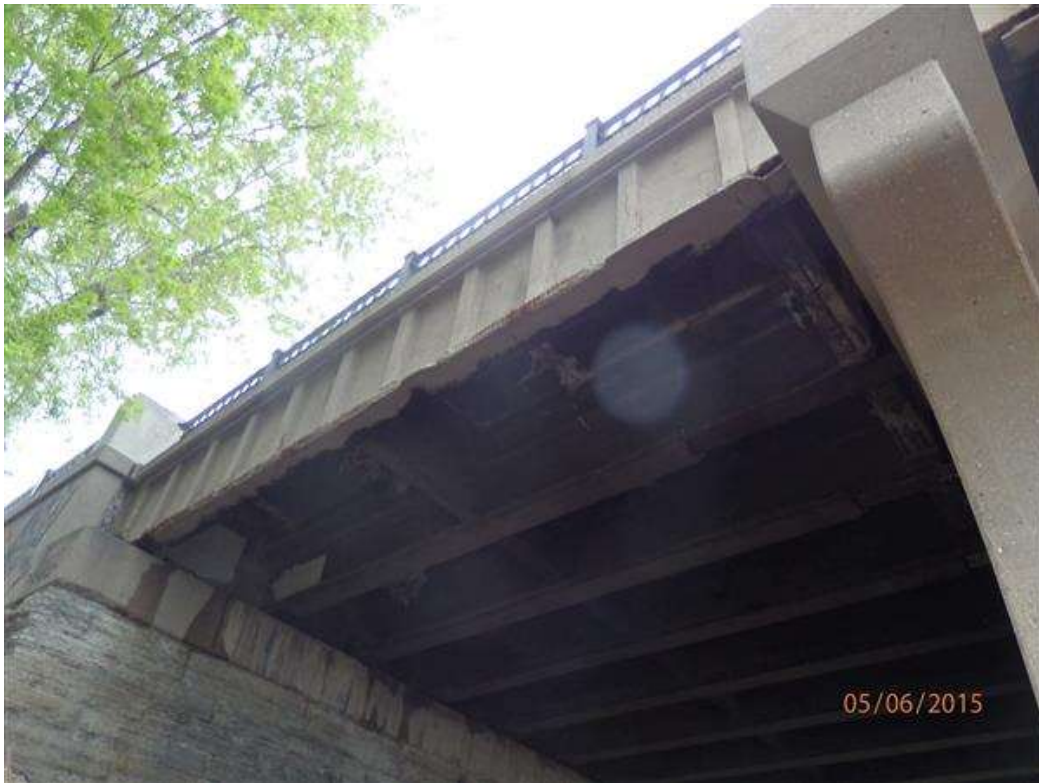
Photo 5 - abut beam - NW.end

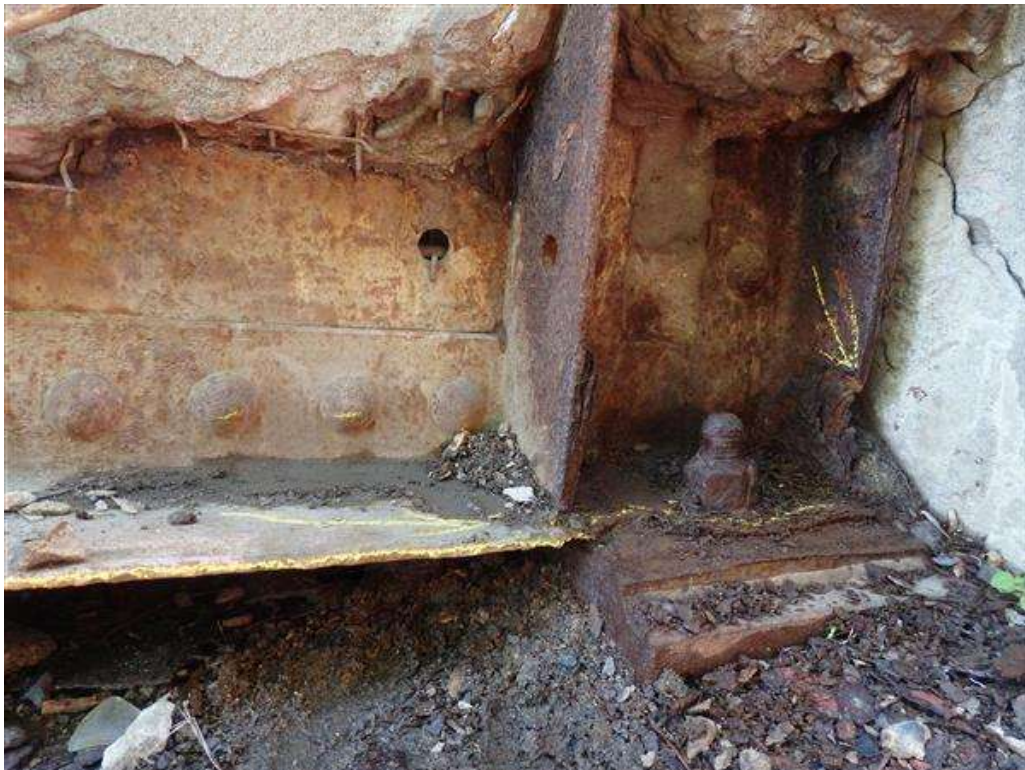
Photo 6 - abut NE bearing

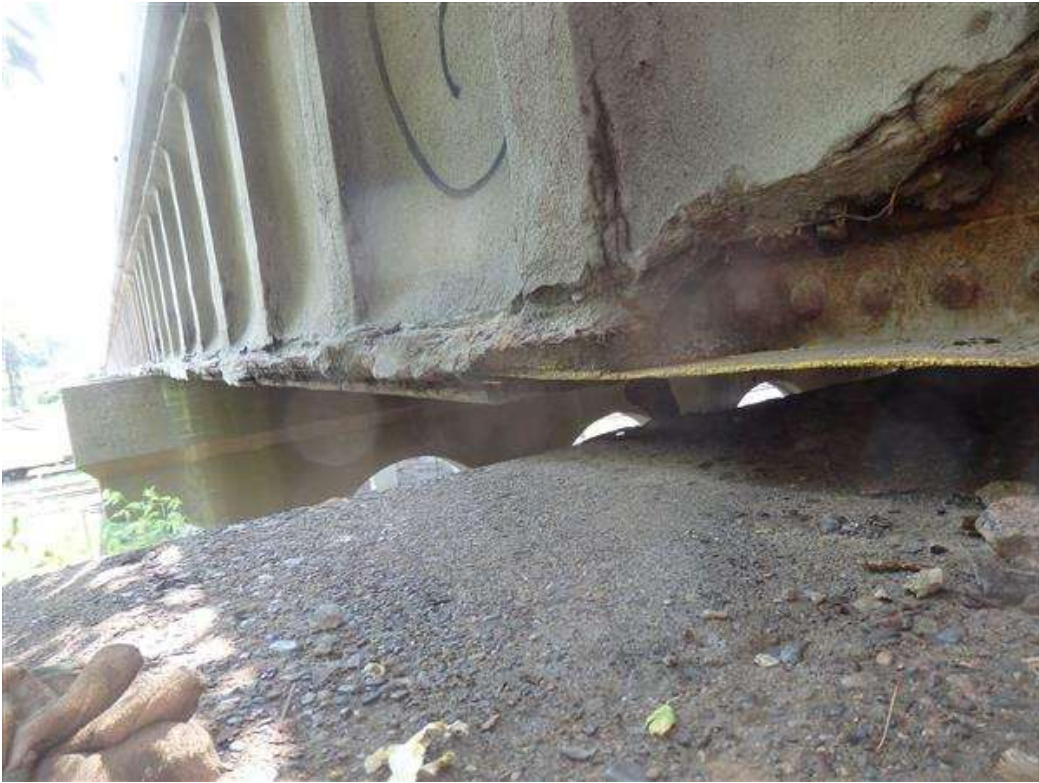
Photo 7 - abut NE fascia beam

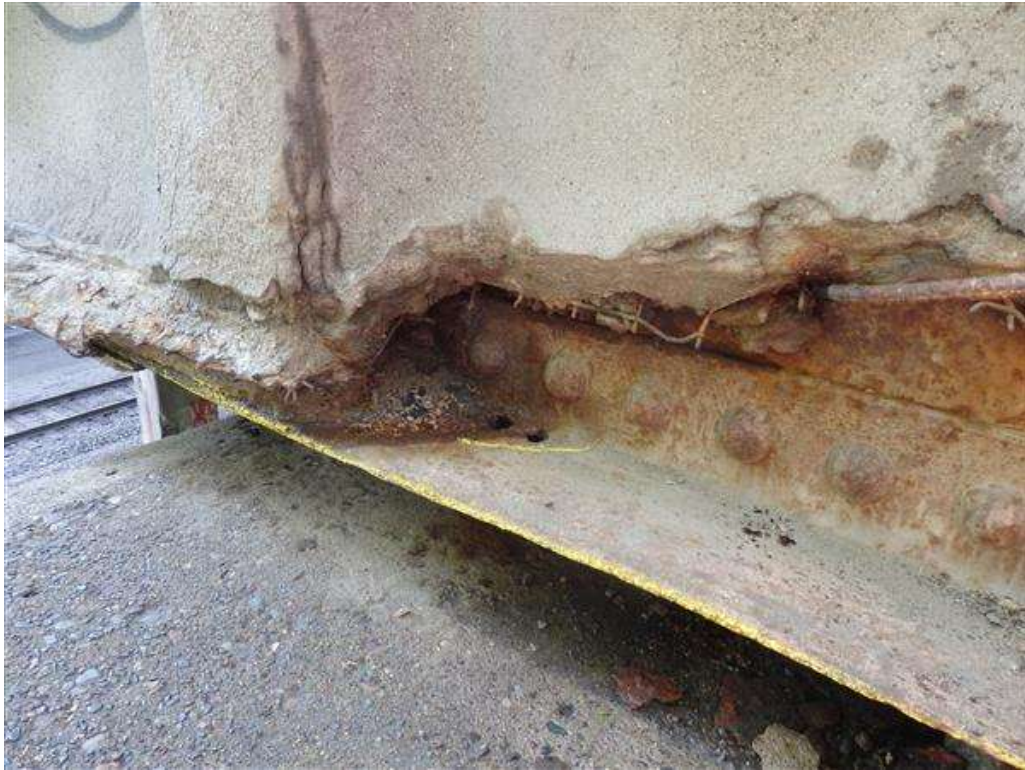
Photo 8 - abut NE fascia beam (2)

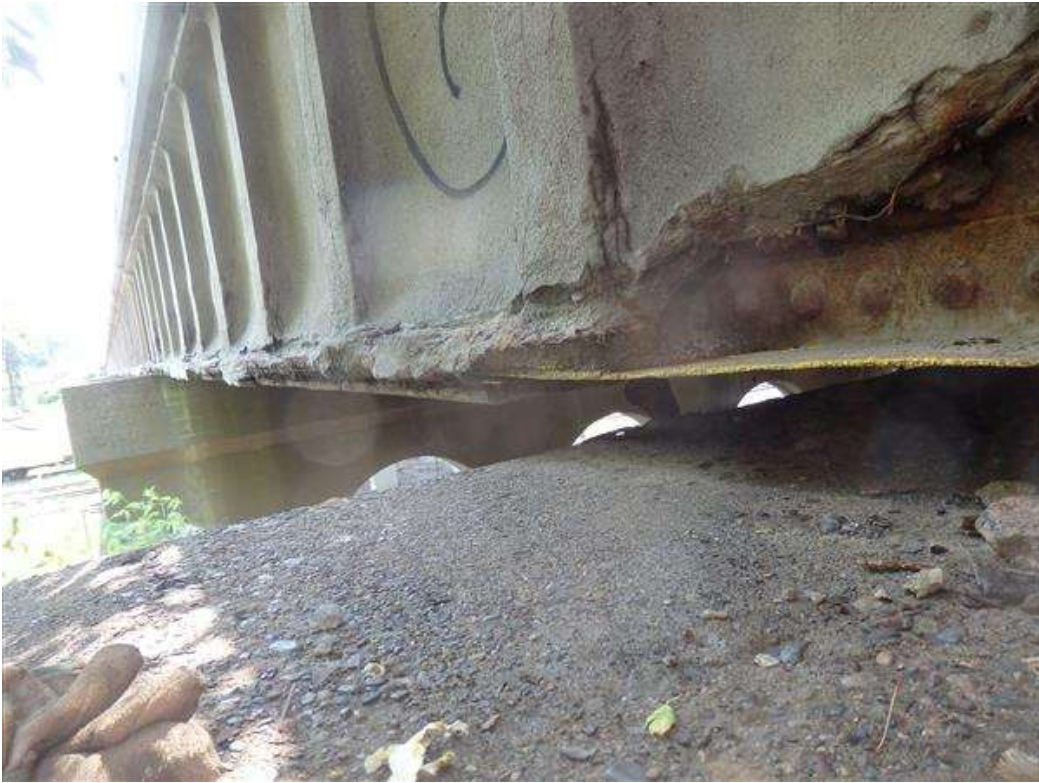
Photo 9 - abut NE fascia beam

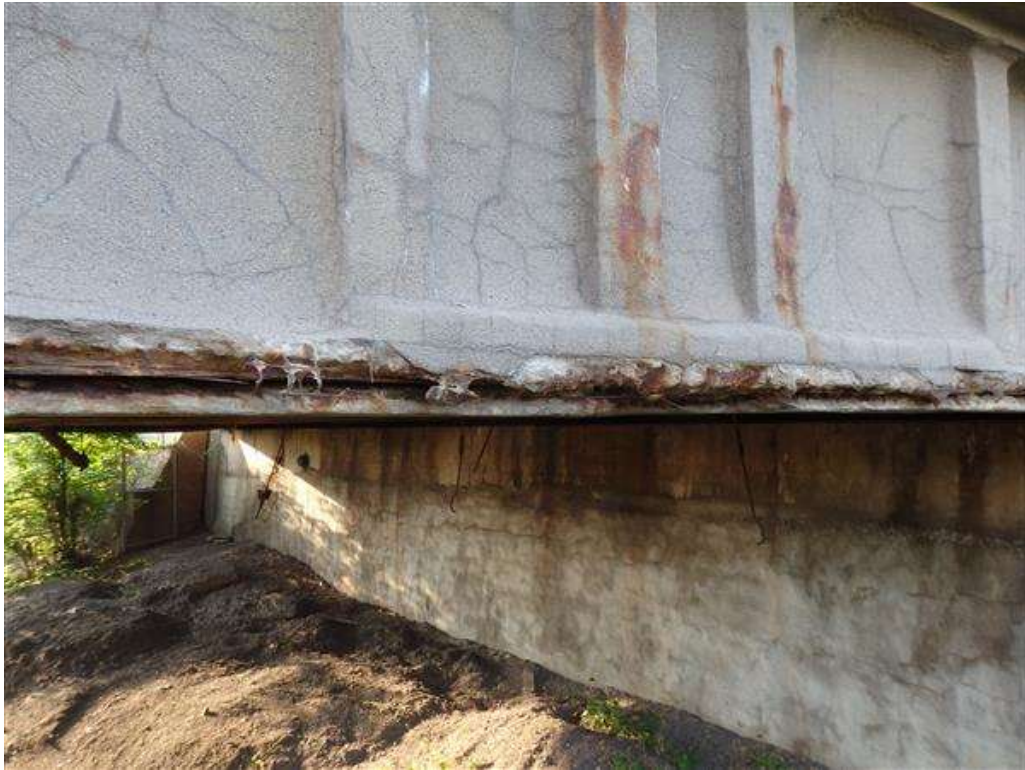
Photo 10 - abut SW fascia b mapcracking

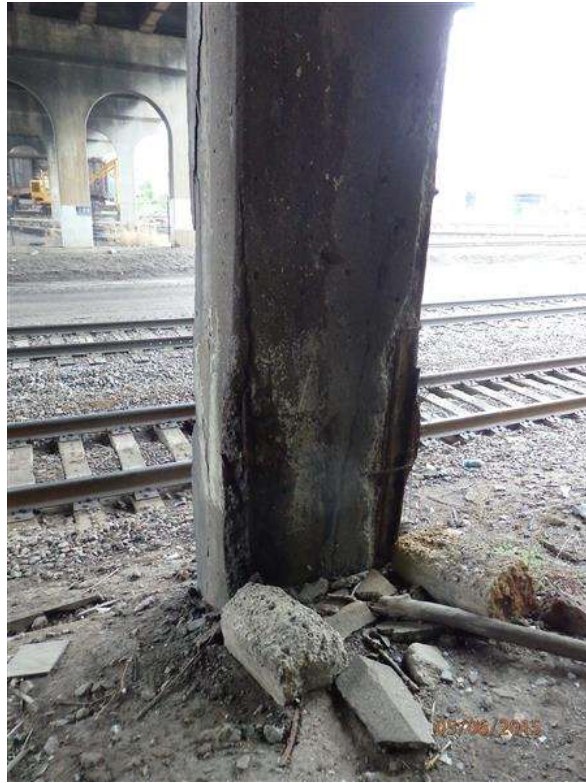
Photo 11 - pier 2 - column E.inner.side

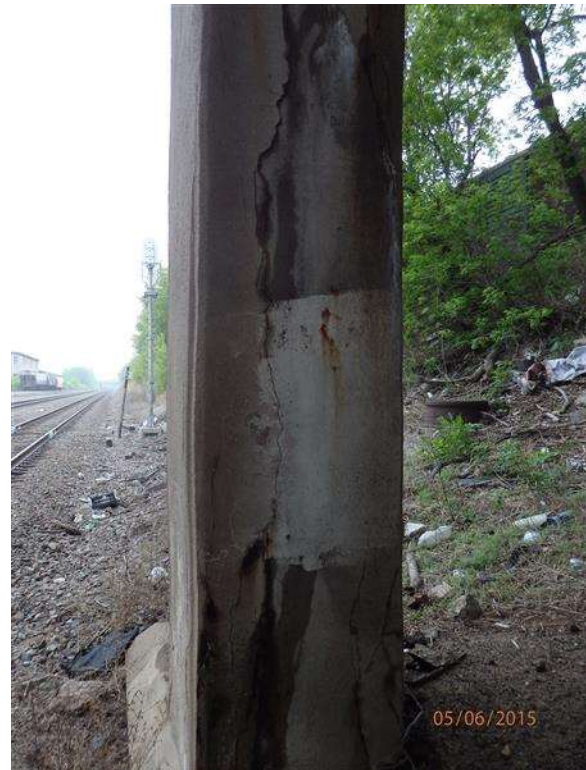
Photo 12 - pier 2 - column E.side

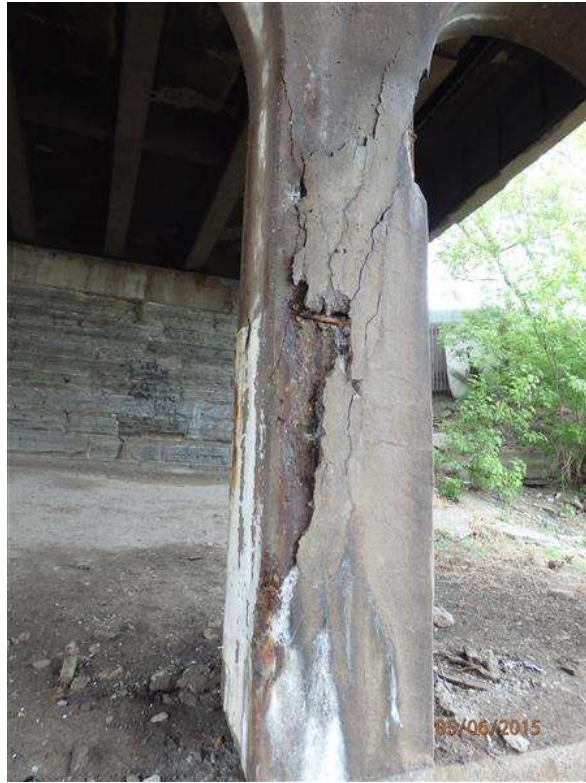
Photo 13 - pier 2 - column W.inner.side

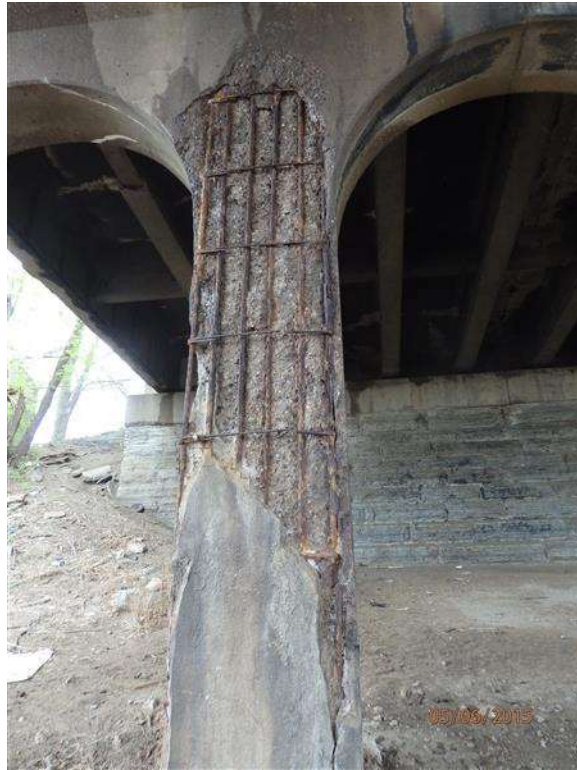
Photo 14 - pier 2 - column W.side

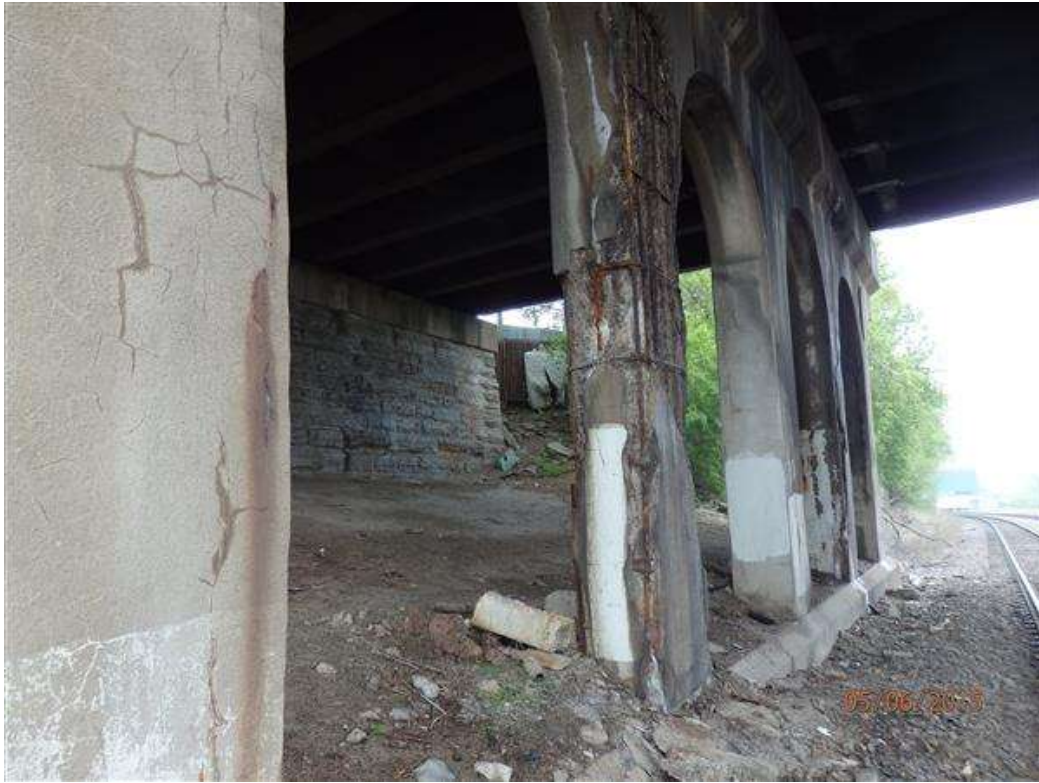
Photo 15 - pier 2 - columns East view

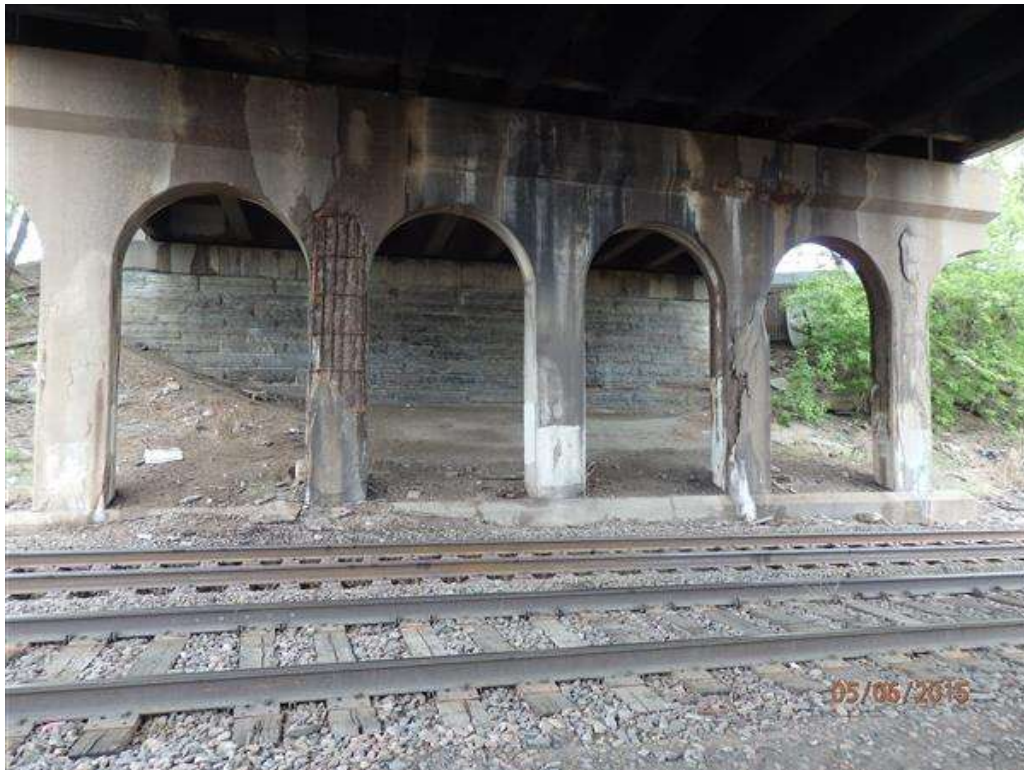
Photo 16 - pier 2 - columns N.side

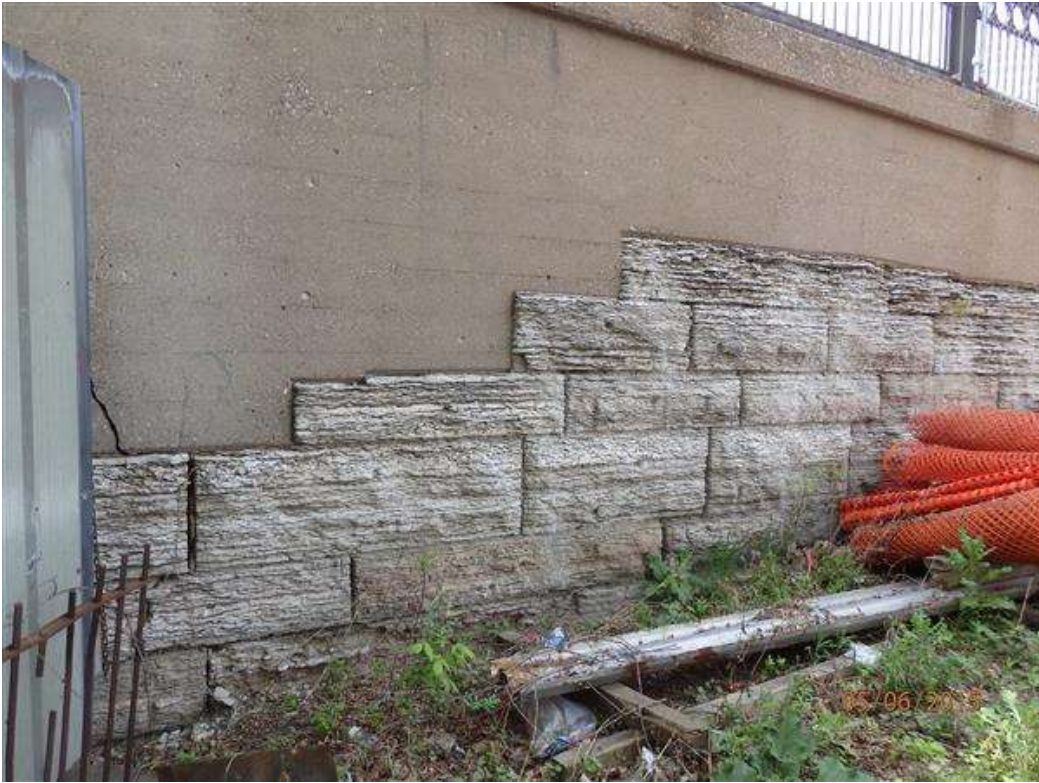
Photo 17 - wing NE_4

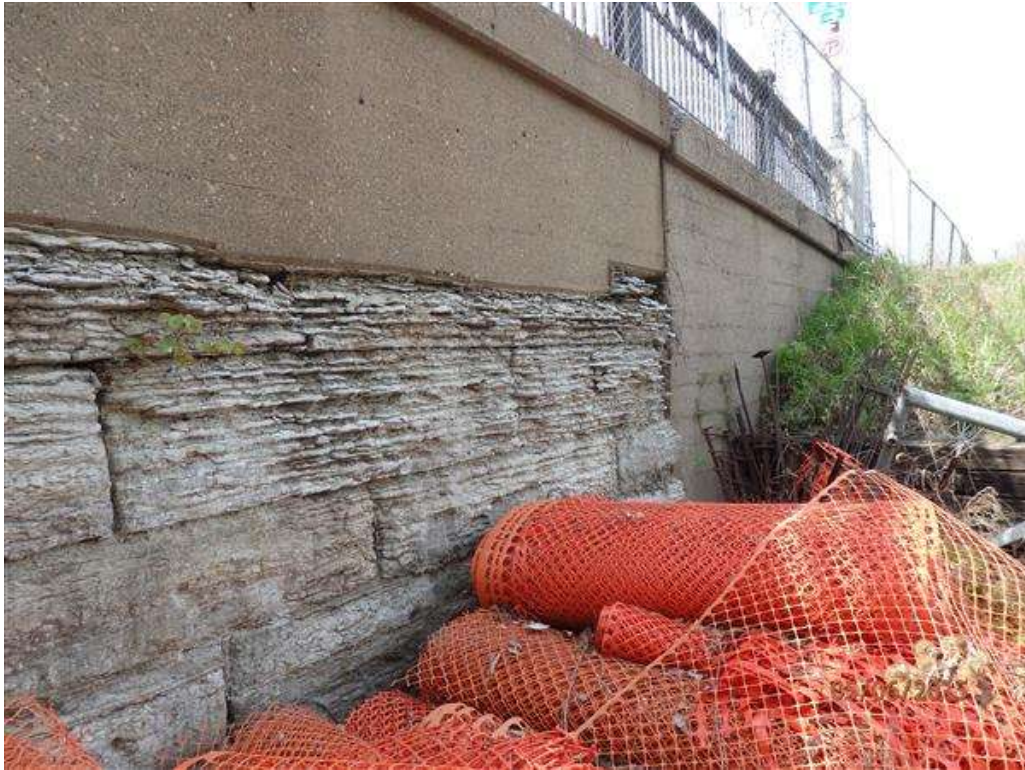
Photo 18 - wing NE_5

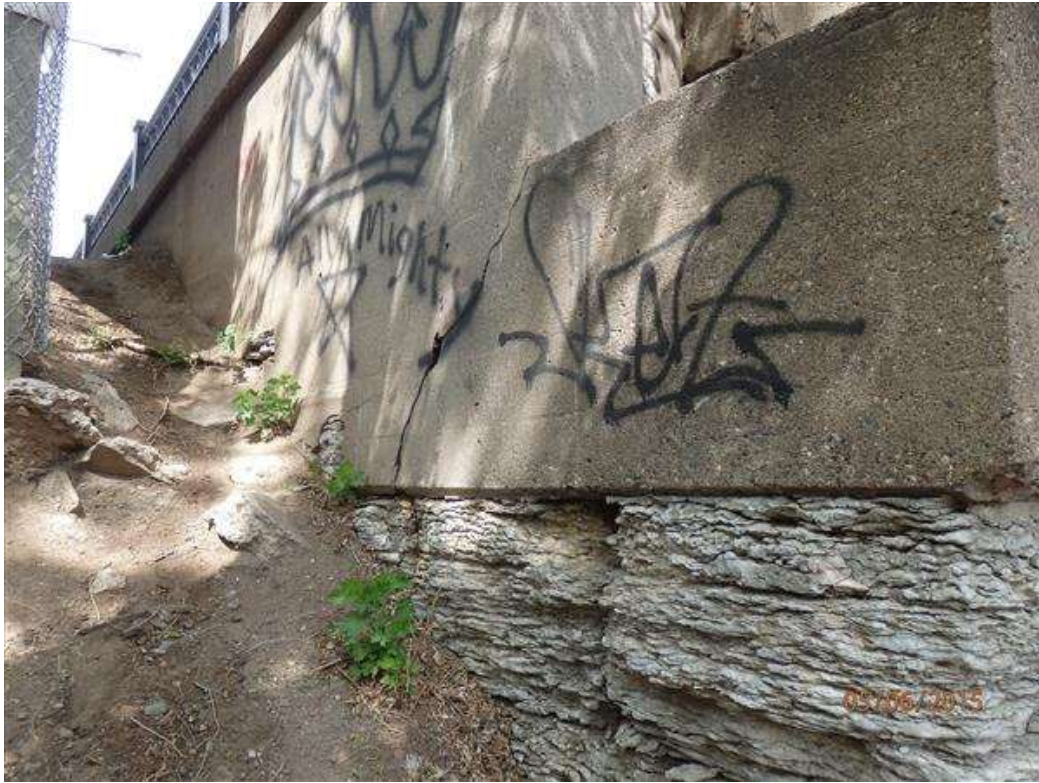
Photo 19 - wing NW_3

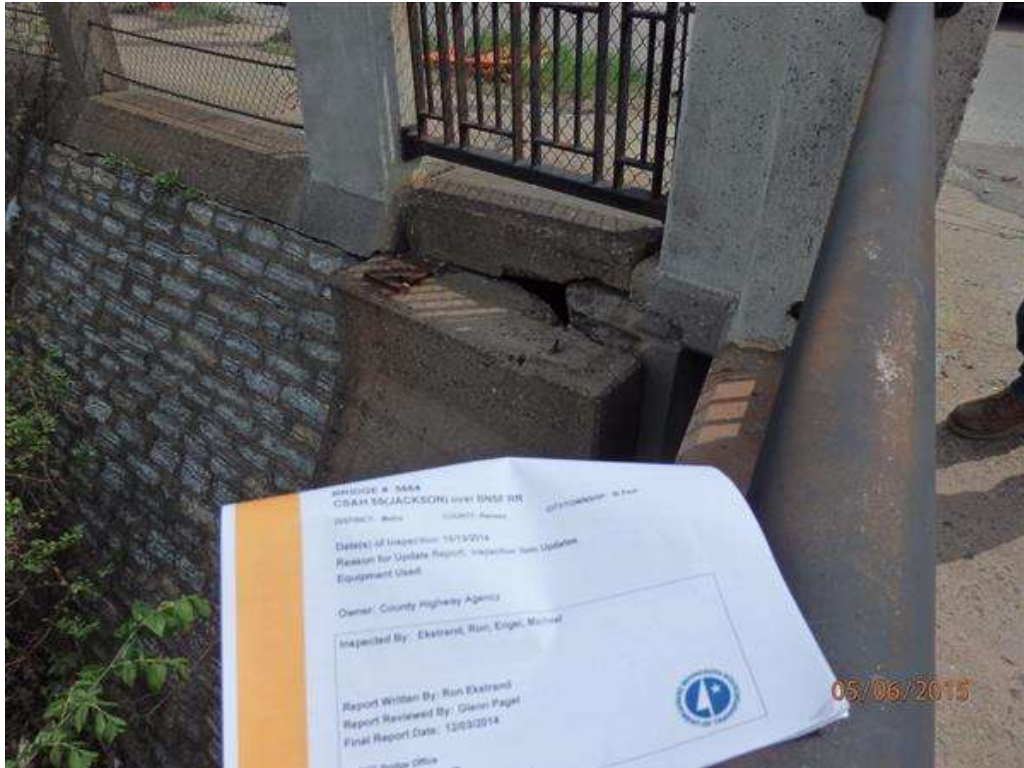
Photo 20 - wing SE_1
