**2015 ROUTINE  
BRIDGE INSPECTION REPORT**

**BRIDGE # 62001  
RICE ST over BNSF RR**

**Date(s) of Inspection:** 11/05/2015

**Inspected By:** Essler, Brian

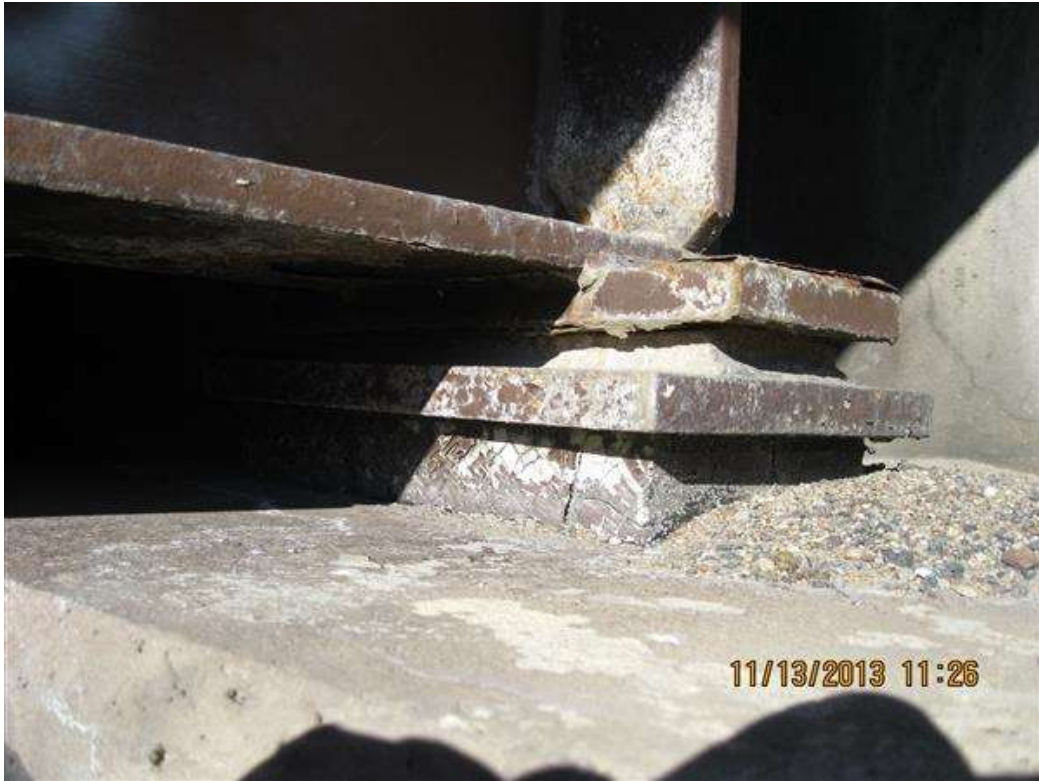
Photo 1 -

Notes: Minor evidence of corrosion exists at the SW corner 2005-2015.  
 No evidence of deterioration 2003.

1. bearing NE cor..JPG

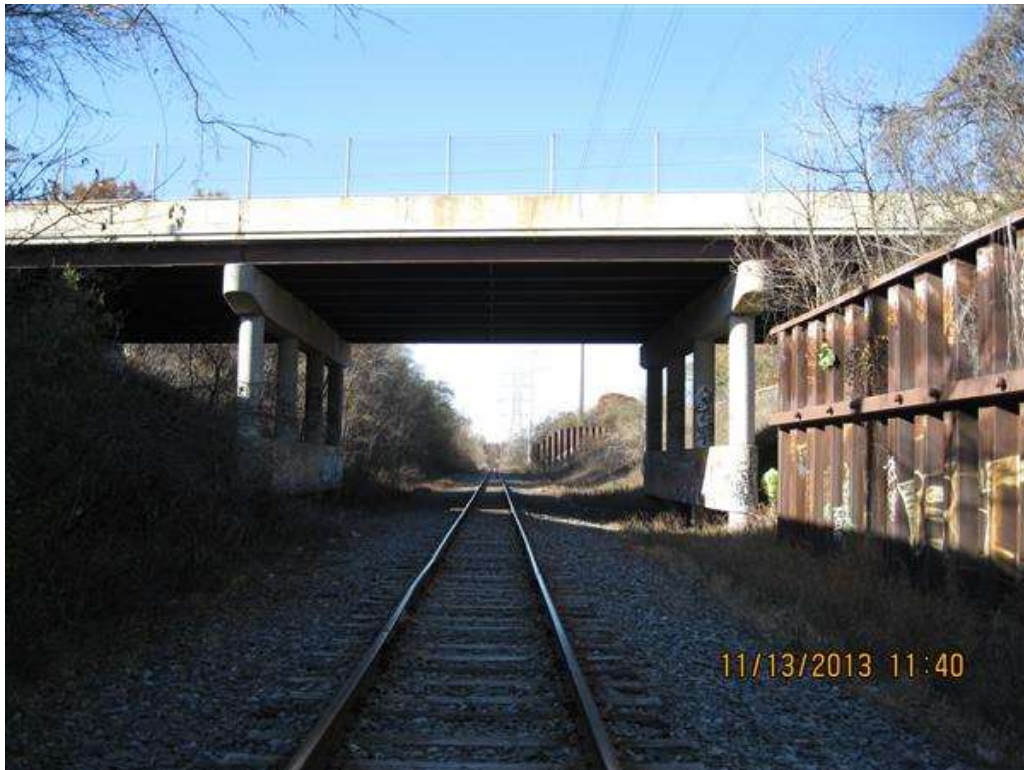
Photo 2 -

2. east side.JPG

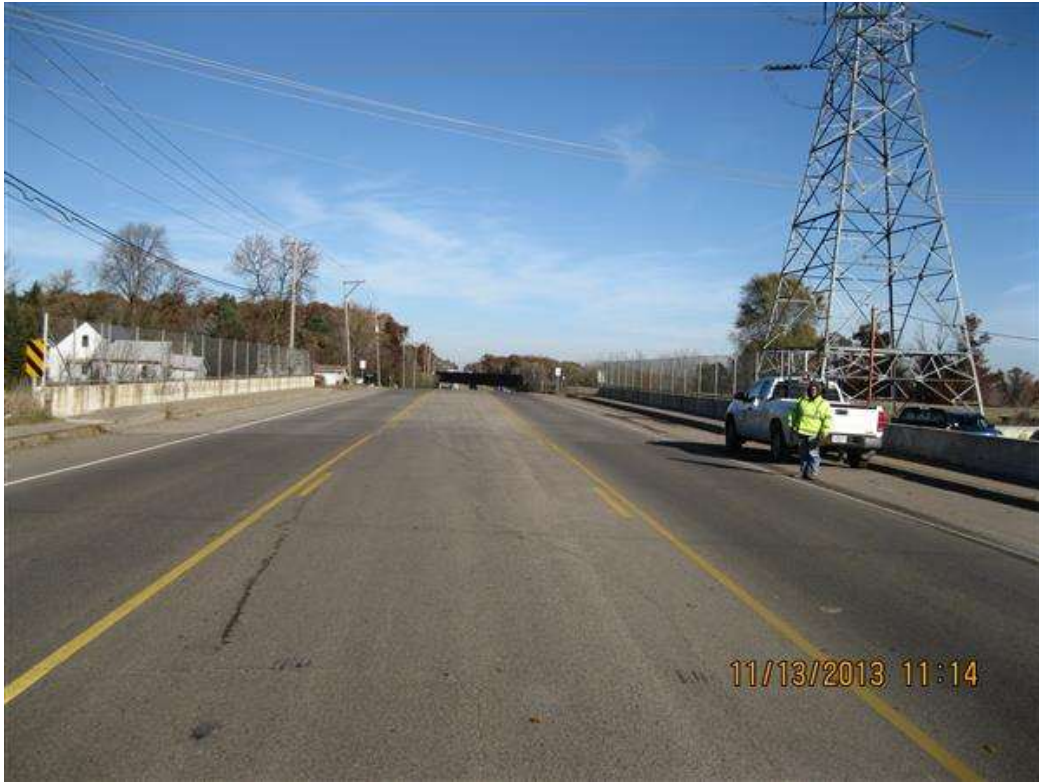
Photo 3 -

3. looking north.JPG

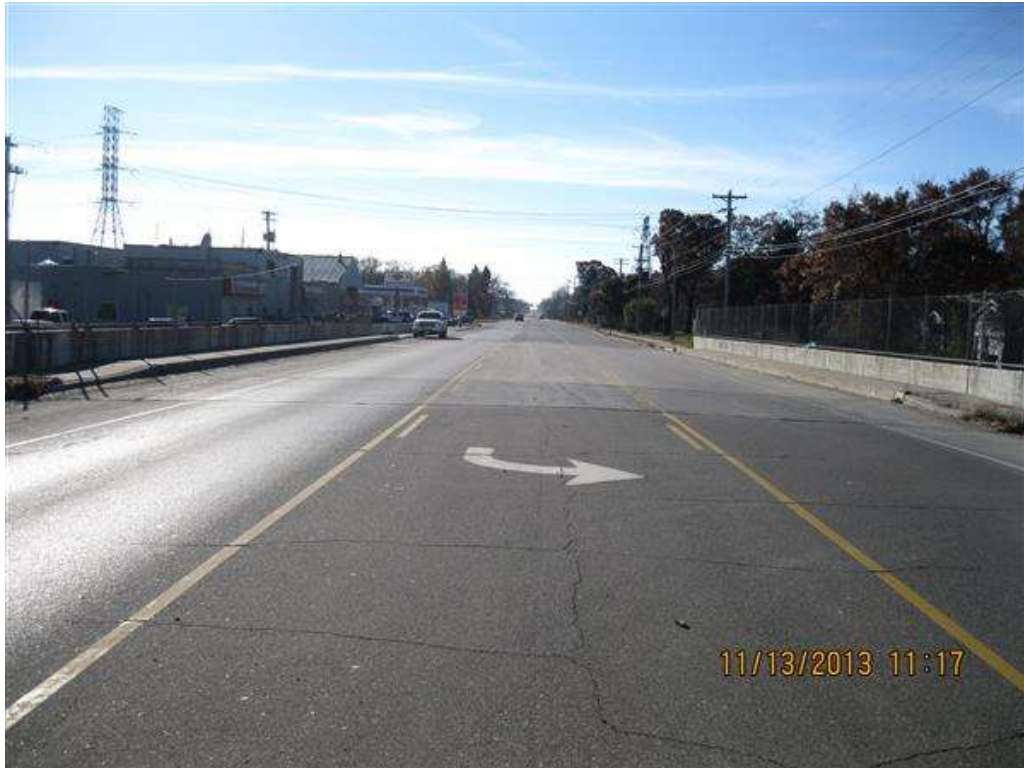
Photo 4 -

4. looking south.JPG

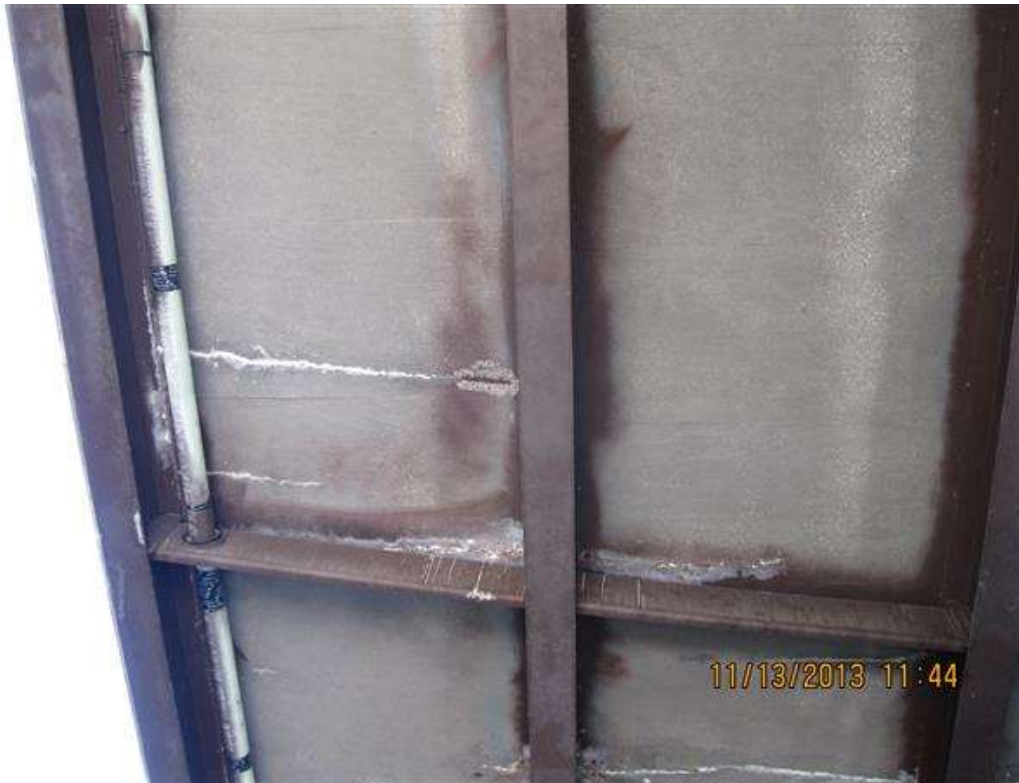
Photo 5 -

Notes: There is a 6" X 6" spall at the north abutment at beam 8 2015  
 there is a 3' X 1' spall between beam 5 & 6 and a 2' X 2' spall with exposed rebar between beam 1 & 2 above the tracks 2015  
 There is delamination @ center of bridge (5' x 2') 2013-2015  
 There is a spall with exposed rebar between beams 7 & 8 above tracks (2' x 1') 2013-2015  
 There are 2 transverse cracks @ mid span entire width. Some delamination is beginning 2011 - 2015.  
 There are numerous transverse cracking extending inward from both sides 2009-2015.  
 South abut. - pier has 80 LF of cracks, between piers 225 LF of cracks and from pier - no. abut. 64 LF of cracks for a total of 369 LF of transverse cracks with leaching & efflorescence 2011 - 2015.  
 There is a transverse crack @ mid span entire width 2007-2009.  
 Previous inspections - There are 3 cracks west side & 5 cracks east side 2007.  
 Transverse cracking with efflorescence and minor rusting. Mostly at center bridge entire width 2001.

5. spall & crack under deck.JPG

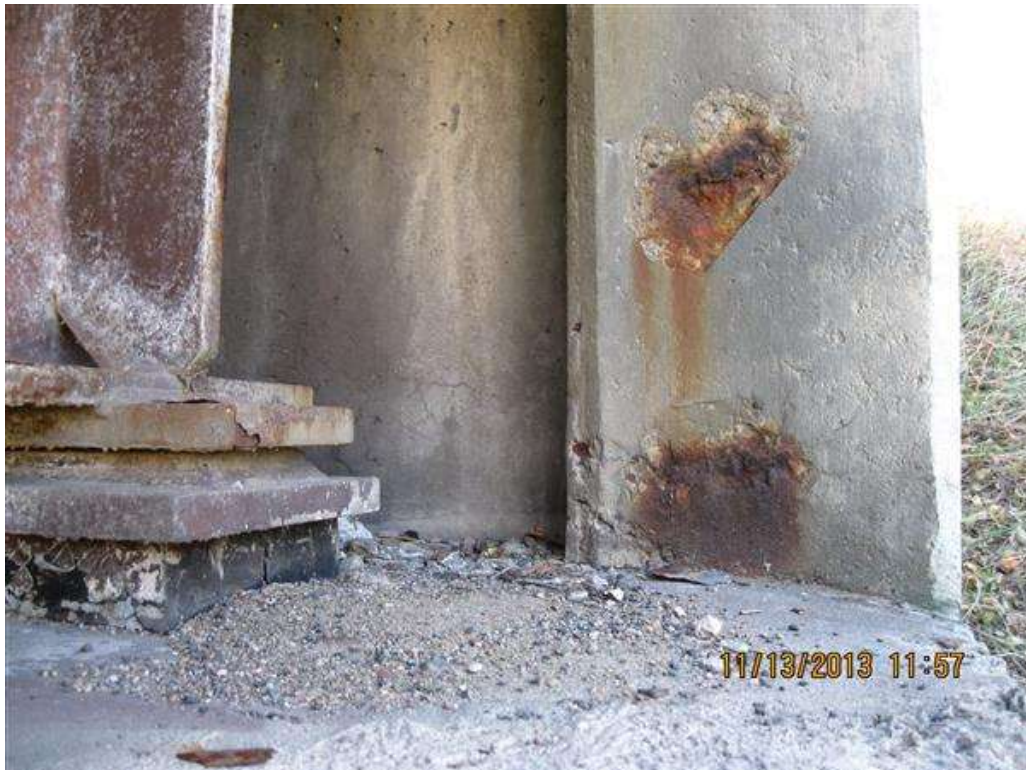
Photo 6 -

Notes: There are 2 spalls with corrosion @ SW corner back wall 2015.  
 There is a 2' moderate crack on the face of the north abutment between girders 4 & 5 2015.  
 Moderate crack in back wall between beams 5 & 6 by construction joint 2013-2015  
 There is minor corrosion NW corner @ backwall 2007-2015.  
 There are 4 minor vertical cracks & minor deterioration of 2 expansion joints @ south abutment 2003-2015.  
 There are 2 -6" areas of delamination with corrosion @ SW corner backwall 2003-2013.  
 The north abutment has minor deterioration of 2 expansion joints @ bridge seat and backwall 2003-2015.  
 There are minor horizontal and vertical cracking @ backwall north side 2003-2015.  
 The north abutment has 6 minor - moderate vertical cracks 2009-2015.  
 15% is condition state 2 2009-2011.  
 10% is condition state 2 2005-2007.

6. spalls by wing on SW cor..JPG

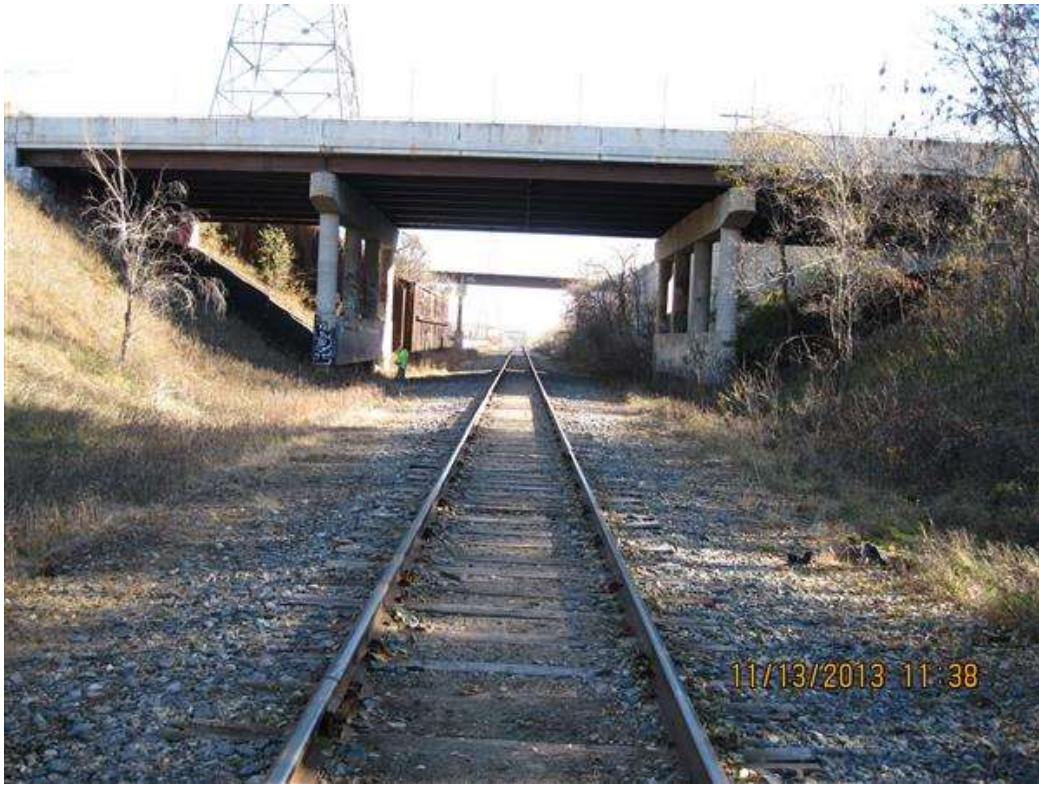
Photo 7 -

7. west side.JPG
