**2016 ROUTINE  
BRIDGE INSPECTION REPORT**

**BRIDGE # 62002  
CP RAIL over CSAH 49(RICE ST)**

**Date of Inspection: 10/13/2016**

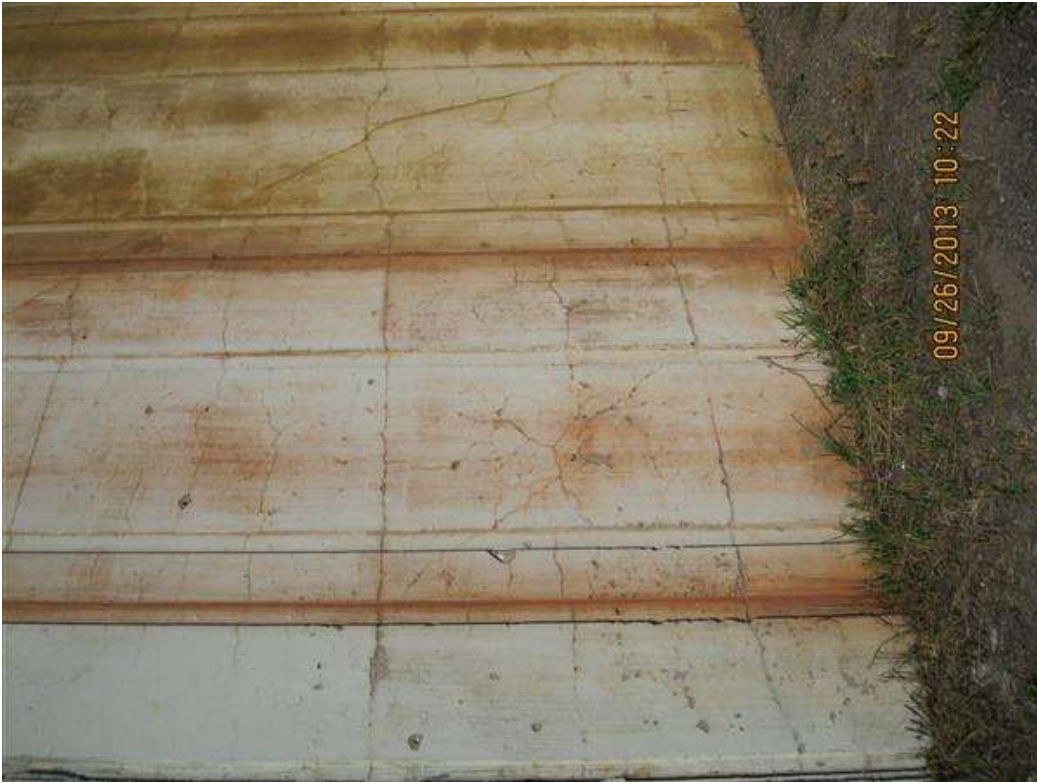
Photo 5 - west abutment

Notes: WEST ABUTMENT  
 [2013-2015] 2 - 10' minor crack's in NW corner  
 [2013-2015] There are numerous moderate spalls at the SW corner.  
 [2007-2015] The west abutment contains numerous moderate diagonal & vertical cracking at the SW corner.  
 [2011-2015] West abut has 4 horizontal cracks the entire length.  
 EAST ABUTMENT  
 [2015] Joint material loose on north end  
 [2015] moderate spall on NE corner 2' x 3"  
 [2013-2015] 8' diagonal minor crack in SE corner  
 [2007-2015] The east abutment has diagonal cracking near the south side.  
 [2003-2015] East abutment has 4- 16' moderate vertical cracks with numerous minor horizontal cracking present.
