**2015 ROUTINE  
BRIDGE INSPECTION REPORT**

**BRIDGE # 62079  
CO Road E (CSAH 15 over BNSF RR)**

**Date(s) of Inspection: 11/12/2015**

**Final Report Date: 01/05/2016**

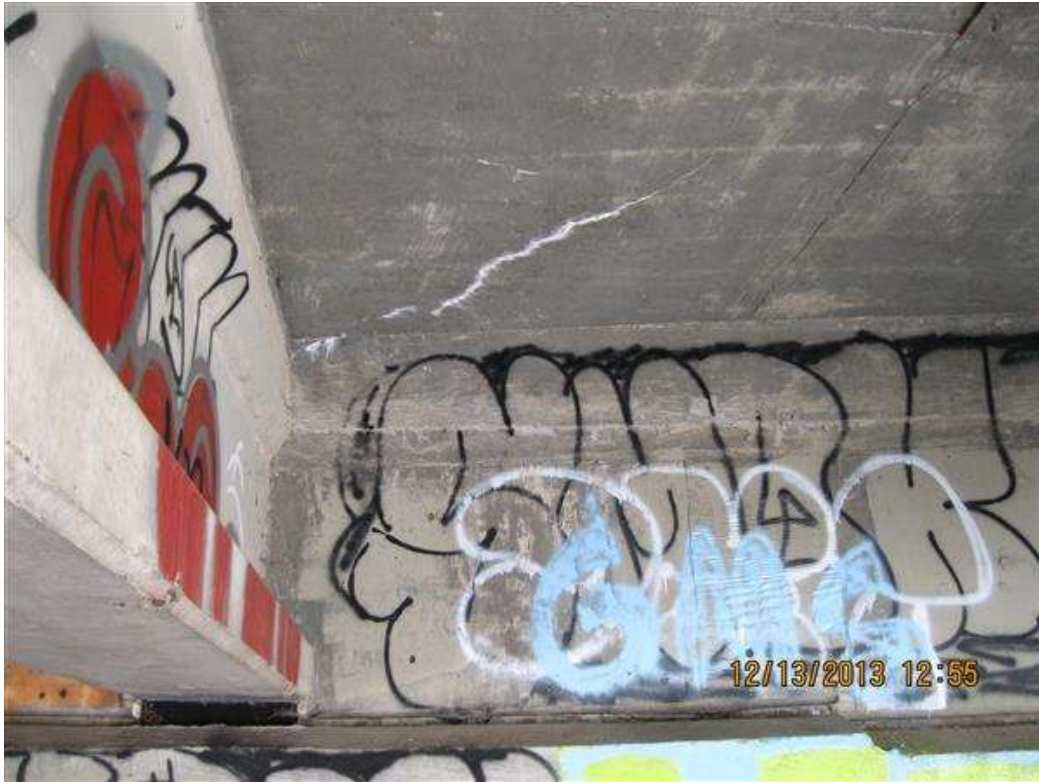
Photo 1 -

1. crack under bridge.JPG

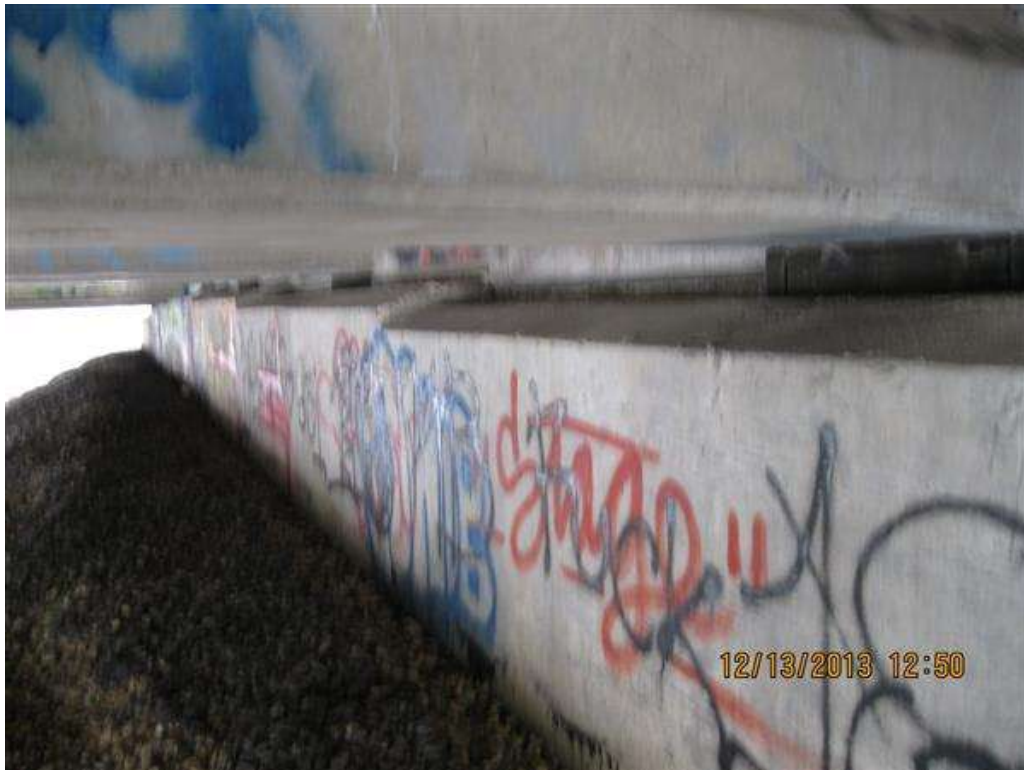
Photo 2 -

2. east bearings.JPG

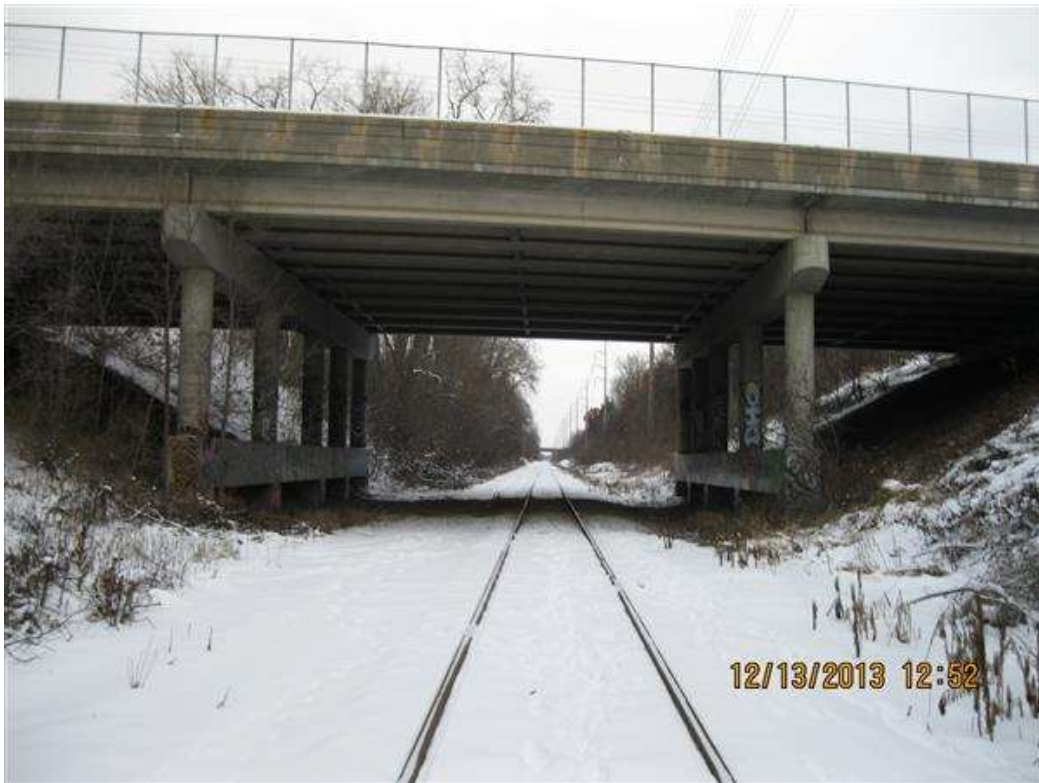
Photo 3 -

3. looking north.JPG

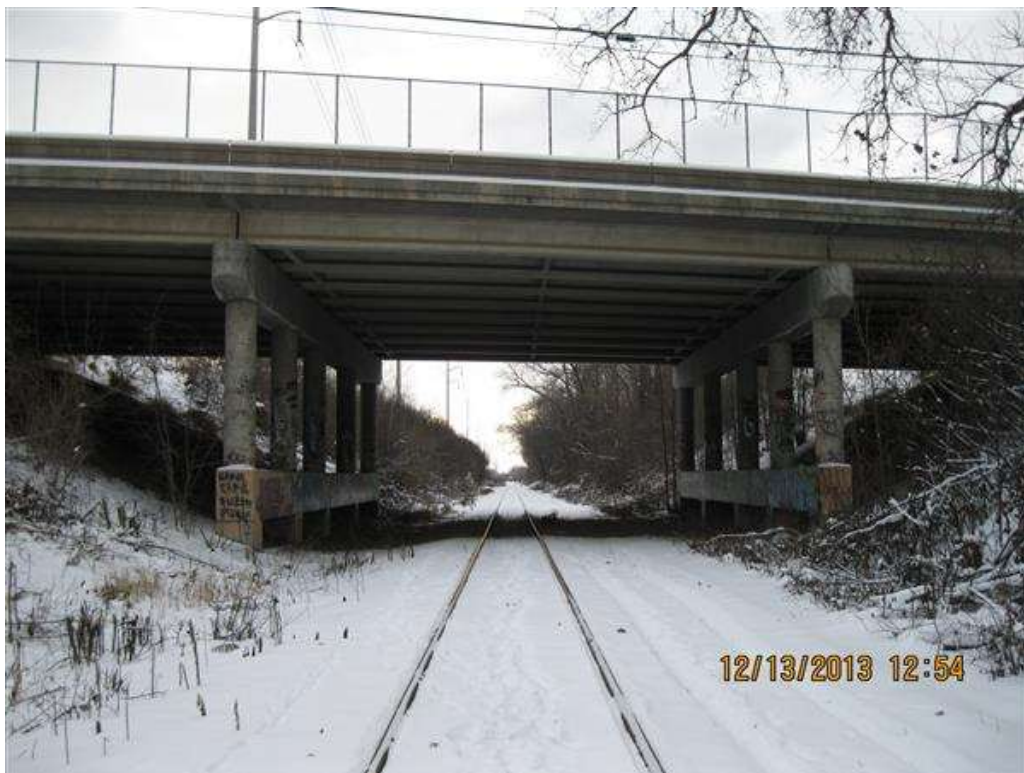
Photo 4 -

4. looking south.JPG

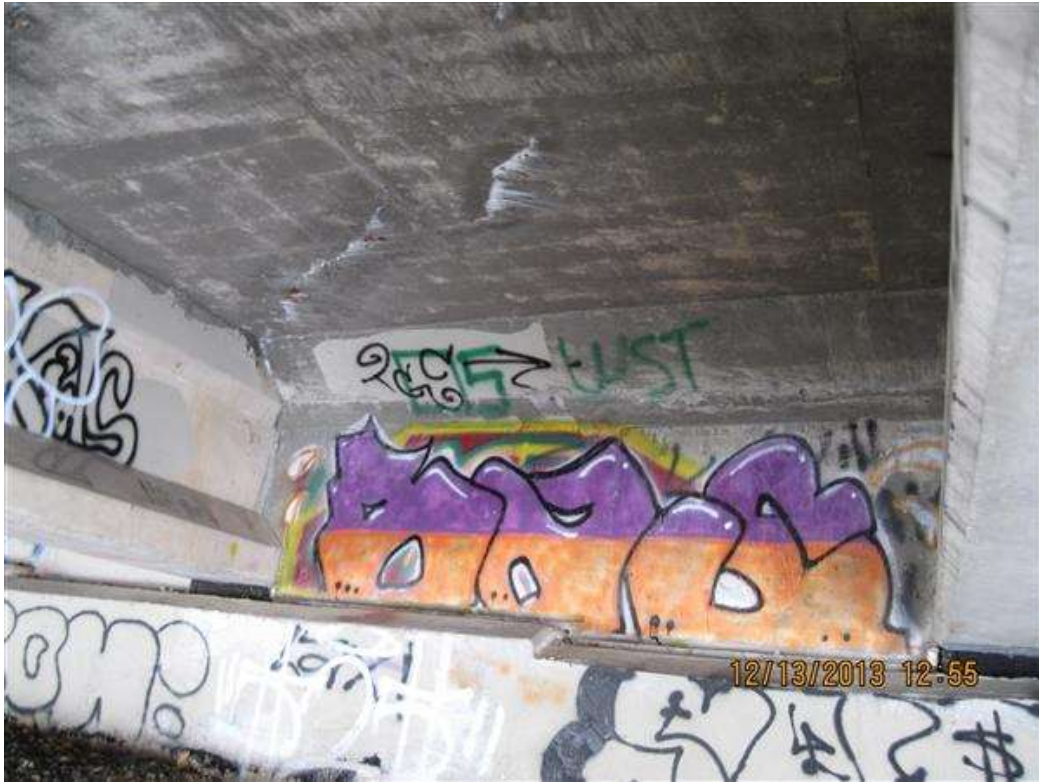
Photo 5 -

5. more cracks under bridge.JPG

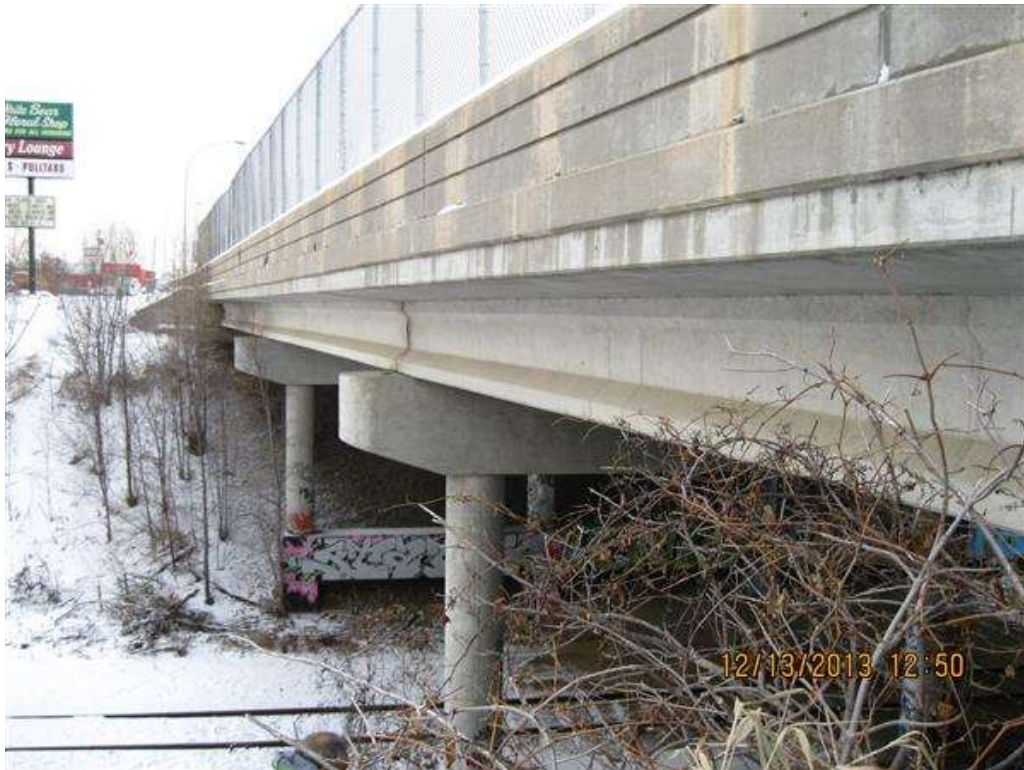
Photo 6 -

6. south beams.JPG

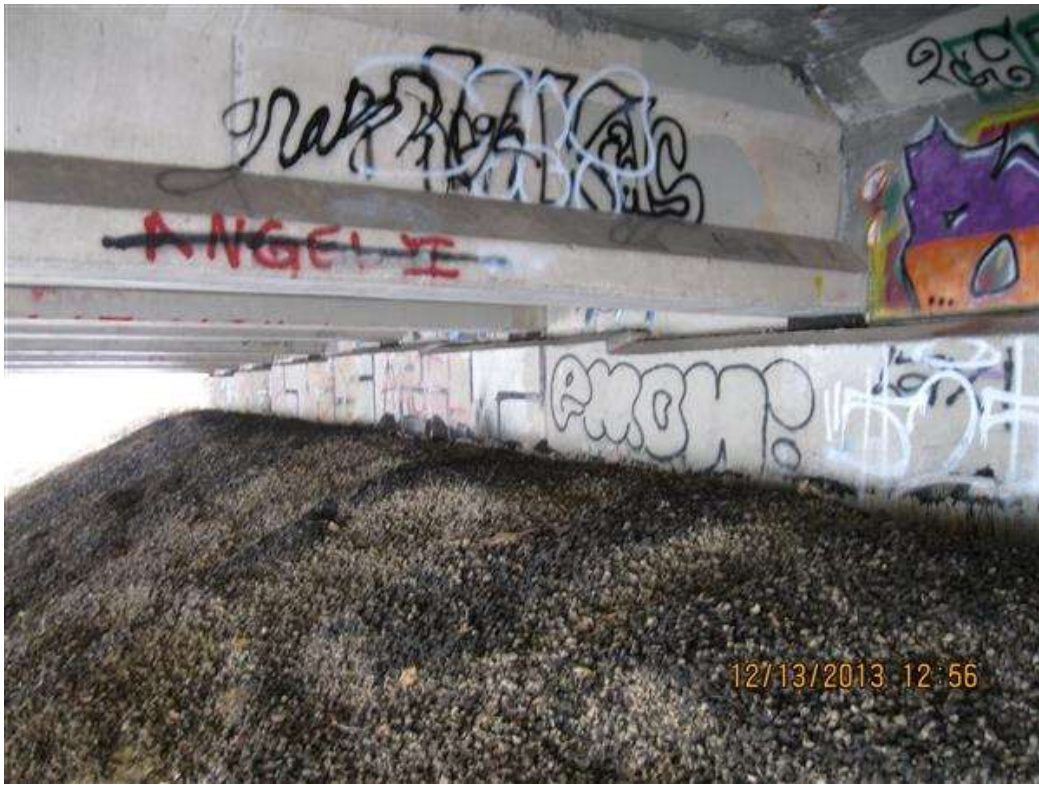
Photo 7 -

7. west bearings.JPG

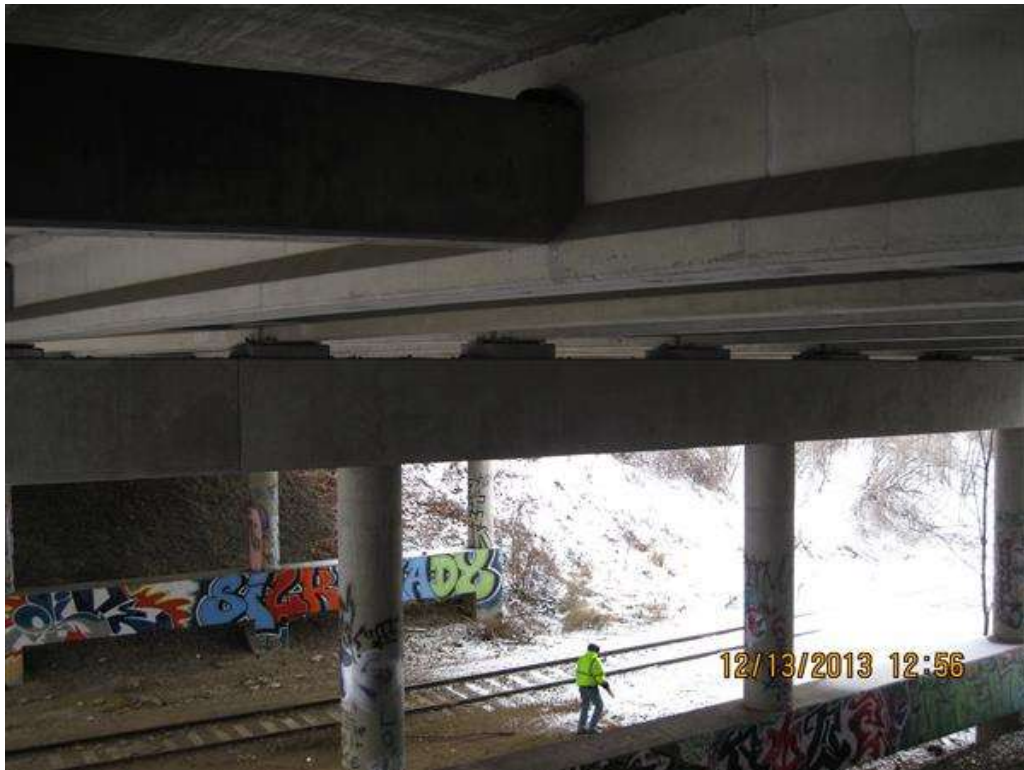
Photo 8 -

8. west pier.JPG
