**2015 ROUTINE  
BRIDGE INSPECTION REPORT**

**BRIDGE # 62516  
CSAH 44(SILV LK) over RICE CREEK**

**Date(s) of Inspection:** 09/22/2015

# MnDOT BRIDGE INSPECTION REPORT

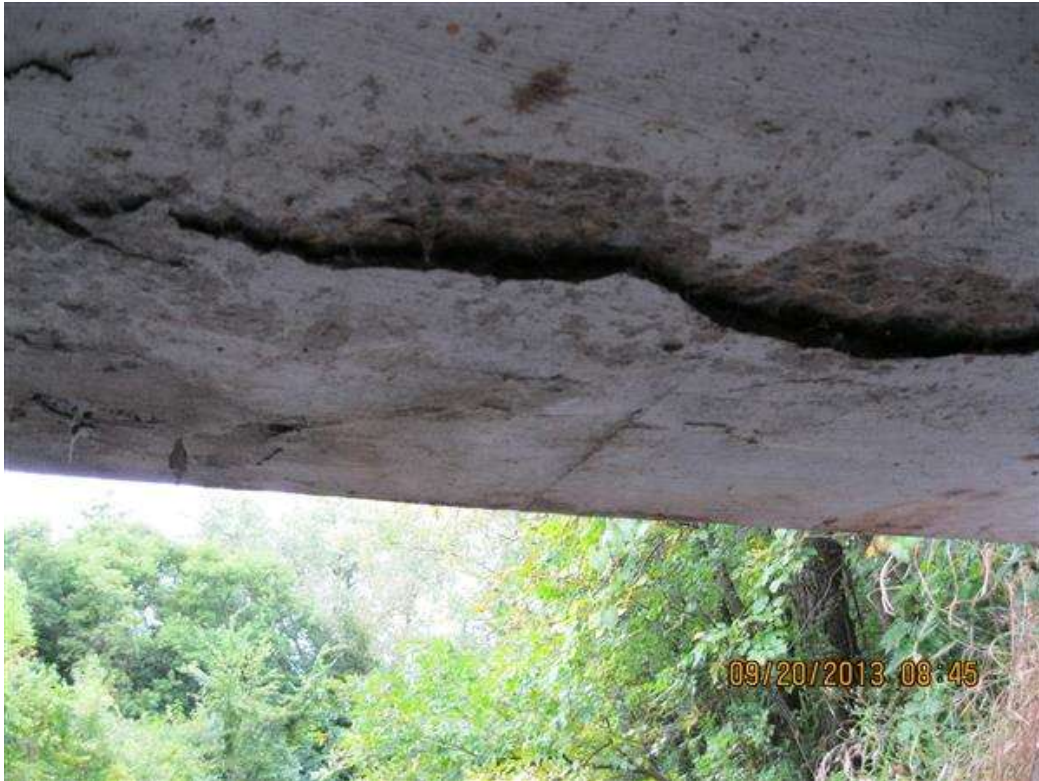
Notes: There is a 4' crack at top on east end culvert #3 2013-2015  
 There is delamination with exposed rebar and corrosion at top east end & moderate delamination & scaling at top on west end culvert #2 2013-2015.  
 There is moderate delamination & scaling at top on west end culvert #3 2013-2015  
 There is delamination with exposed rebar and corrosion at top & bottom west end culvert #1 2011-2015.  
 There is moderate scaling all culverts at flow line 2009-2015. There is a major spall #1 culvert at north side of east end at construction joint 2009-2015.  
 There is minor amount of debris in culvert #1 2009.  
 There is debris in culvert #1 2007.  
 Tree is blocking east end culvert #2 2011.  
 There is minor - moderate deterioration of construction joints east end of all culverts 2007-2011.  
 South barrel east end has some spalling @ construction joint 1990-2005.  
 There is moderate delamination at top inside west end of culvert #3 2011.

Photo 1 - Delamination west end north culvert 2013

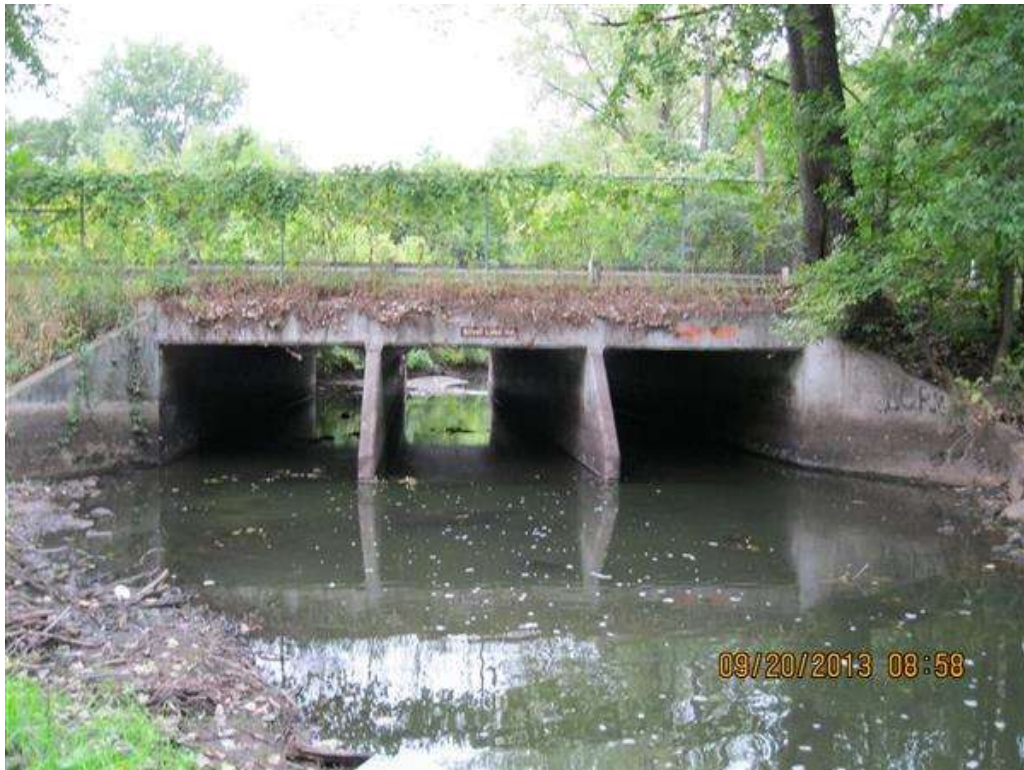
There is minor delamination at west end of culvert #3 2005-2009.  
 Spalling at east end culverts #1 & #2 2001-2009.  
 Culverts also contain minor scaling 2003-2007.

Photo 2 - east end culverts 2013

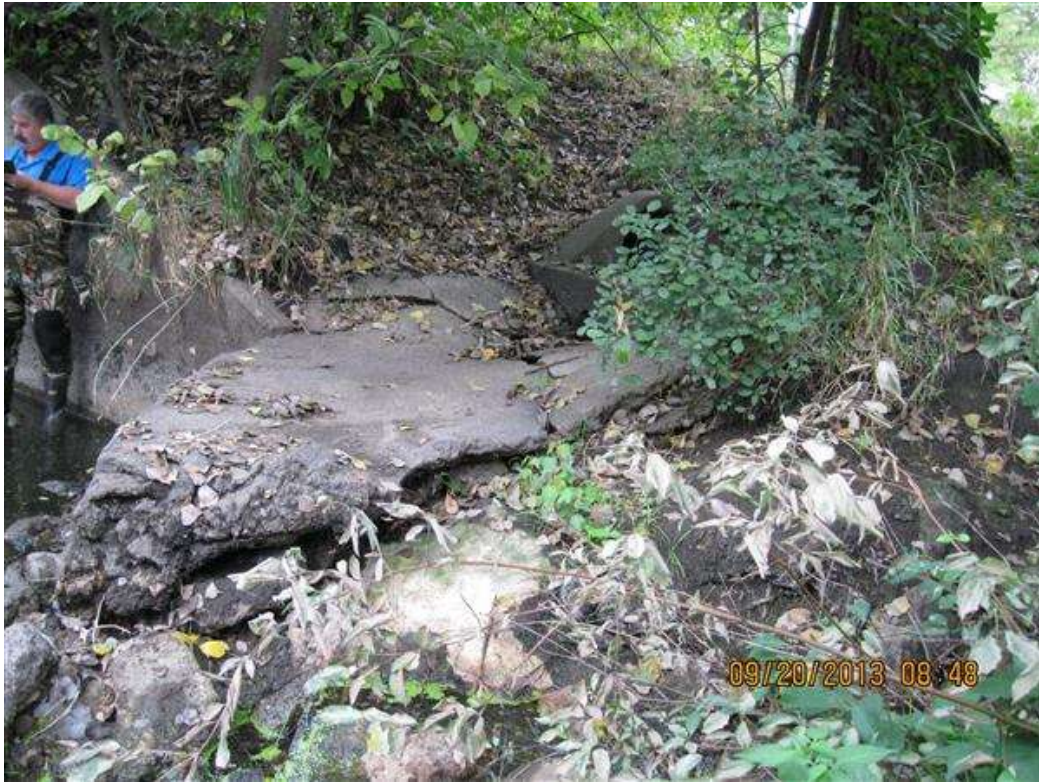
Notes: There is moderate erosion of banks on the east side 2007-2015.  
 Some slumping & undermining of banks at the west side. Minor erosion of banks on the east side 2003-2005.  
 Need fill & turf establishment at NW corner of bridge. Erosion by wingwall at NW corner slope 1997-2015.  
 NE & NW corner surge basin in spillway has settled and cracked 1997-2015.

Photo 3 - East end spillway 2013

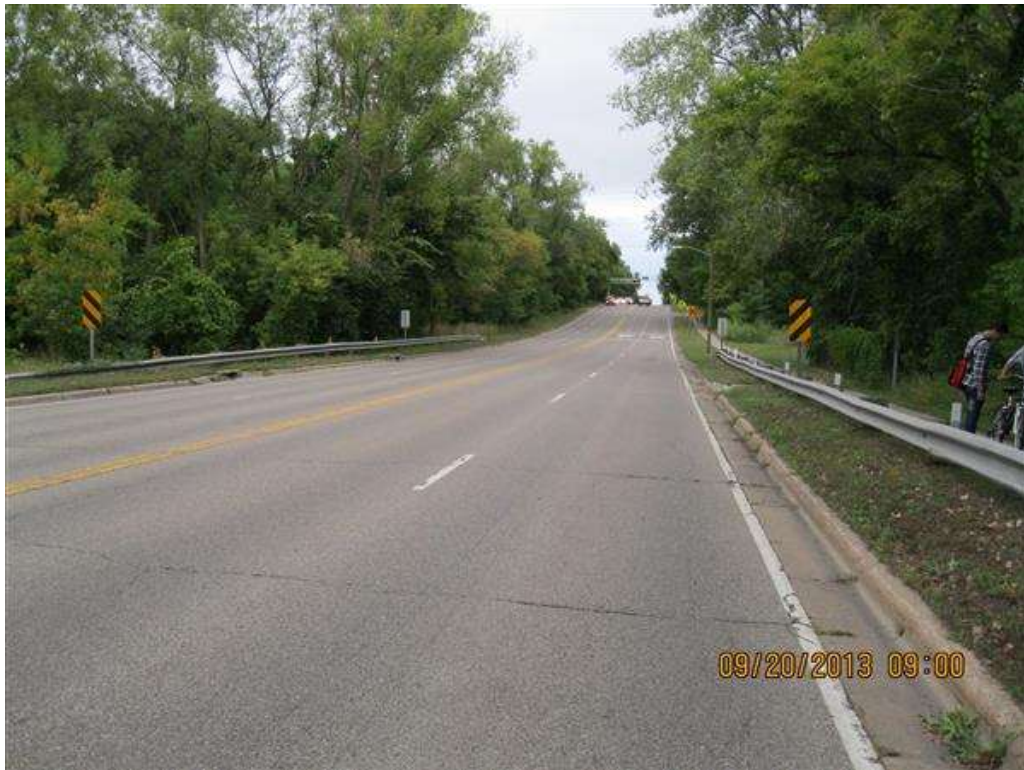
Notes: There is moderate cracking 2007-2015. Minor cracking 2005.  
 Bituminous overlay 2004.

Photo 4 - roadway northbound 2013

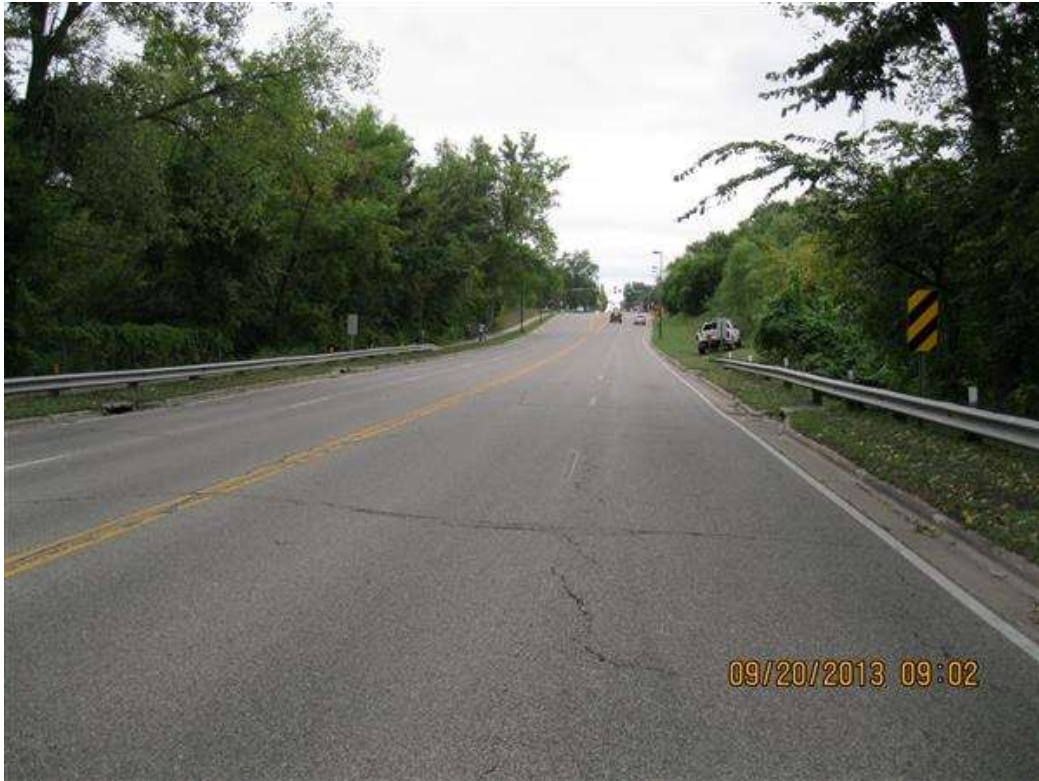
Photo 5 - roadway southbound 2013

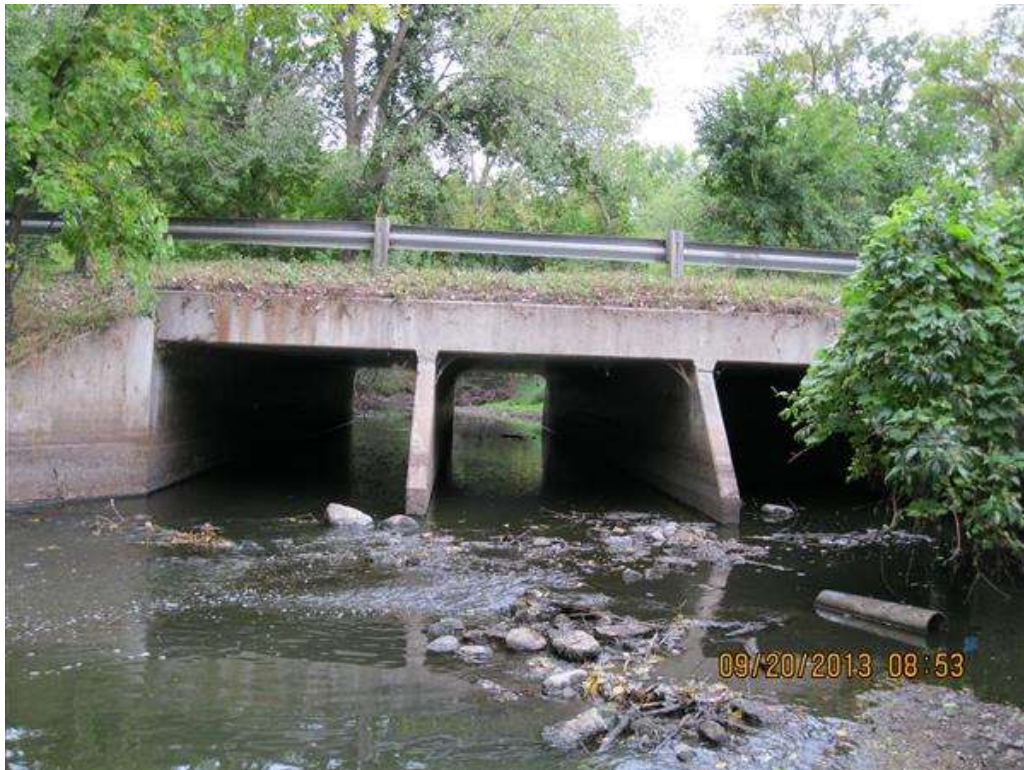
Notes: Minor spalling west end NW wingwall 1997-2015.  
 Exposed rebar with minor corrosion west end of culvert #1 & #2 2001-2015.

Photo 6 - west end culverts 2013

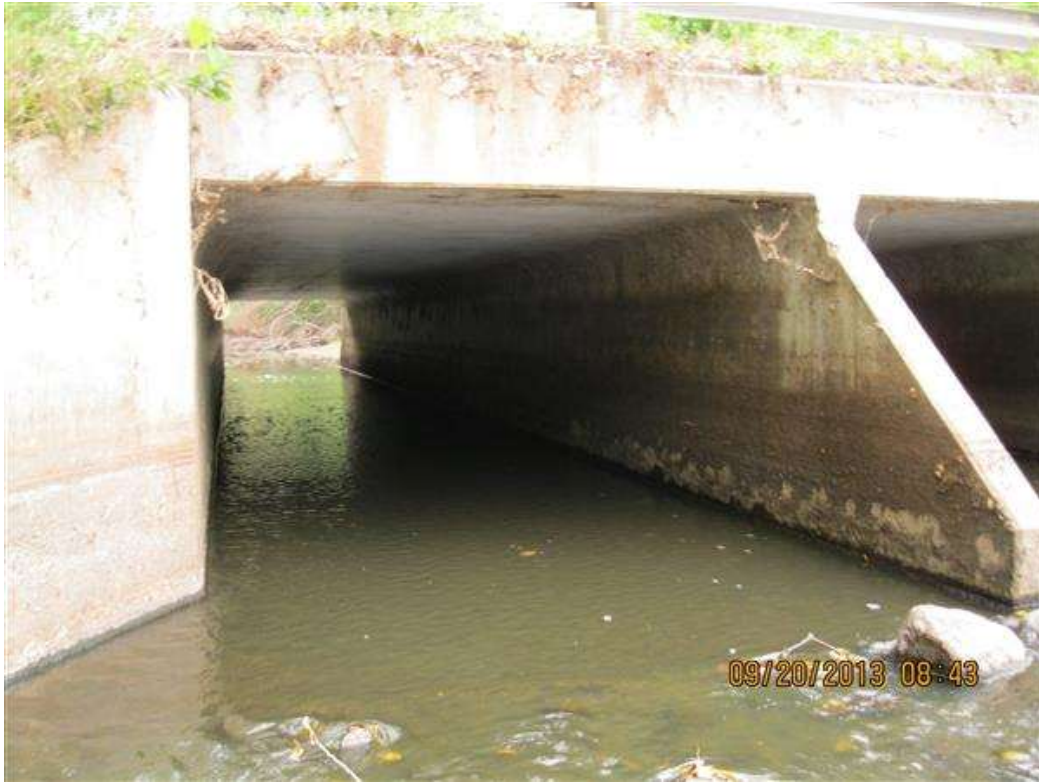
Photo 7 - west end north culvert 2013
