**2016 ROUTINE
BRIDGE INSPECTION REPORT**

**BRIDGE # 62520
CP RAIL over CSAH 23(CR C)**

Date of Inspection: 10/18/2016

MINNESOTA BRIDGE INSPECTION REPORT

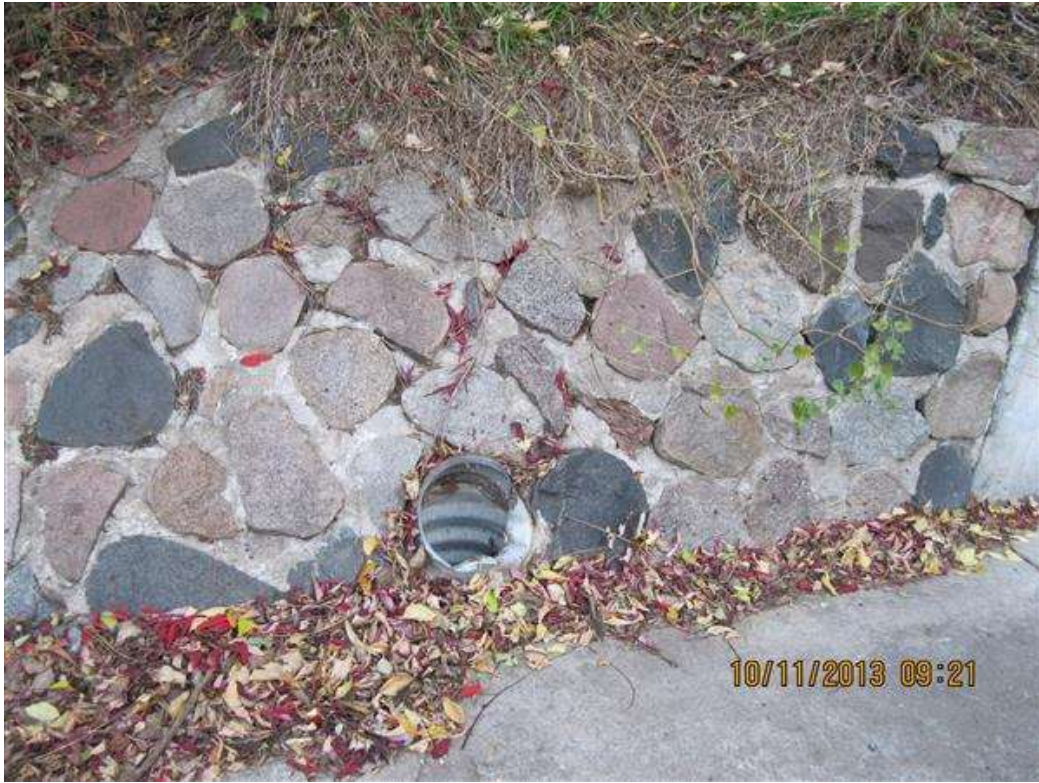
Photo 1 - drain on nw cor

894	Deck & Approach Drainage	Routine	10/18/2016	1 EA	1	0	0	0
		Migrated Values		1 EA	1	0	0	0
<p>Notes: [2002-2016] Drain in NW wingwall at the sidewalk edge should be covered.</p>								
900	Protected Species	Routine	10/18/2016	1 EA	1	0	0	0
		Migrated Values		1 EA	1	0	0	0
<p>Notes: [2016] No protected species found living on this structure.</p>

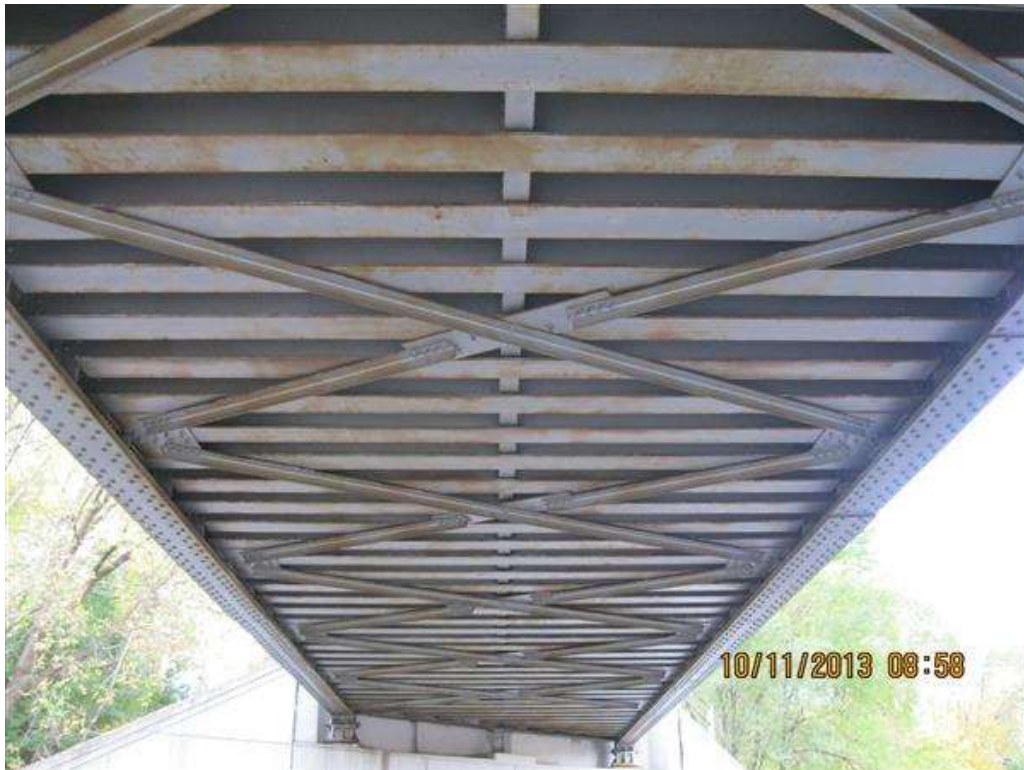
Notes: [2009-2015] Needs to be repainted. 75% has surface rust with minor to moderate corrosion. Steel diagonal bracing is in place.
 [1983-2009] Paint is flaking & floor beam has surface corrosion. Spot painted in 1985.

Photo 2 - floorbeams

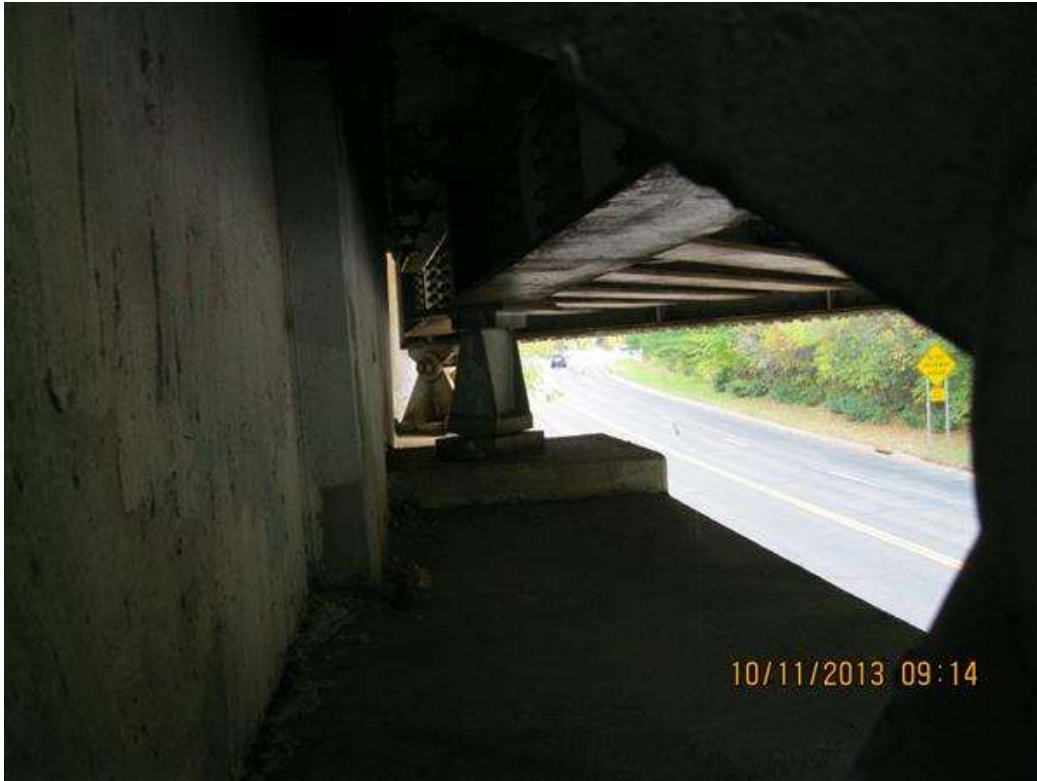
Notes: [2012-2015] Minor to moderate corrosion of fixed bearings at the north end is present. Support member is sound.

Photo 7 - north bearings

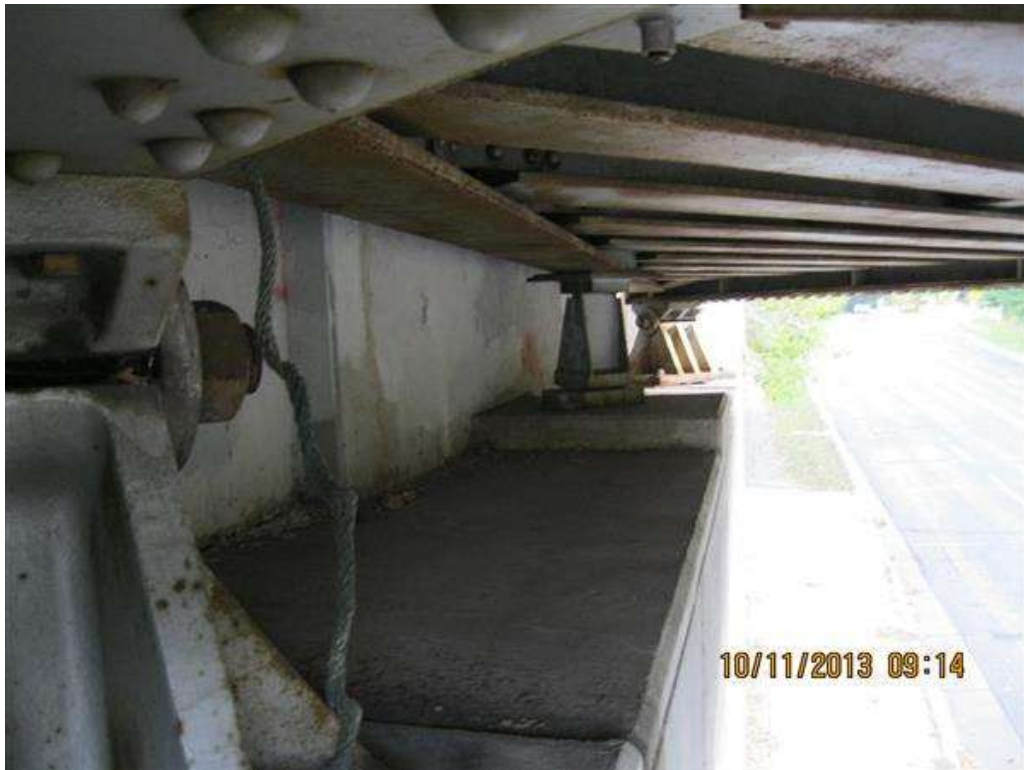
Photo 8 - north bearings-2

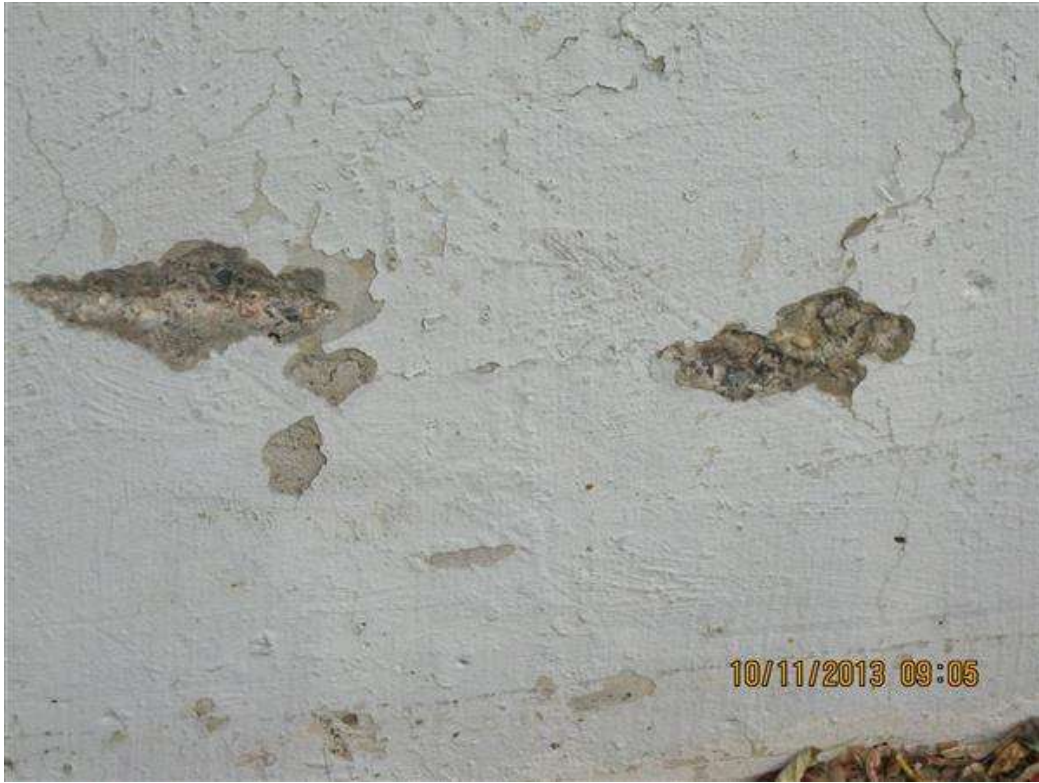
Notes: [2015] 2" spall by name plate on NE corner.
 [2015] 3" spall on SW corner 6' up from ground.
 [2013-2015] Minor paint failure on both abutments
 [2013-2015] 2 - 6" spalls on north abutment, (east side, bottom)
 [2008-2015] Minor scrapes to north abutment from snow plows. North abutment has numerous minor to moderate spalling, moderate vertical and horizontal cracking w/leaching & efflorescence.
 [2013-2015] There is a crack located at top of backwall at the NW corner.
 [2001-2015] South abutment has minor but numerous vertical and horizontal cracking w/leaching & efflorescence.
 [2012-2015] Also some minor to moderate spalling is present on both abutments.
 [1983-2015] Hairline cracks @ steel girder base all corners.
 4" rigid steel conduit drilled through north and south backwall of each abutment on the west side.

Photo 9 - spalls on NE cor
