**2016 ROUTINE
BRIDGE INSPECTION REPORT**

**BRIDGE # 62525
CSAH 31(WB MRYLD) over CP RAIL**

Date(s) of Inspection: 05/23/2016

Final Report Date: 06/08/2016

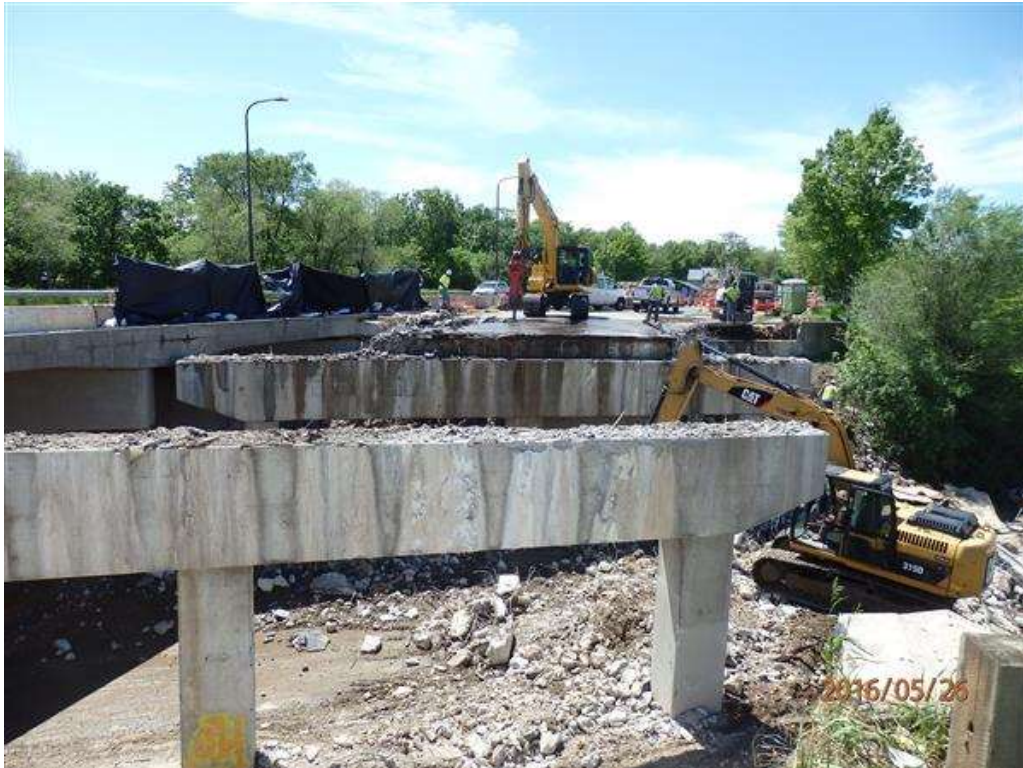
Photo 1 - 2016.PNG

2016 Bridge Re-hab. Project Ramsey County
