**2016 ROUTINE
BRIDGE INSPECTION REPORT**

**BRIDGE # 62529
BNSF RR (ABAN) over CSAH 19(BEAM AVE)**

DISTRICT: Metro **COUNTY:** Ramsey **CITY/TOWNSHIP:** Maplewood
STATE: Minnesota

Date of Inspection: 08/03/2016
Equipment Used: Ladder, Confined Space Entry

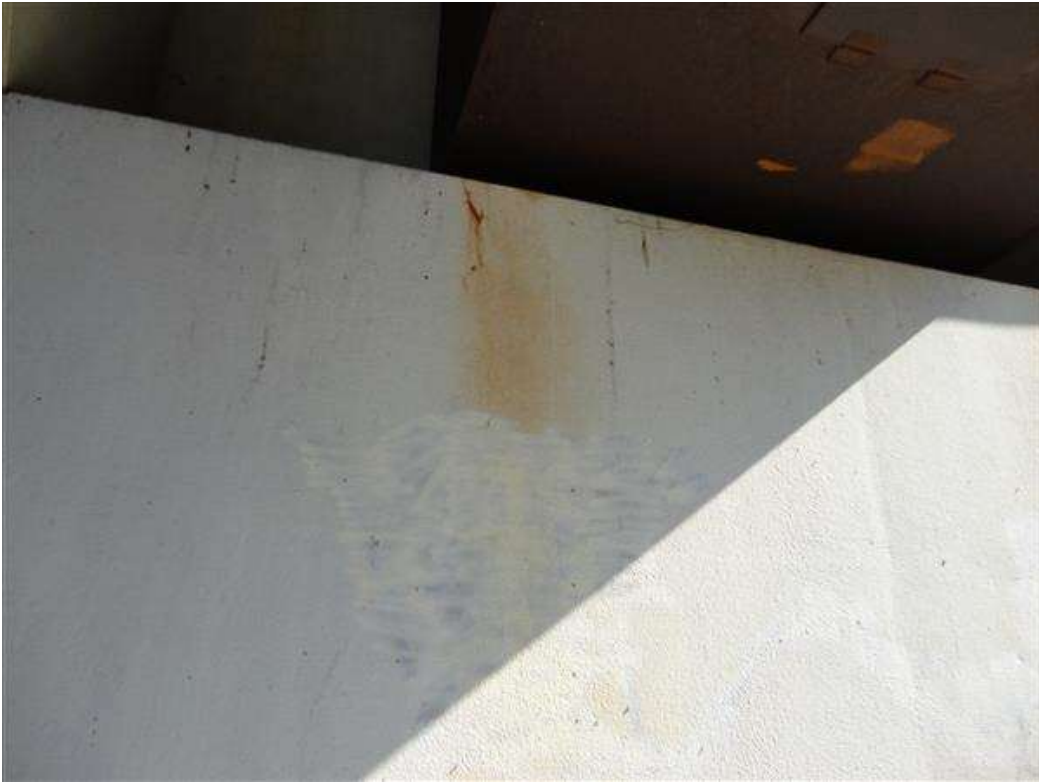
Photo 1 -

1. 62529 So Abut.JPG

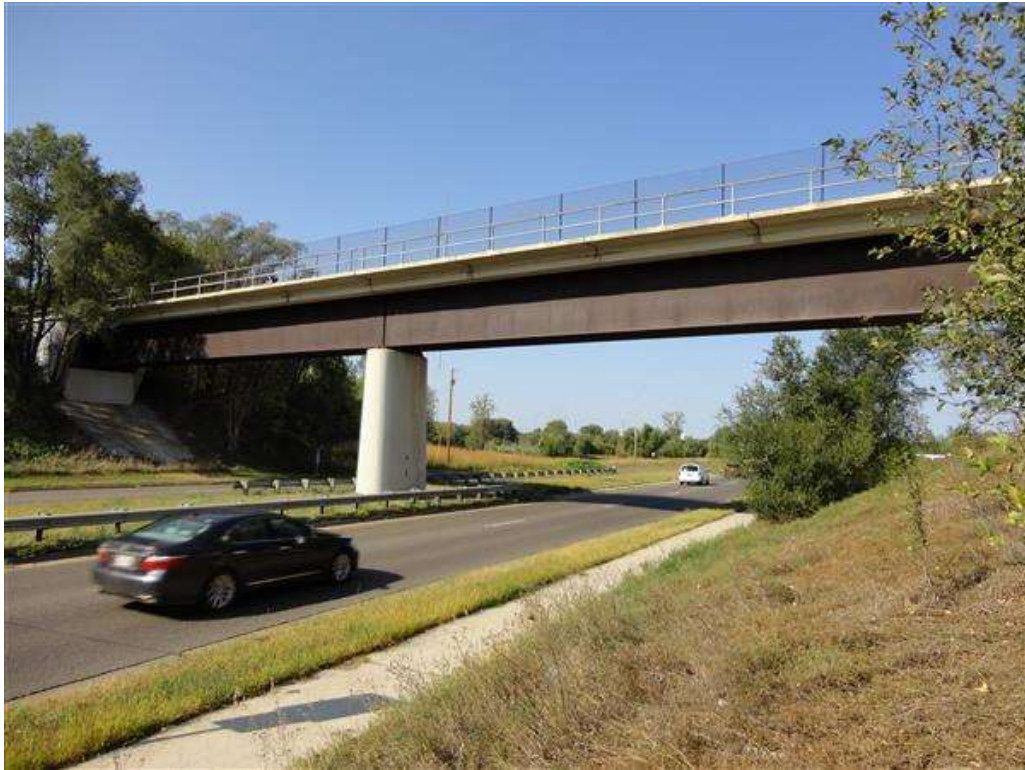
Photo 2 -

2. 62529 So Side.JPG

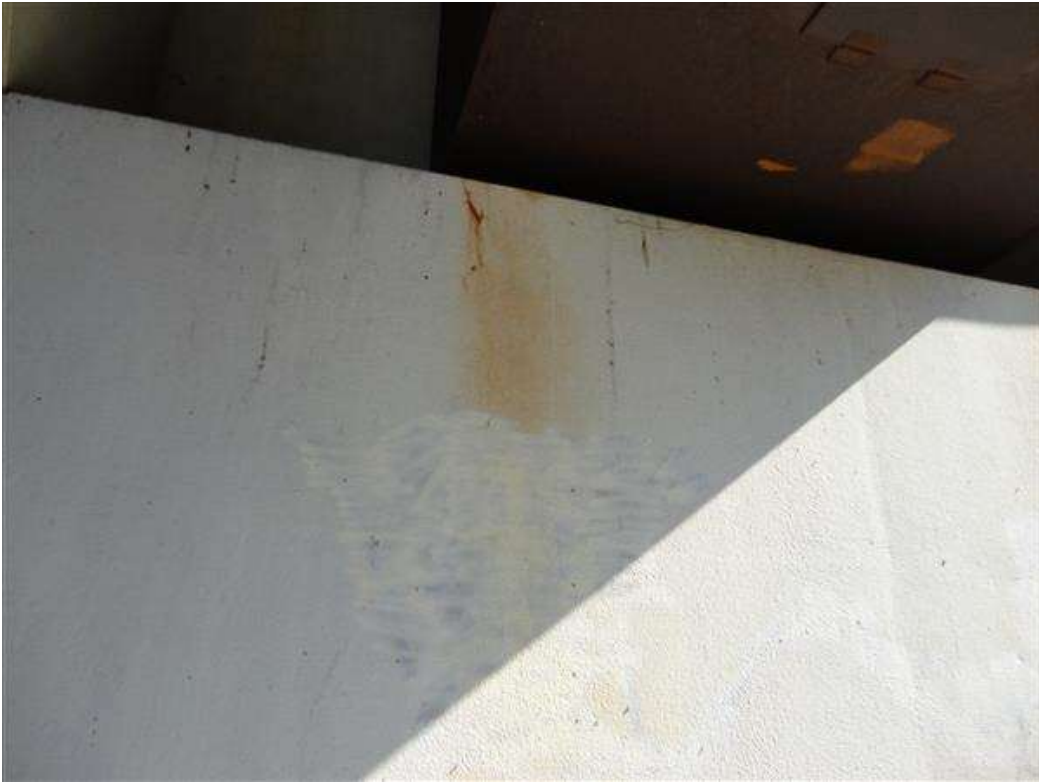
Photo 3 -

Notes: [2014-2015] 1' vertical crack w/rust 4' from NW corner. Minor paint failure in NE corner.
 [2013] There are numerous minor vertical cracks on both north & south abutments, numerous minor horizontal cracks on north abutment.
 [2008-2012] There are numerous minor vertical cracks on the front face of south abutment. [2008-2012] There are minor vertical & horizontal cracks on the front face of north abutment.
 [2002-2012] Minor horizontal hairline cracks across backwall face of both abutments about 1' below bottom of deck stringers. Bridge has full height abutment 15 LF in length for each abutment.

3. CrackInSouthAbut..JPG

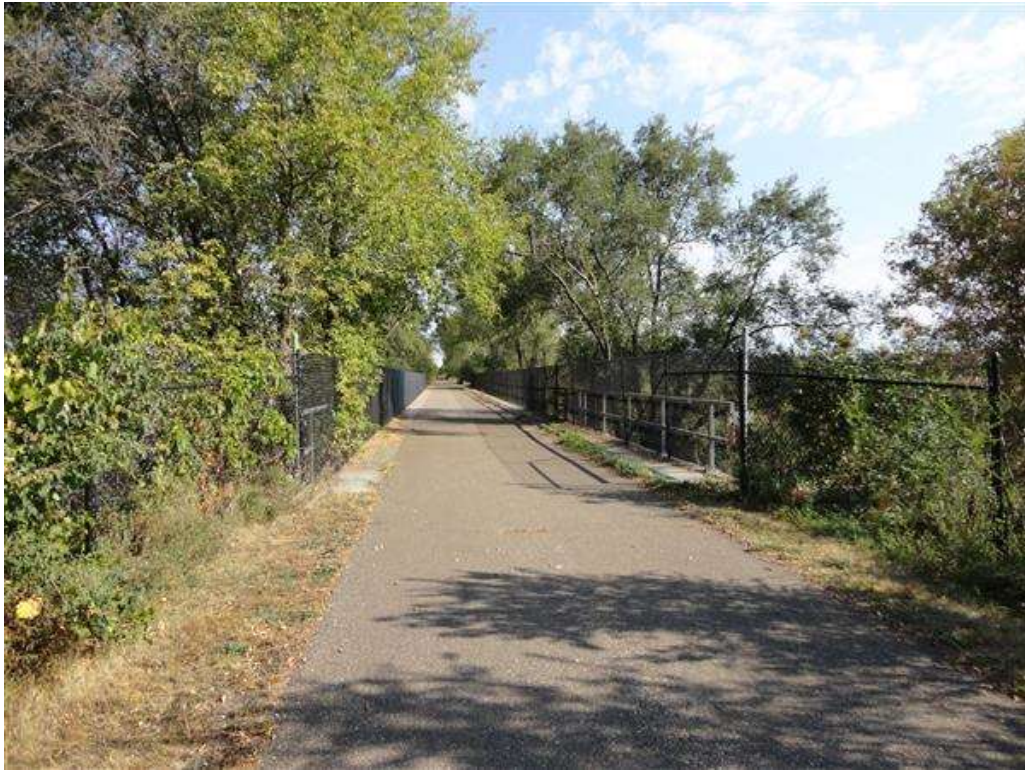
Photo 4 -

4. NorthboundTrail.JPG

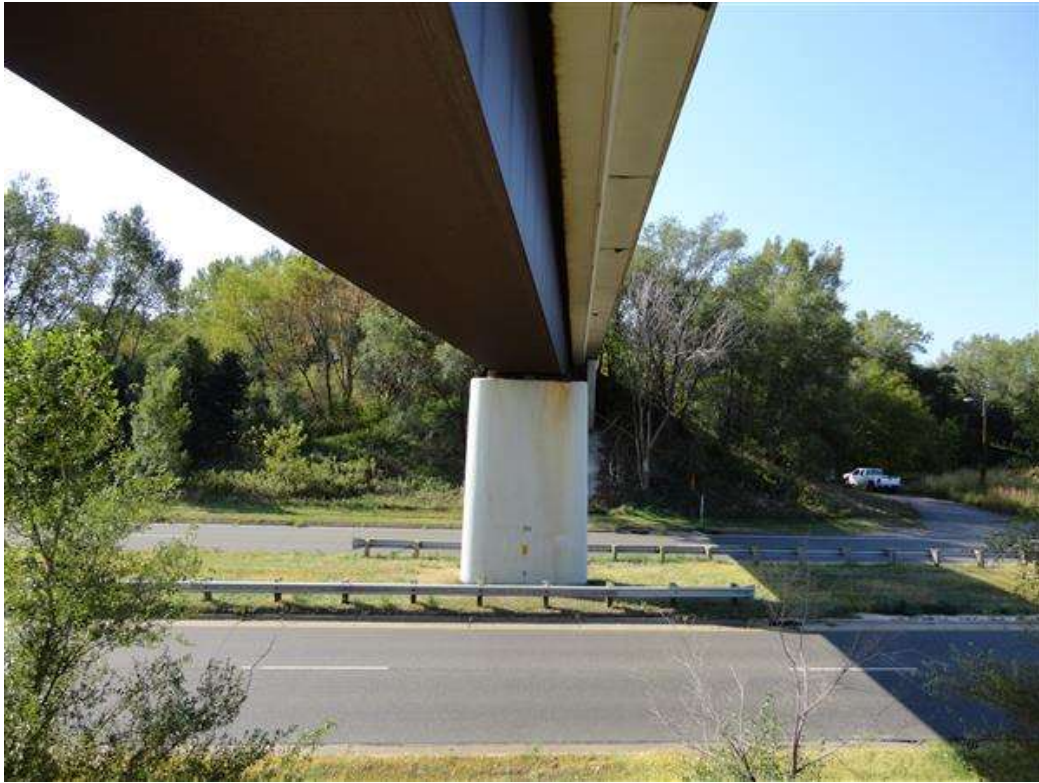
Photo 5 -

Notes: [2013-2015] Numerous moderate cracks both horizontal & vertical. Bearing seats are in good condition. Delamination on west side of pier wall (6" dia.- 13' up from ground, 4" dia. - 9" up from ground). Paint is peeling on south side of pier
 [2007-2012] There is a moderate scrape on the south side.
 [2008-2012] Numerous moderate horizontal and vertical cracks are present but no evidence of corrosion.
 [2007-2012] Bearing seats are in good condition.
 [2012] Delamination is starting on the west side of the pier wall.

5. PierLookingSouth.JPG

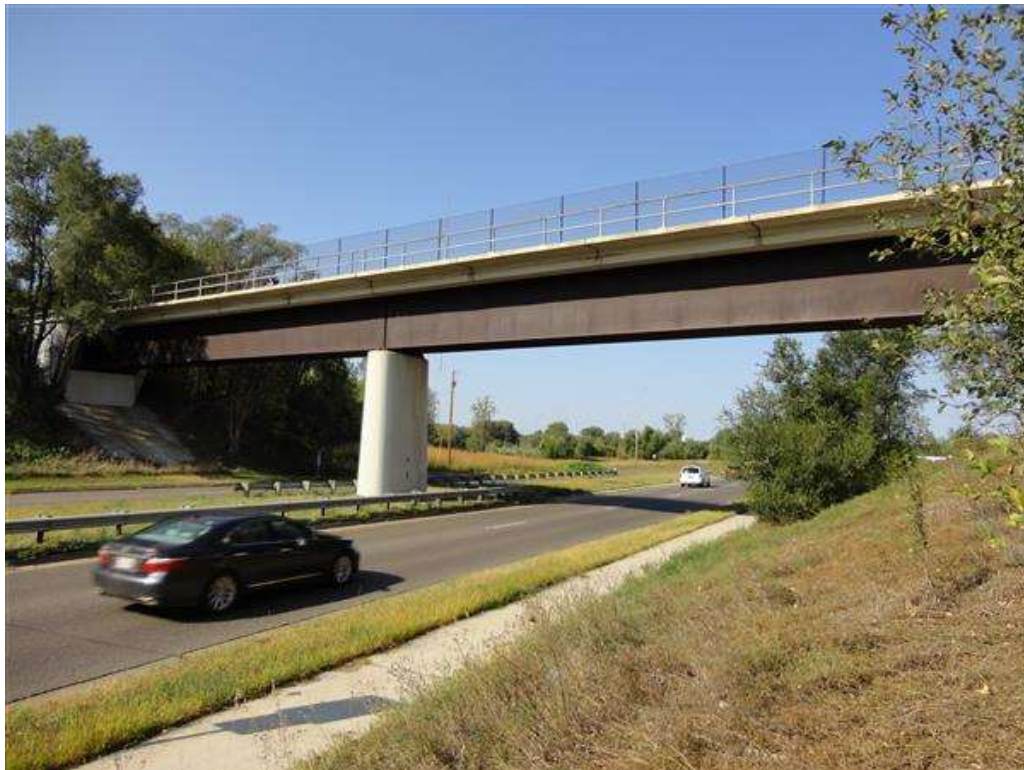
Photo 6 -

6. WestboundBeamAve..JPG

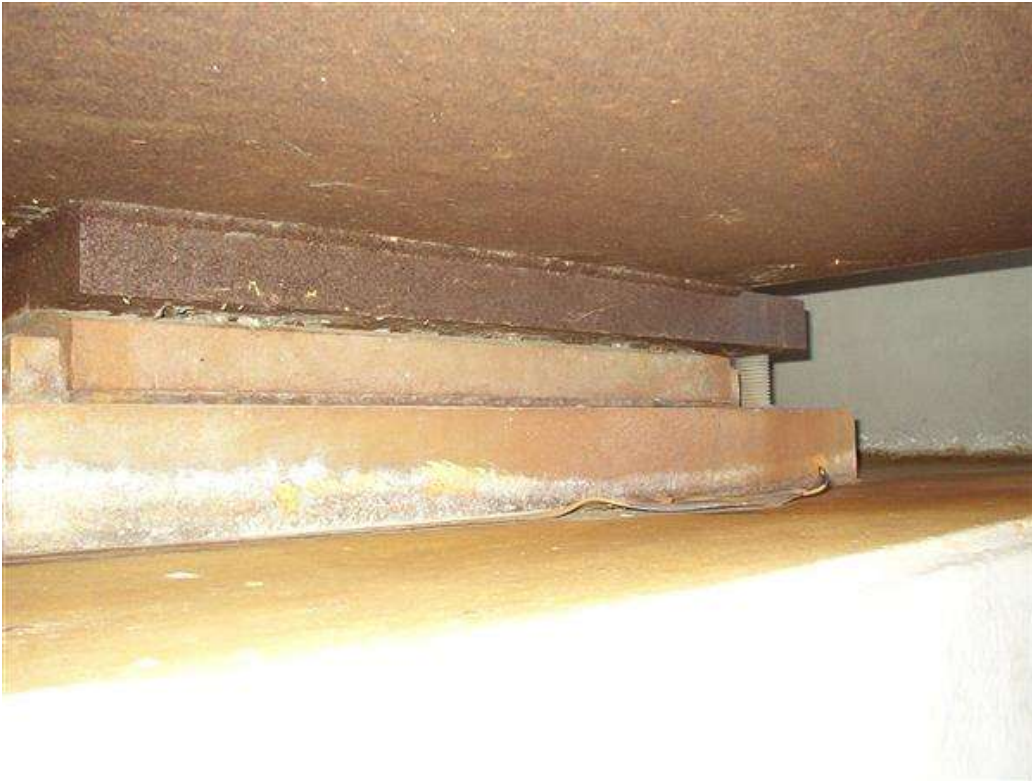
Photo 11 -

Notes: [2013-2015] Bearing assemblies have minor to moderate corrosion
 [2002-2012] Bearing assemblies have minor- moderate corrosion. Pictures taken @ SE bearing 2007.
 There are four expansion bearings at the abutments.

11. SE Bear2.JPG
