**2015 ROUTINE
BRIDGE INSPECTION REPORT**

**BRIDGE # 62537
CSAH 22(KELLER PY) over KOHLMAN CREEK**

Date(s) of Inspection: 11/02/2015

BRIDGE 62537 CSAH 22(KELLER PY) OVER KOHLMAN CREEK

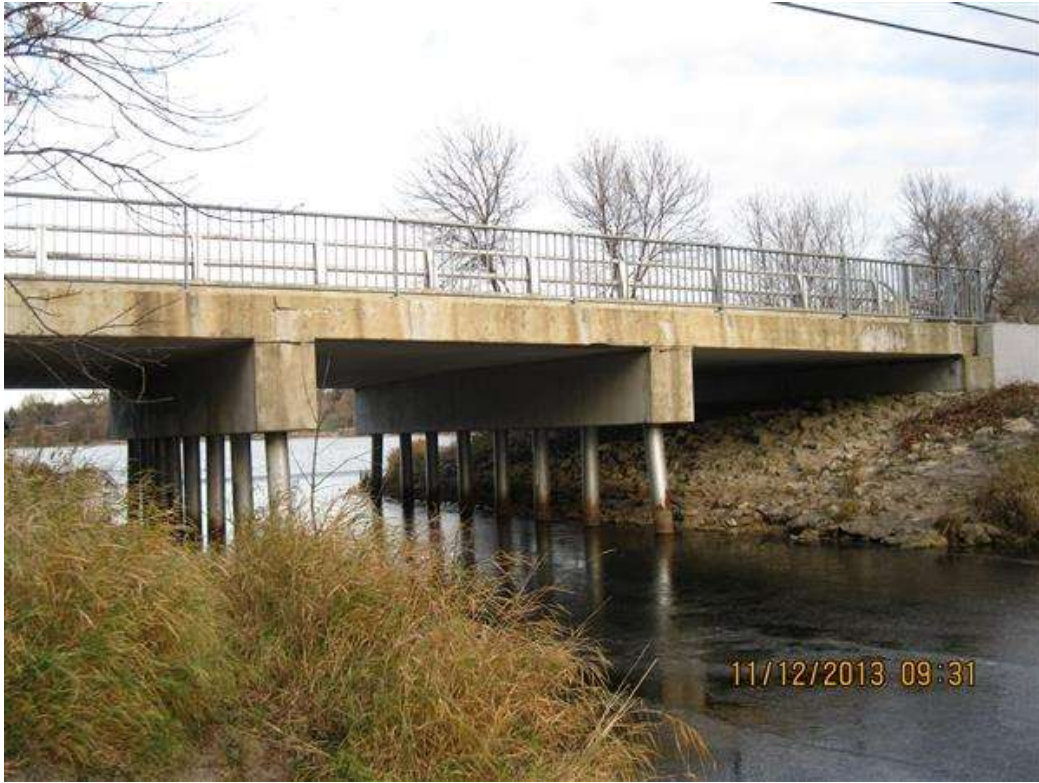
Photo 1 -

1. east side.JPG

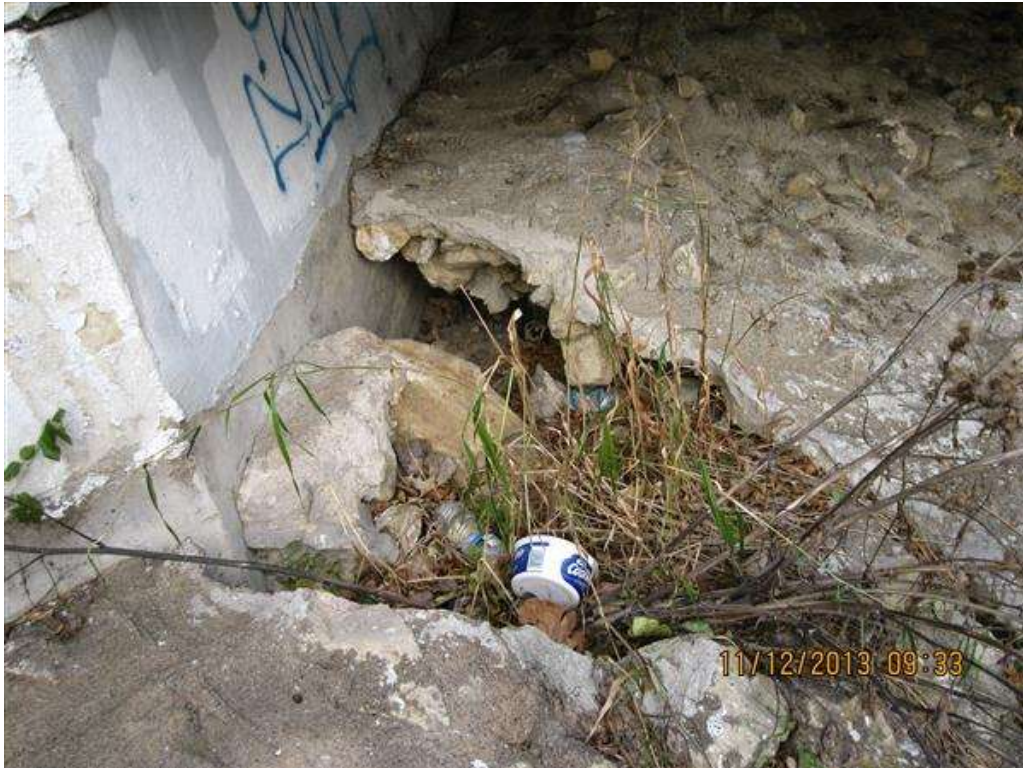
Photo 2 -

Notes: There is moderate cracking & moderate settlement. There is severe settlement @ SE corner -3' X 3' void 2009-2015.
There is moderate deterioration of grouted riprap slope protection 2007-2015.
The SW corner has moderate deterioration of grouted riprap slope protection 2007-2015.
There is settlement of riprap @ wingwalls 2007-2015.
Settlement @ NW, SE and SW corners 1999-2015.

2. erosion on SE corner.JPG

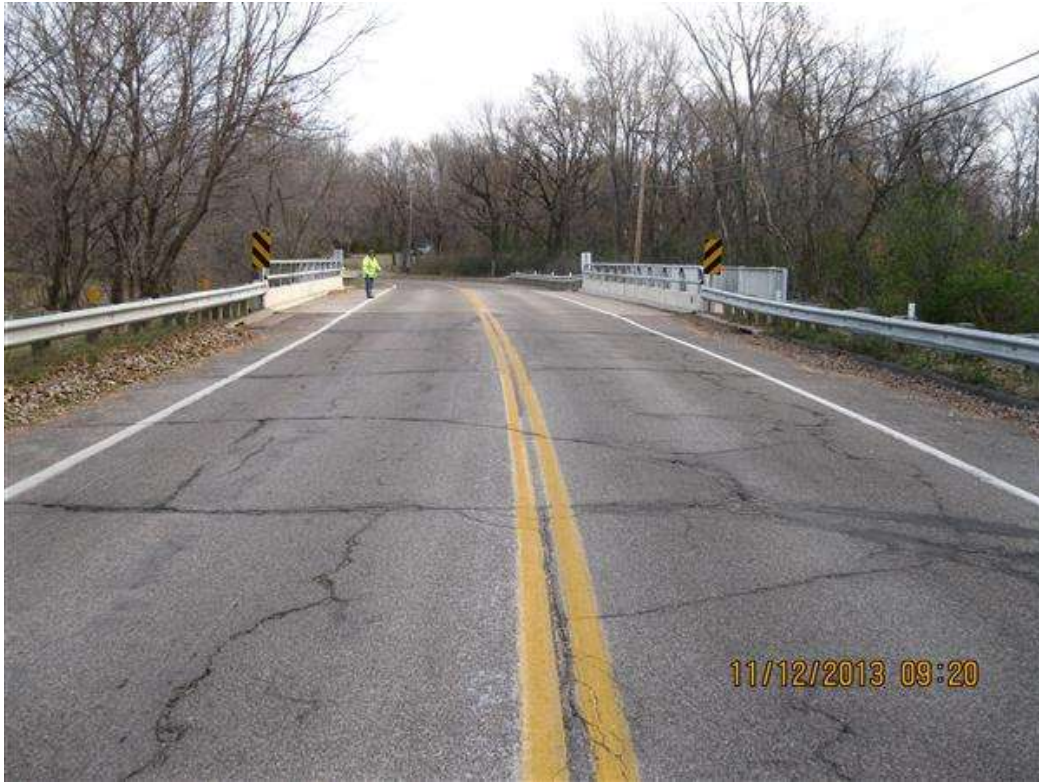
Photo 3 -

3. looking north.JPG

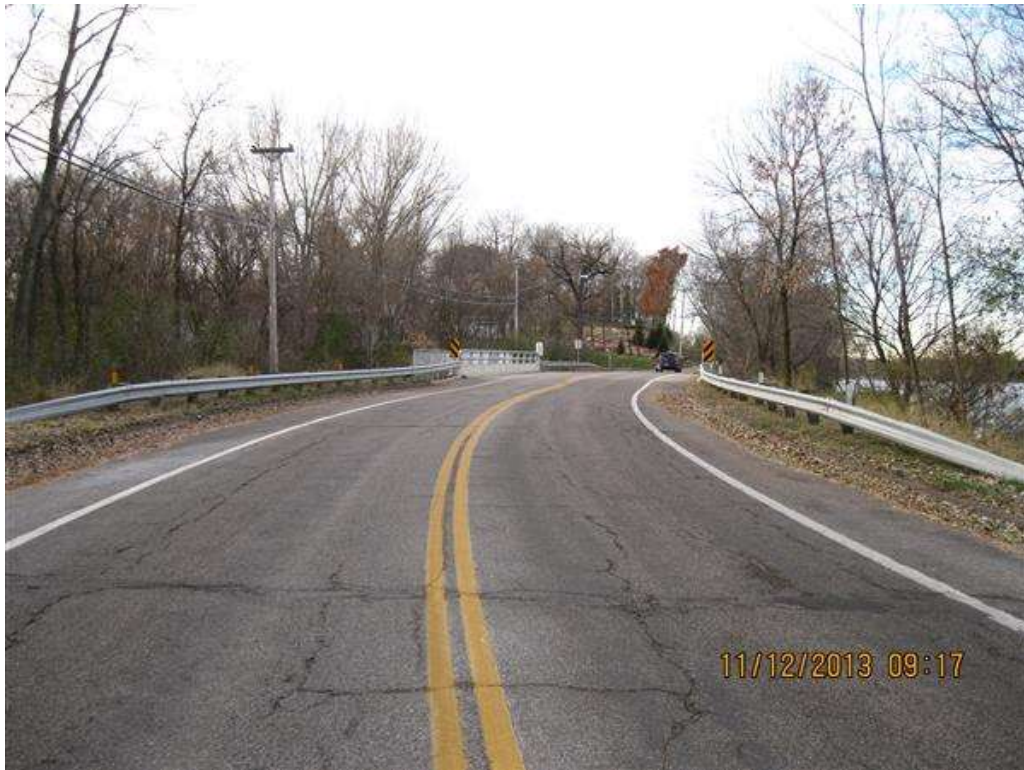
Photo 4 -

4. looking south.JPG

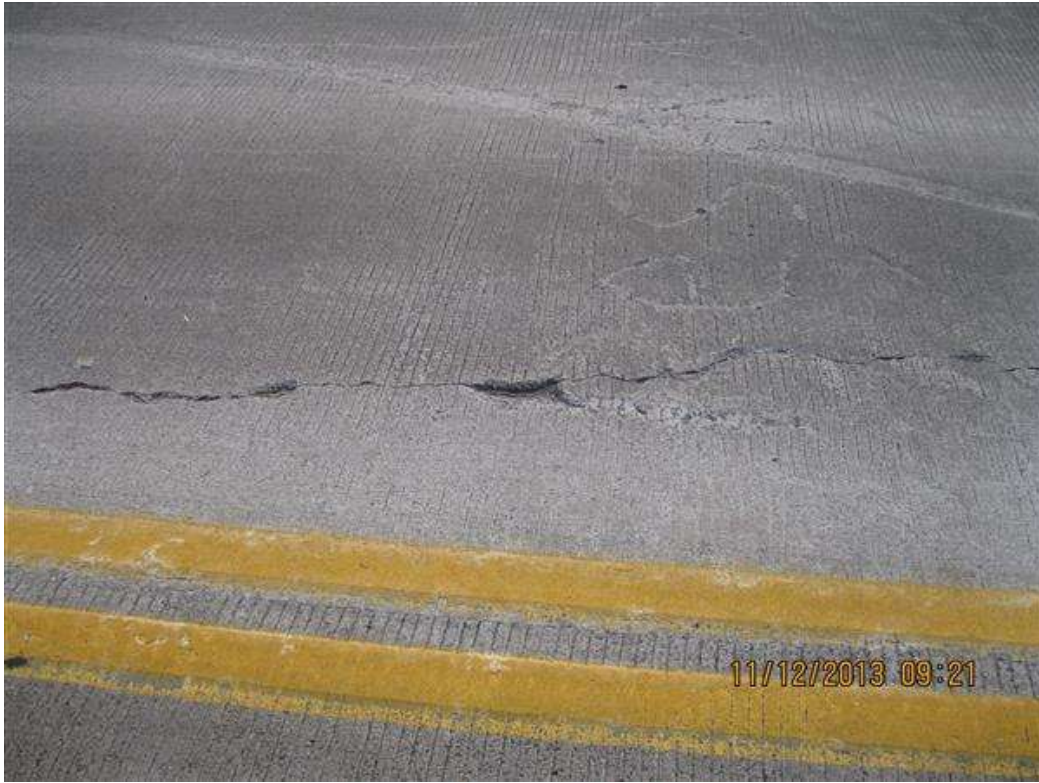
Photo 5 -

Notes: [2015] CL crack has 10 moderate spalls 1 w/ rust on north end.
 [2013-2015] There are 3 longitudinal cracks on entire length of deck - NB, CL, SB (w/ moderate spall in CL crack)
 [2013-2015] minor 10' diagonal crack in NW corner
 Some moderate spalling exists on deck 2011 - 2015.
 There is 15' diagonal cracking @ SW corner 2007-2015.
 There are 2 longitudinal cracks the entire length of deck 2001-2015.
 There is a total of 181 LF of longitudinal cracking 2009-2013.
 Minor transverse cracking in deck 2001-2015.
 There is a total of 36 LF of transverse cracking 2009-2015.
 Distressed is >2% and <10% 2005-2015.
 Deterioration of the east 1/2 of wearing surface due to vandalism after low slump overlay placement.

5. spall on deck.JPG

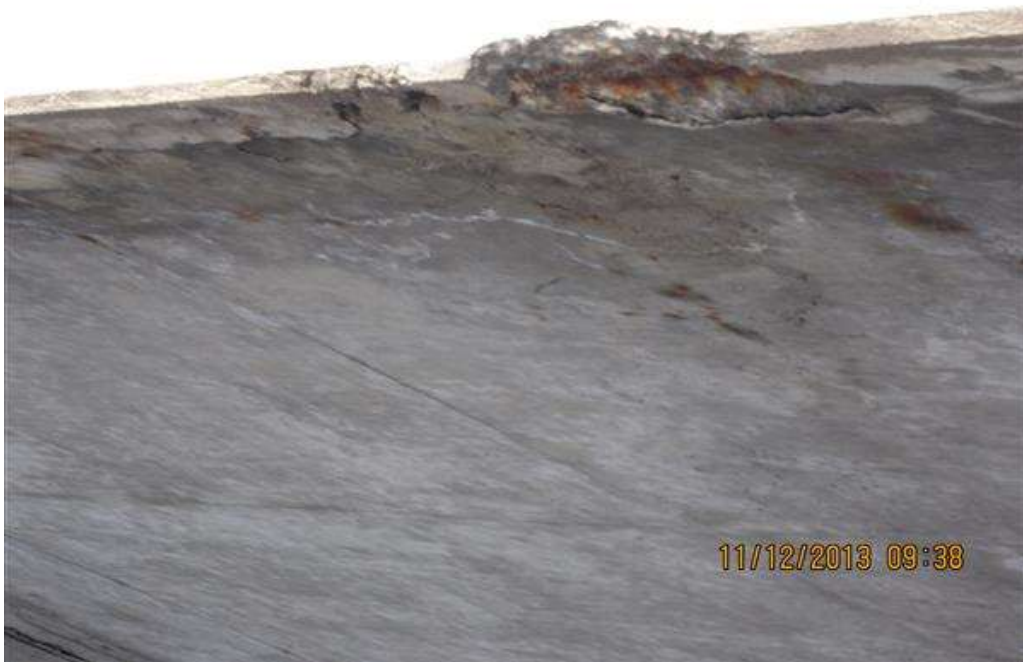
Photo 6 -

Notes: [2013-2015] paint is failing on east fascia
[2013-2015] moderate spall (1' x 0.5') w/ delamination on east side fascia between piling.
There is cracking with corrosion the entire length east fascia. Cracking underneath and side 10" down from top 2007-2015.
There is a 1.5' X 1.0' area with exposed re-bar @ NE corner near north abutment 2007-2015.
Between south abutment and the C-I-P piling:
Paint failure on the SE fascia 2015.
2 cracks w/ delamination.
There is a diagonal crack with efflorescence @ SW corner near abutment 2007-2013.
There are 3 longitudinal cracks w/efflorescence & corrosion 2005-2013.
Between the C-I-P piling:
There are 2 longitudinal crack w/efflorescence & corrosion 2005-2013.
Delamination with exposed rebar & corrosion present @ east fascia between piling 2009-2013.
Between the C-I-P piling and north abutment:
3' x 1' delamination @ CL., moderate crack 15' long - 20' from west end. There are 2 longitudinal cracks w/efflorescence & moderate corrosion and 1 moderate longitudinal crack w/efflorescence & corrosion 2005-2015.

6. spall under deck east side near north pier.JPG

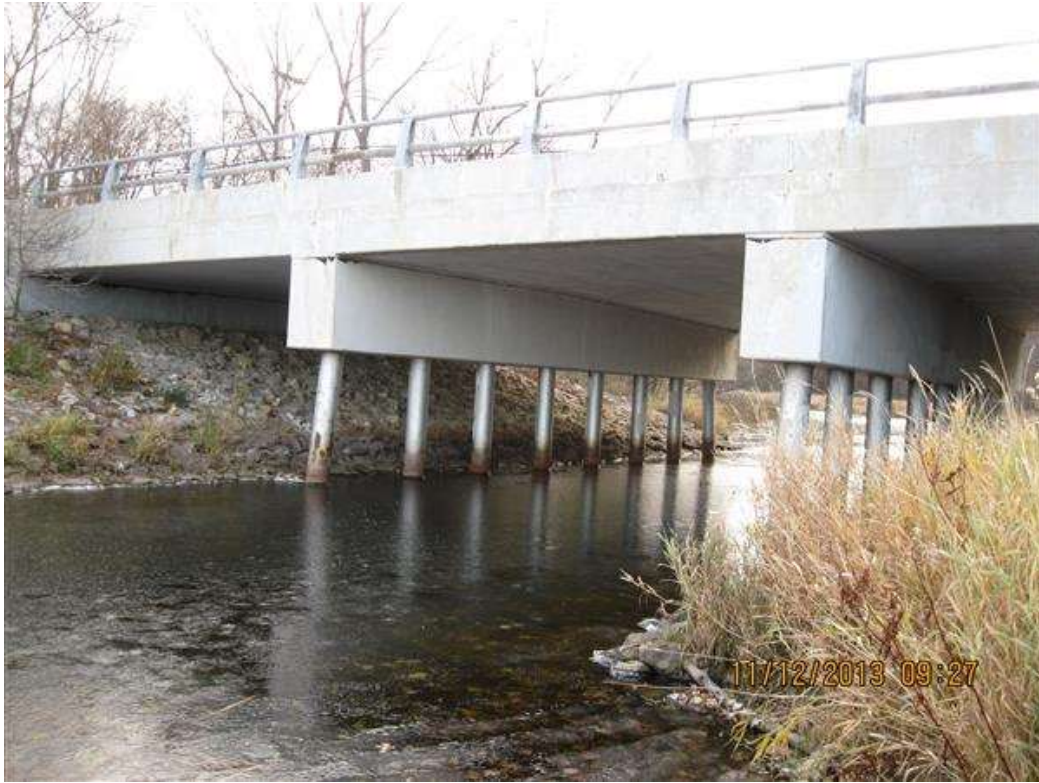
Photo 7 -

7. west side.JPG
