**2015 ROUTINE
BRIDGE INSPECTION REPORT**

**BRIDGE # 62543
CSAH 68(MCKNIGHT) over UP RR**

Date(s) of Inspection: 10/16/2015

Inspected By: Essler, Brian

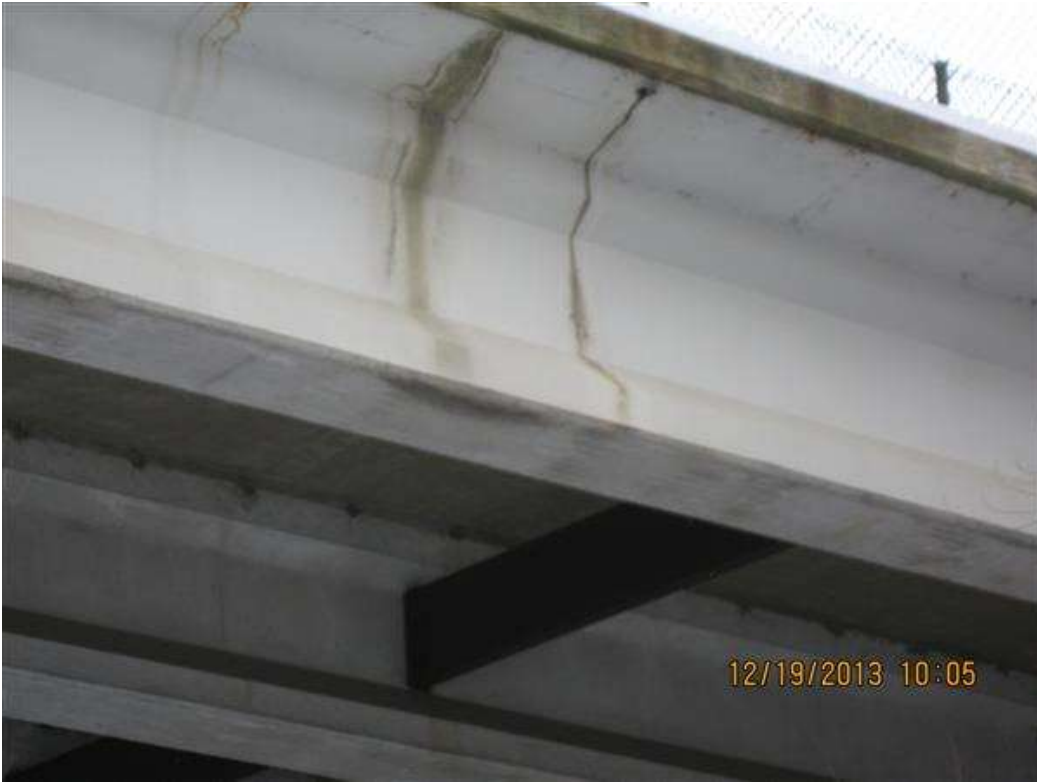
Photo 1 - crack in beam NE corner

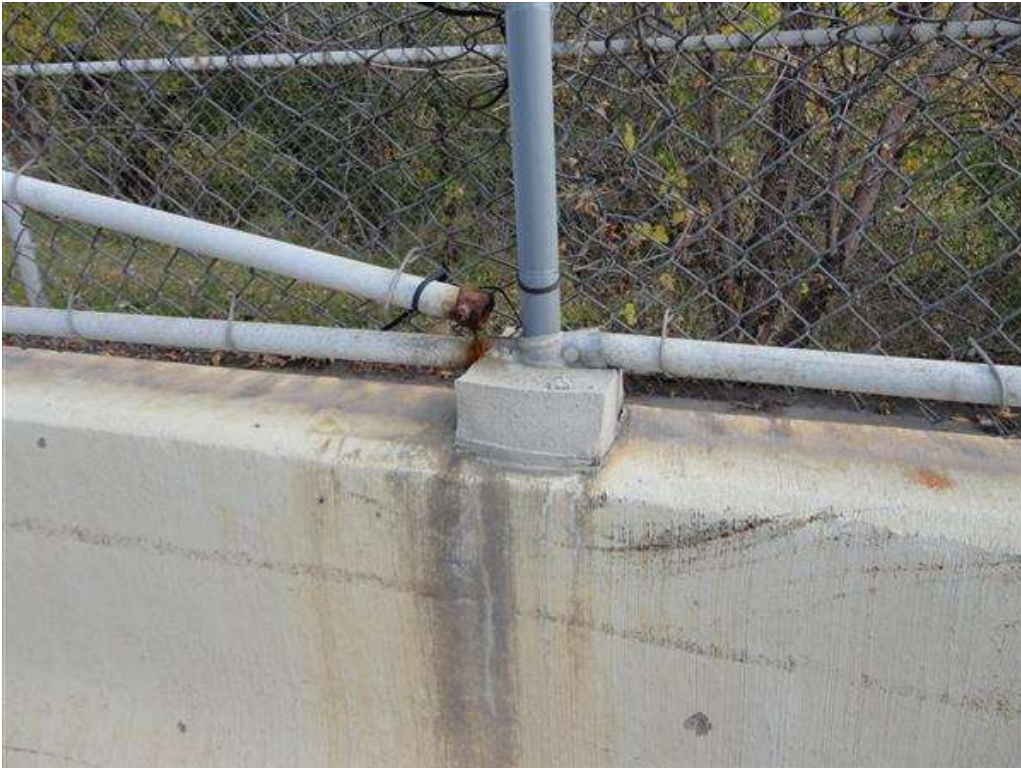
Notes: [2013-2015] Numerous minor vertical cracking & moderate spalling w/efflorescence at east rail.
 [2005-2015] West rail has numerous vertical cracks, spalling present. Also corrosion at NW corner.
 [2005-2015] Major spalling 82' south of NW corner. Anchorage is exposed & bottom of rail fence is loose.
 East side has parapet rail with CL-fence on top. West side has J barrier with CL-fence on top.

Photo 4 - East rail repair

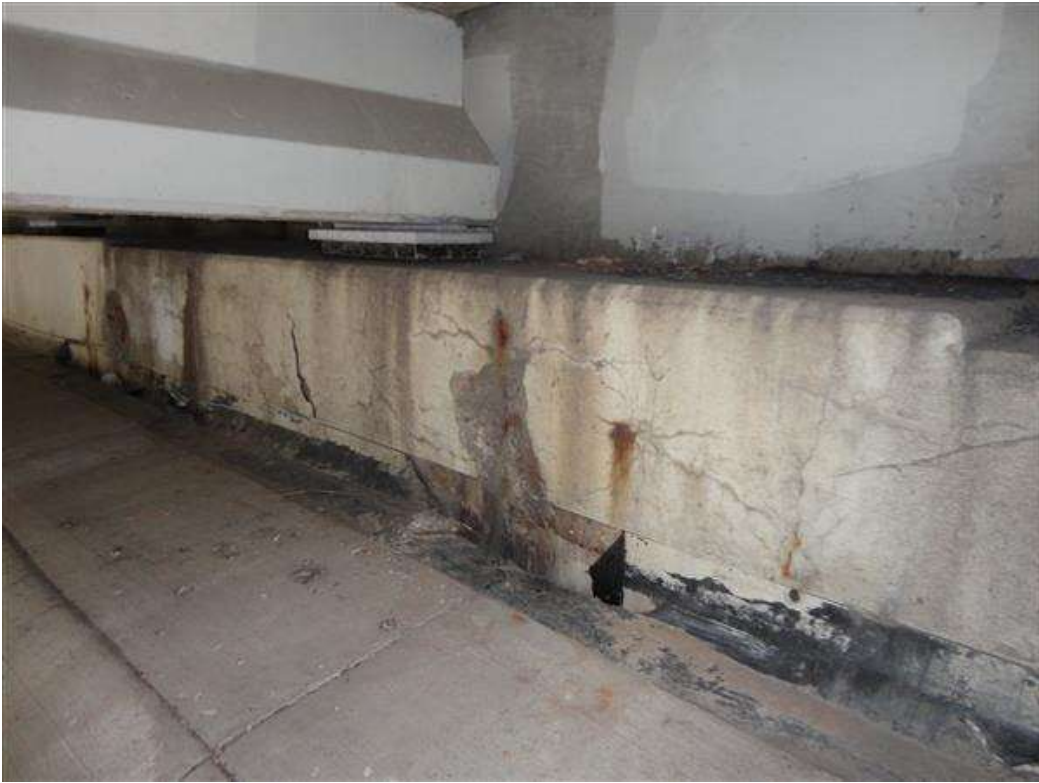
Photo 11 - South abutment 1

Notes: [2015] The south abutment has 9 moderate spalls with corrosion between girder 4-7.

[2013-2015] The south abutment has 15 minor to moderate vertical cracks with some moderate corrosion. At concrete girder #7 there is exposed re-bar with corrosion.

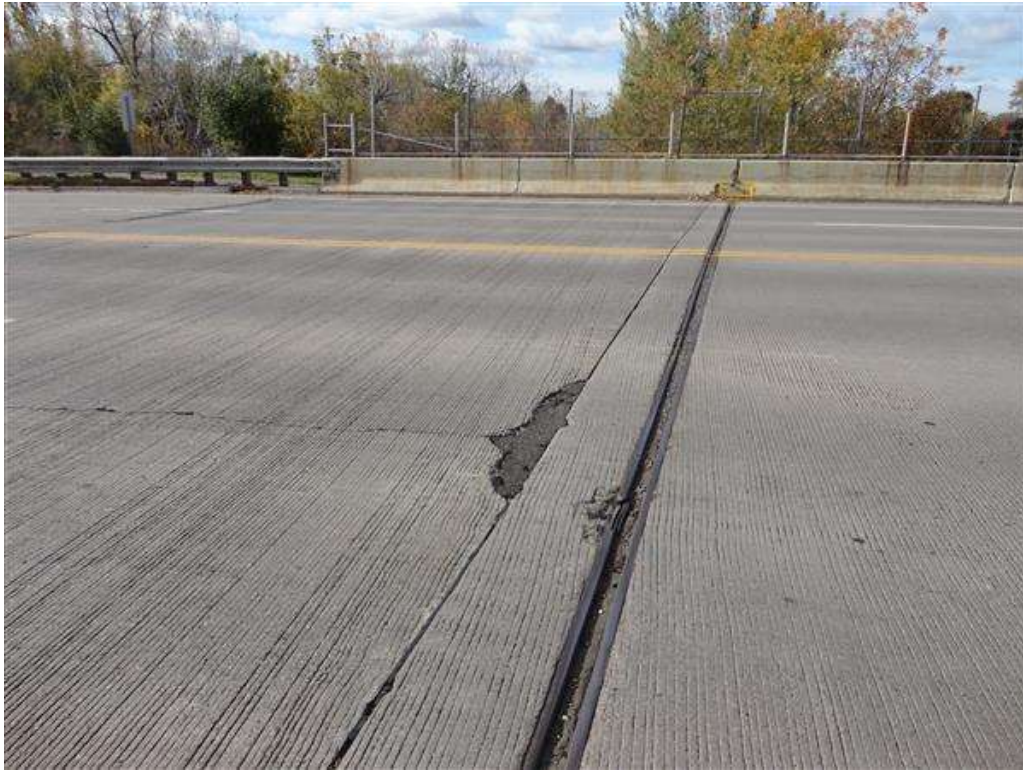
Notes: [2013-2015] There are 4 longitudinal cracks w/spalls in so. approach slab & 6 long. cracks in north approach slab (4 moderate longitudinal & 2 minor longitudinal cracks).
 [2013-2015] There is 125 LF of moderate cracking on the north approach slab + 88 LF moderate cracking on the south approach slab for a total of 213 LF.
 [2013-2015] The south approach slab has major delamination adjacent to joint at SE corner in need of rehabilitation (area 4.5' X 0.5').
 [2011-2015] The north approach slab has two major spalls at deck joint.
 [2001-2013] Moderate cracking & spalls present at northbound & southbound outside lanes.

Photo 14 - South approach spall

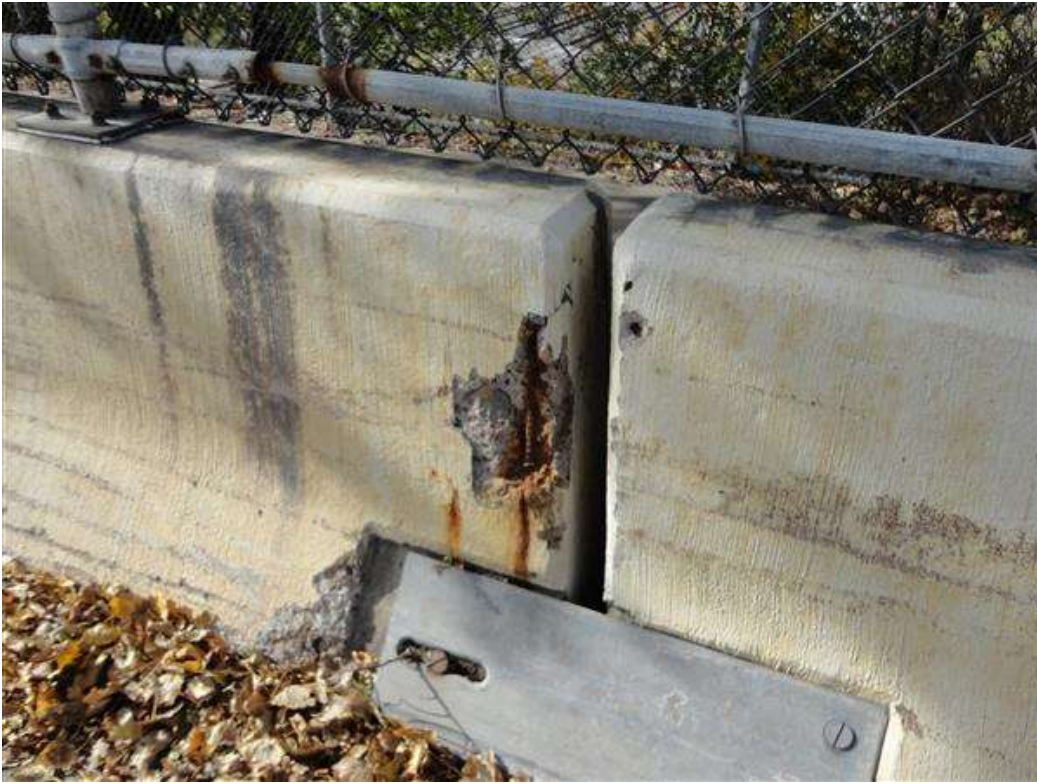
Photo 15 - Spall on east rail

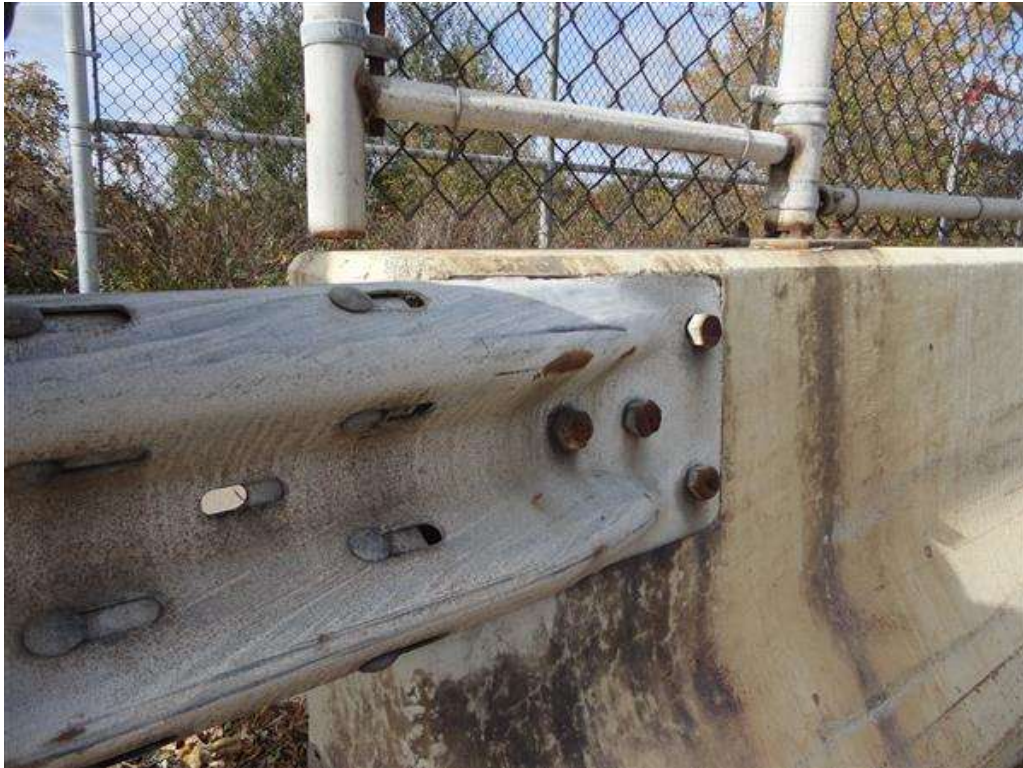
Photo 16 - SW guardrail connection

Notes: [2015] Guardrail repaired NE & NW sections. Twisted end treatment at all corners.

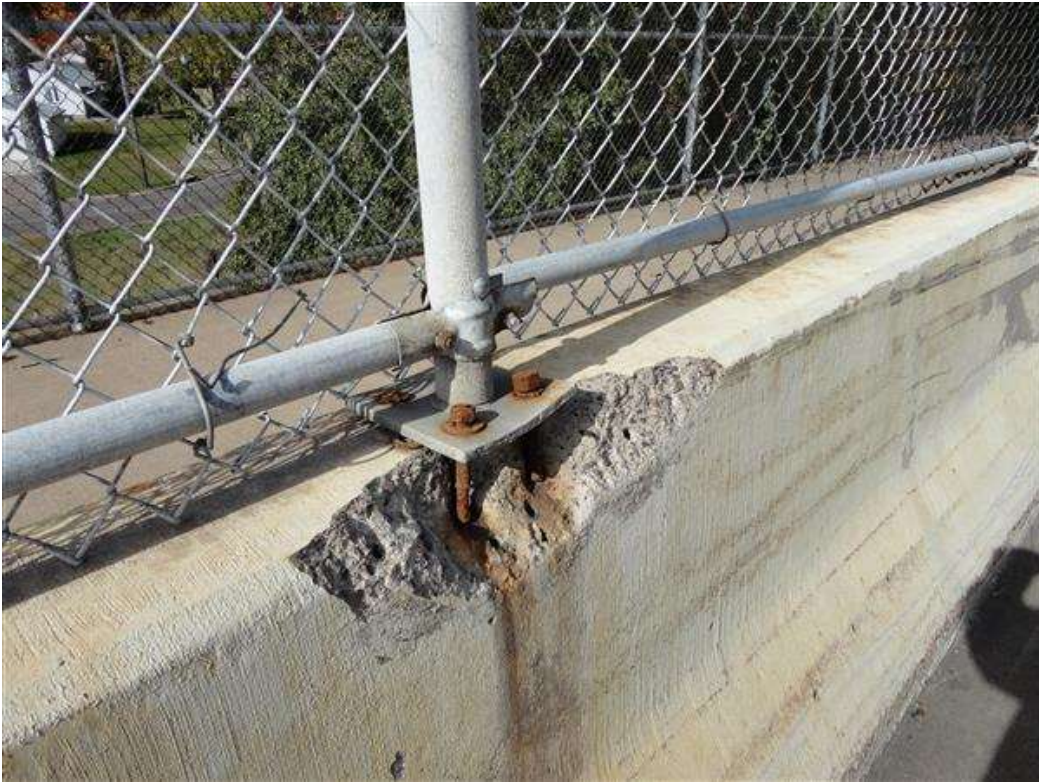
Photo 17 - West rail spall.

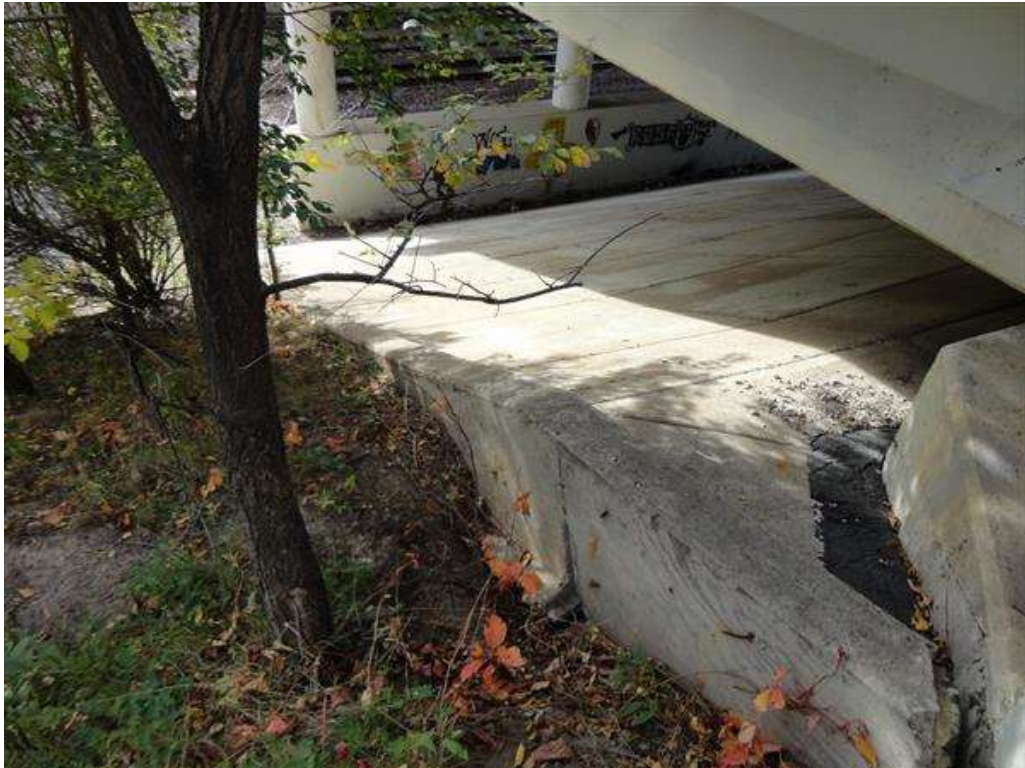
Photo 18 - SW WW slope paving.

Notes: [2015] Moderate erosion at the NE corner along the slope paving.
 [2013-2015] The south slope pavement has minor cracking.
 [2009-2015] The north slope pavement has a 0.5' settlement along the north abutment.
 There is movement of the north slope pavement from abutment. There is a 0.3' gap @ joint.
 [2005-2015] Cracking 90% across the north side slope paving.
 [2001-2015] Minor erosion along back side of wing walls & slope paving. Need fill.
 [1997-2015] Bit. felt at top of slope paving both ends of bridge need repair.
