**2015 ROUTINE  
BRIDGE INSPECTION REPORT**

**BRIDGE # 62554  
CSAH 30(LARPENT A) over DNR TRAIL**

**DISTRICT:** Metro

**Date(s) of Inspection:** 10/12/2015

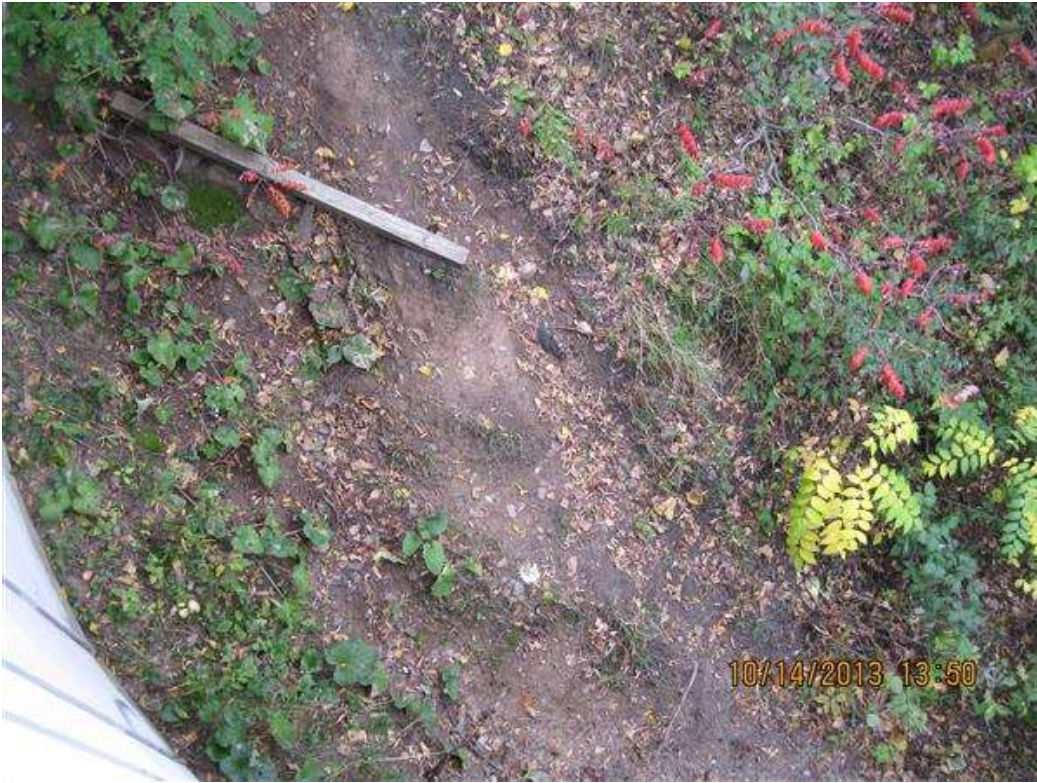
Photo 1 -

Notes: There is some settlement of material at behind all wing walls 2011-2015.  
There is some major erosion @ NW corner behind the wing wall 2009-2015. Material has been deposited on the DNR trail.  
Requires maintenance.  
Moderate erosion @ NW corner 2007.  
Minor erosion @ NW corner 2003-2005.

1. erosion @ NW wing wall.JPG

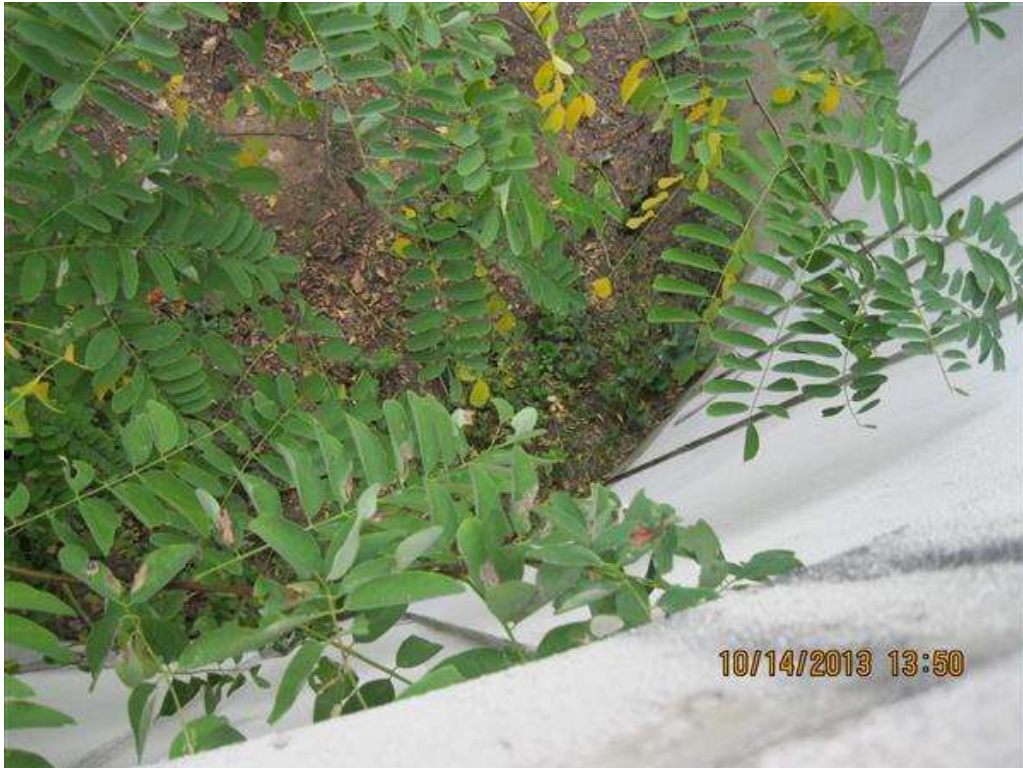
Photo 2 -

2. erosion @ NW wingwall-2.JPG

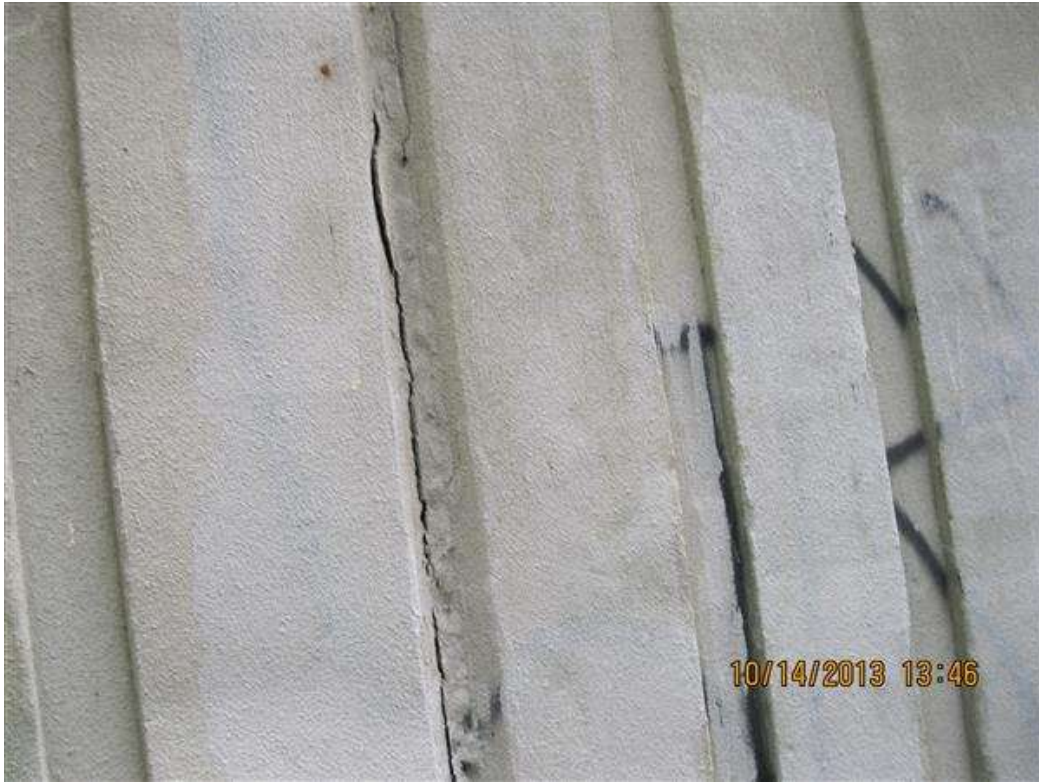
Photo 3 -

Notes: Some corrosion @ SE corner 2015  
Abutment sidewalls south side caulked. 2015  
Abutment wings have minor vertical & horizontal cracking & spalling w/efflorescence 2003-2015.  
Spalling on exposed aggregate @ all 4 corners 2007-201.  
Abutment sidewalls south side need caulking. Some corrosion @ SE corner 2003-2013.  
Minor deterioration of cork in joints 2013.  
Graffiti has been painted over 2013.

3. joint in SW wing wall.JPG

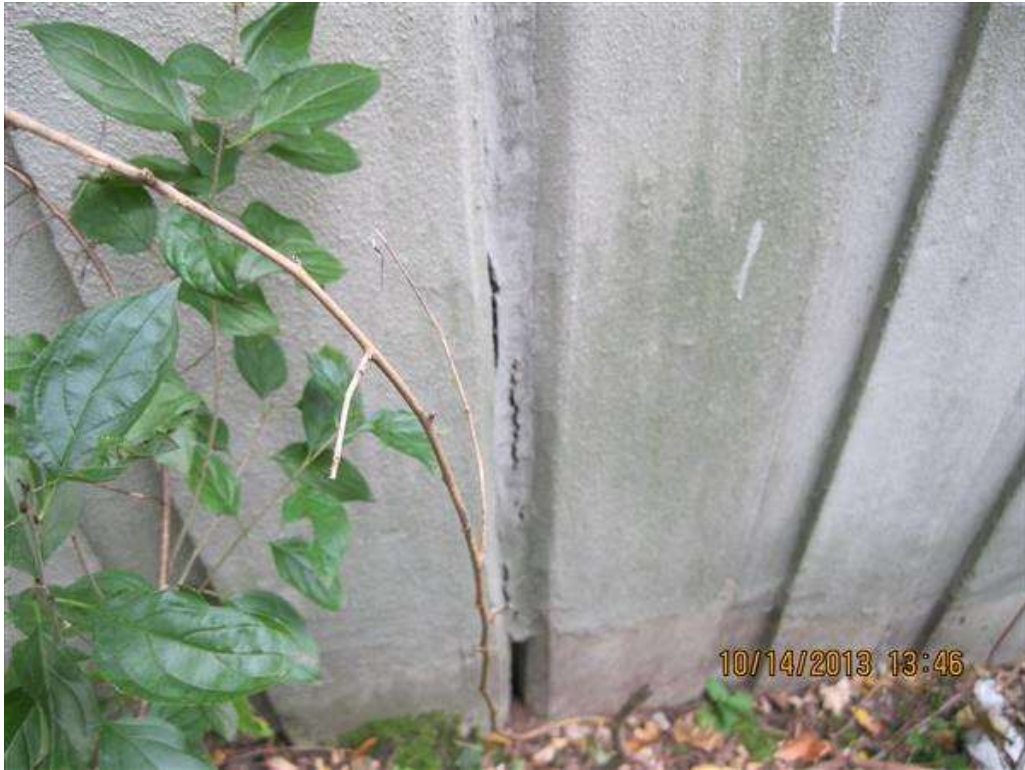
Photo 4 -

4. joint in SW wing wall-2.JPG

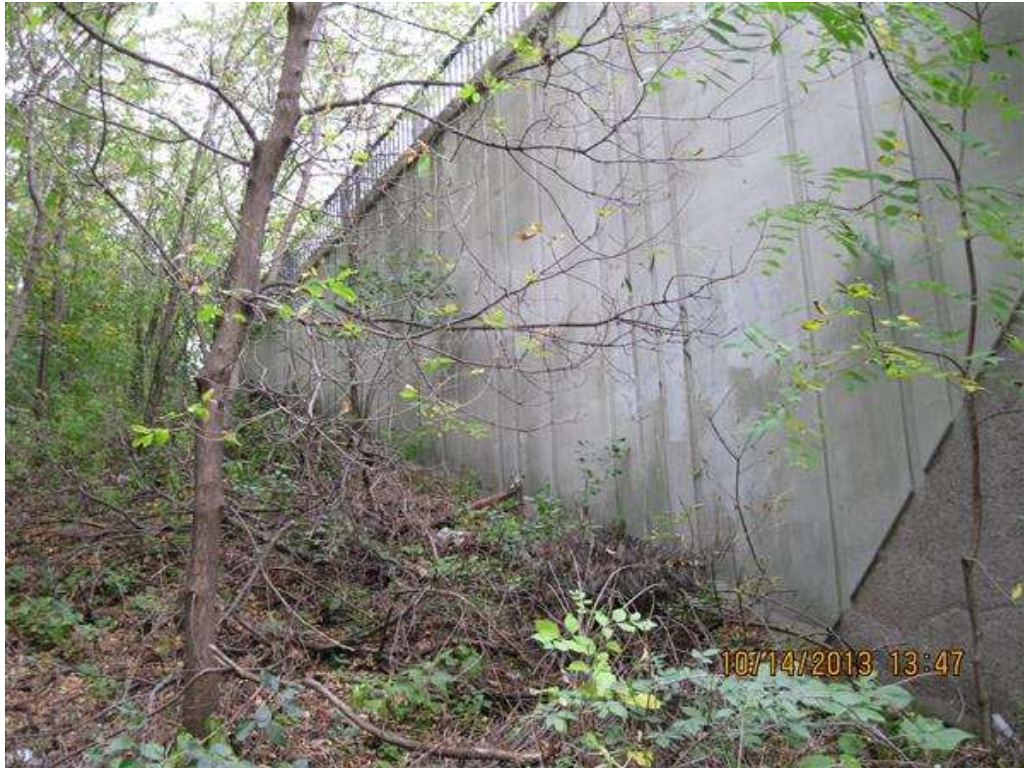
Photo 8 -

8. NE wing wall.JPG

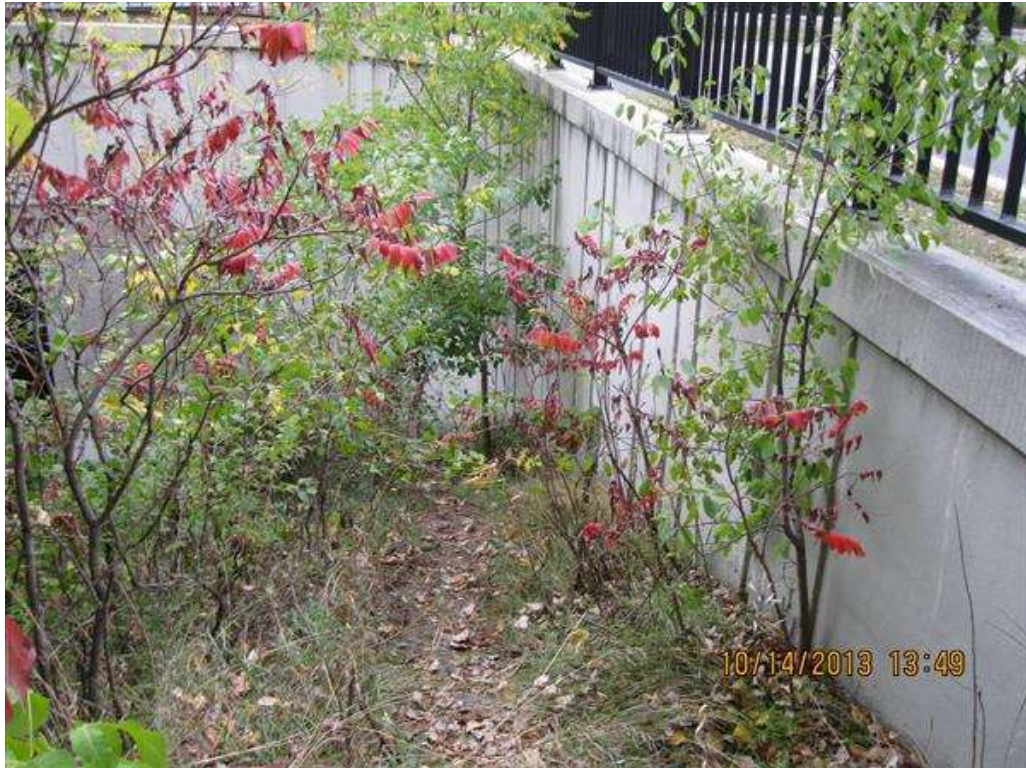
Photo 10 -

10. NW wing wall.JPG

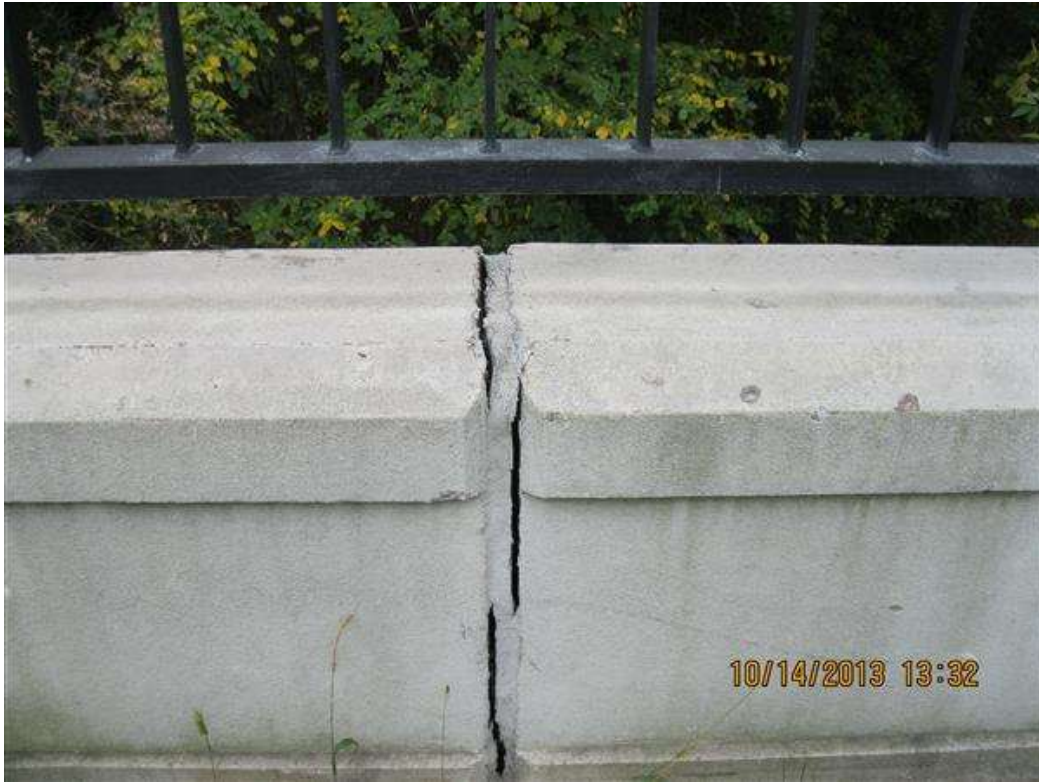
Photo 11 -

Notes: Railing on both sides have minor - moderate spalls cracks and spalls w/efflorescence 1997-2015.  
Paint on metal railing is chalking and flaking off 2005-2015.  
Minor deterioration of cork in joints 2013-2015.  
Railing is combination conc. parapet and metal railing. 154 LF north side and 143 LF south side.

11. railing south side.JPG
