**2015 ROUTINE
BRIDGE INSPECTION REPORT**

**BRIDGE # 62563
CSAH 23(CR C) over REC TRAIL**

DISTRICT: Metro

Date(s) of Inspection: 09/16/2015

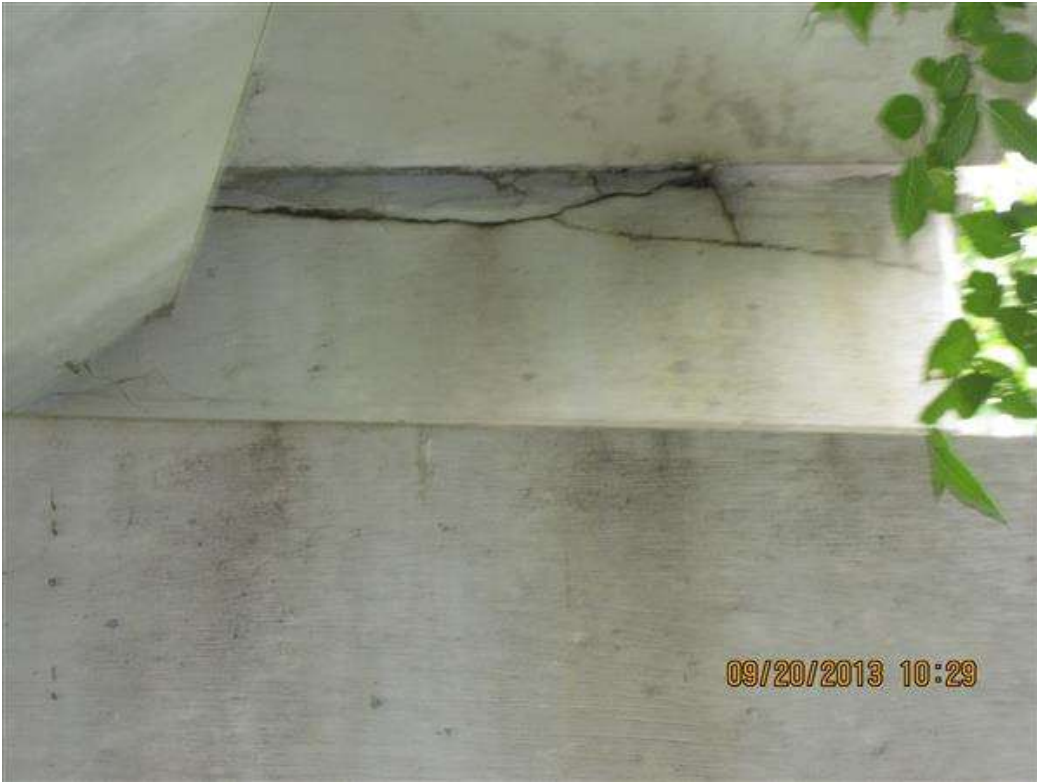
Photo 1 -

Notes: There are 4 moderate 1" - 2" spalls w/ rust present on the NE corner of east abutment 2015.
 The south end of east abutment has 3' moderate horizontal crack up by the SE corner of parapet -2013-2015.
 The south end of west abutment has 2' minor horizontal crack up by the SW corner of parapet - 2013-2015.
 There is a full height crack on both abutments at construction joints 2011-2015.
 The west abutment has minor spalls present 2009-2015.
 Debris on both abutments - need to be cleaned for further inspection.
 There is graffiti on the west abutment 2005-2015.
 There is minor vertical cracking of backwall of west abutment at SW corner 2007-2015.
 There are 4-14' minor vertical cracks on west abutment and 5-14' minor vertical cracks on east abutment + 5 LF of horizontal cracking east abutment for a total of 131 LF of cracks 2009-2015.
 The north 1/2 of east abutment contains alligator cracks. The east abutment contains spalls with re-bar corrosion present @ SE & NE corners 2007-2015.

1. Crack in SE Parapet.JPG

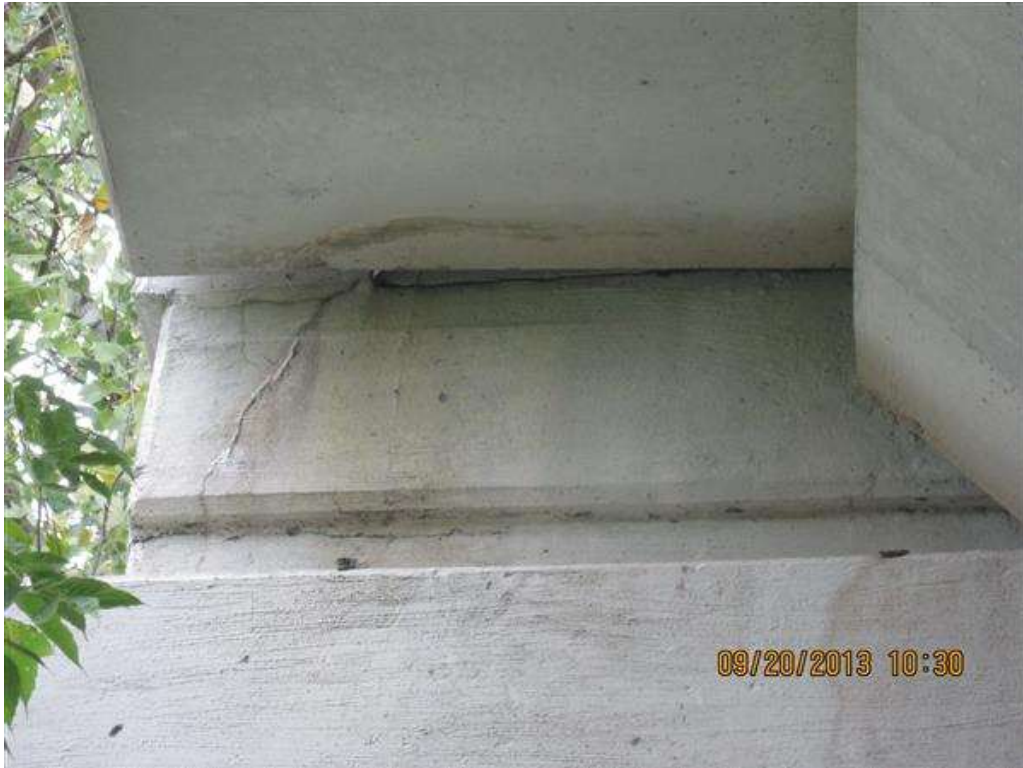
Photo 2 -

2. Crack in SW Parapet.JPG
