**2016 ROUTINE  
BRIDGE INSPECTION REPORT**

**BRIDGE # 62566  
CSAH 51(LEXINGTON) over RICE CREEK**

**DISTRICT: Metro                      COUNTY: Ramsey                      CITY/TOWNSHIP: Shoreview  
STATE: Minnesota**

**Date of Inspection: 09/14/2016  
Equipment Used: Life Jacket**

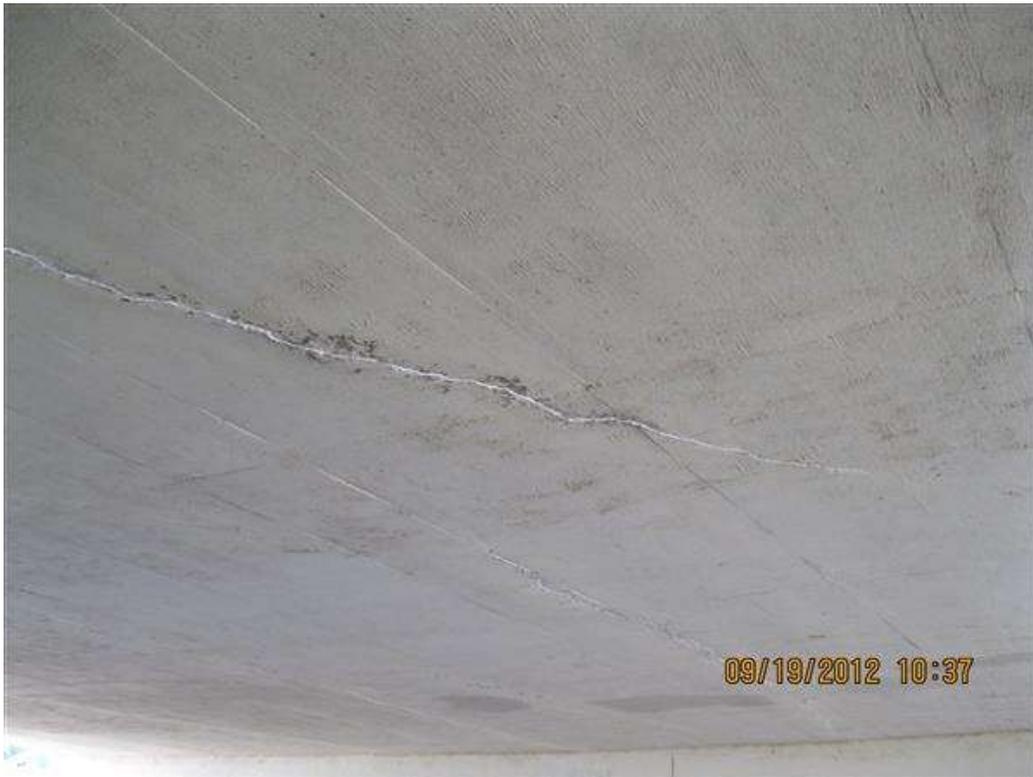
ELEM NBR	ELEMENT NAME	REPORT TYPE	INSP. DATE	QUANTITY	QTY CS 1	QTY CS 2	QTY CS 3	QTY CS 4
38	Reinforced Concrete Slab	Routine	09/14/2016	2739 SF	2439	0	300	0
		Migrated Values		2739 SF	2439	0	300	0
<p>Notes: [2016] There are moderate spalls at the SE corner underside of the deck                      [2014-2016] There are 10 longitudinal cracks across the bridge + diagonal cracking at sides. Approximately 10 X L= 300 LF of cracks.                      [2010-2016] Moderate cracking w/efflorescence                      [2010-2012] There are 6 longitudinal cracks across the bridge + diagonal cracking at sides. Approximately 6 X L= 240 LF of cracks.                      [2002-2008] Cracking with efflorescence underside the deck is light.                      [2004] There are three longitudinal cracks across the bridge and diagonal cracking near corners. Approximately 5 X L = 200 LF of cracks.</p>

Photo 1 - cracks under deck north side cl

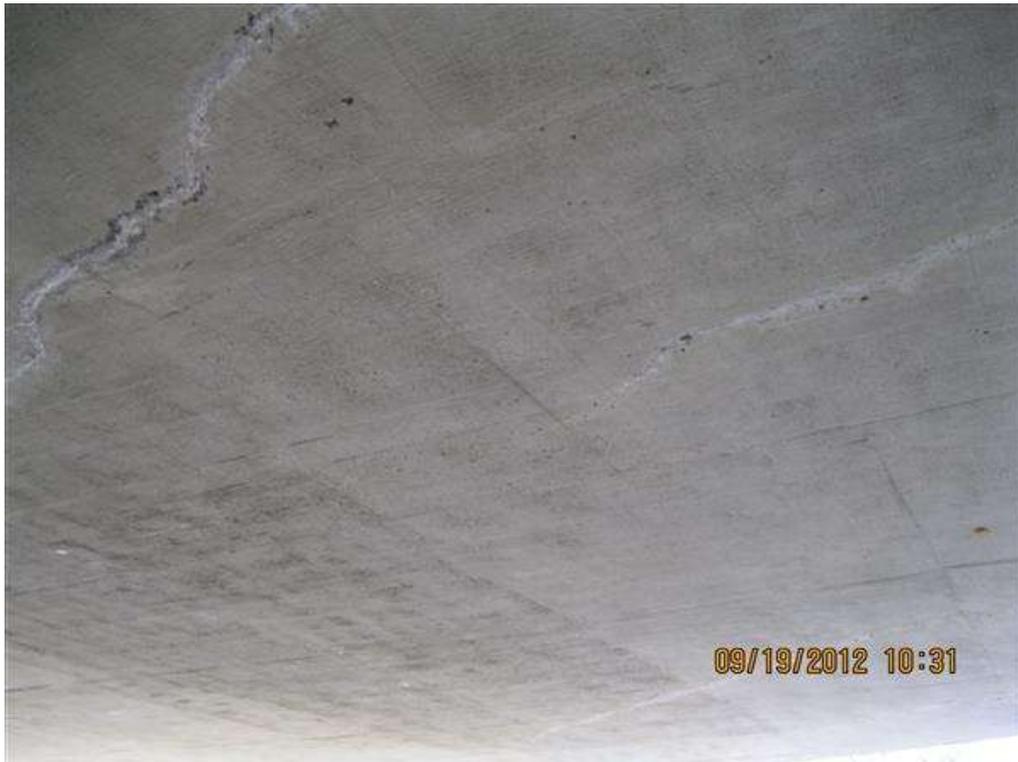
Photo 2 - cracks under deck south side cl

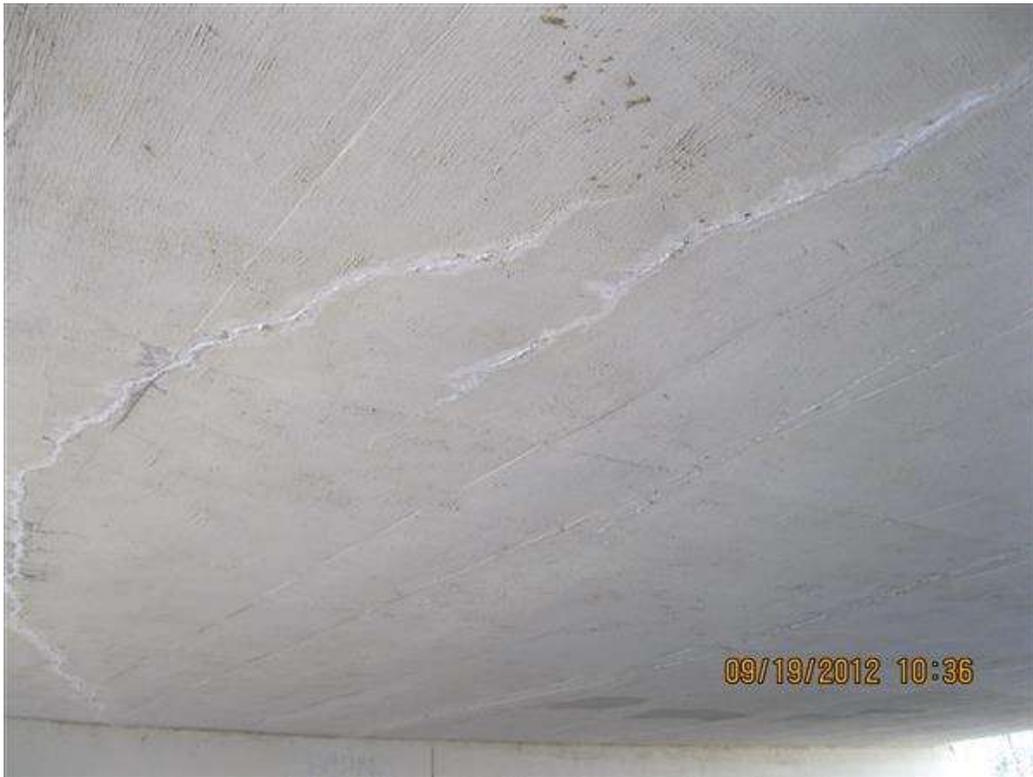
Photo 3 - cracks under deck south side cl2

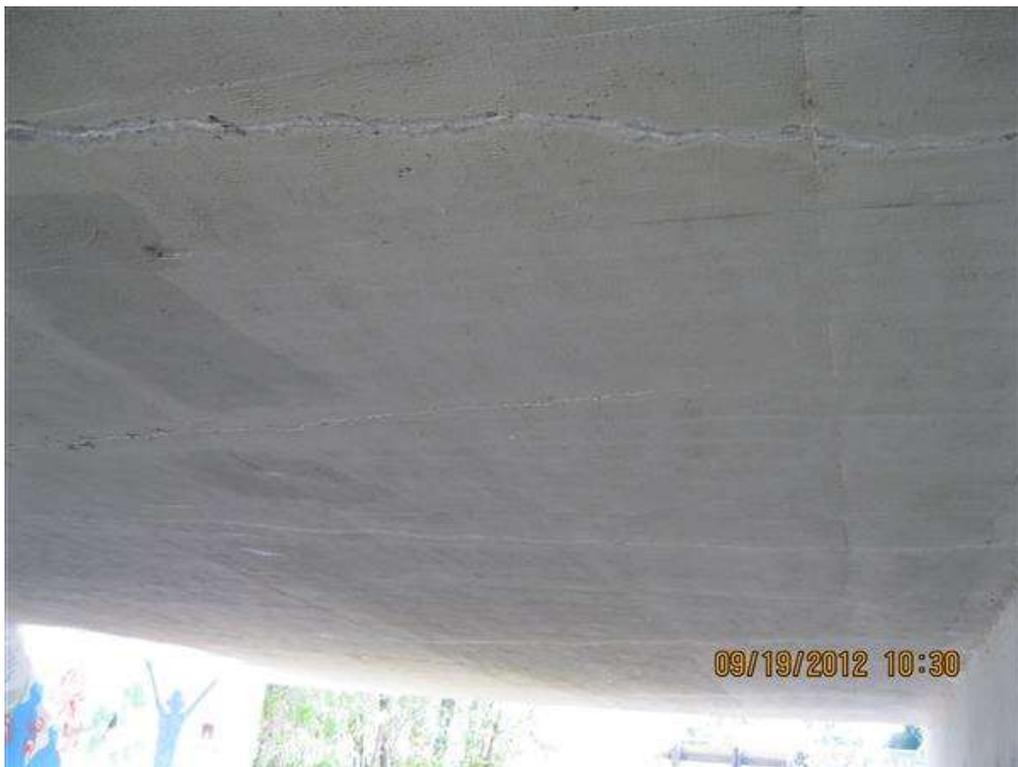
Photo 4 - cracks under deck south side cl3

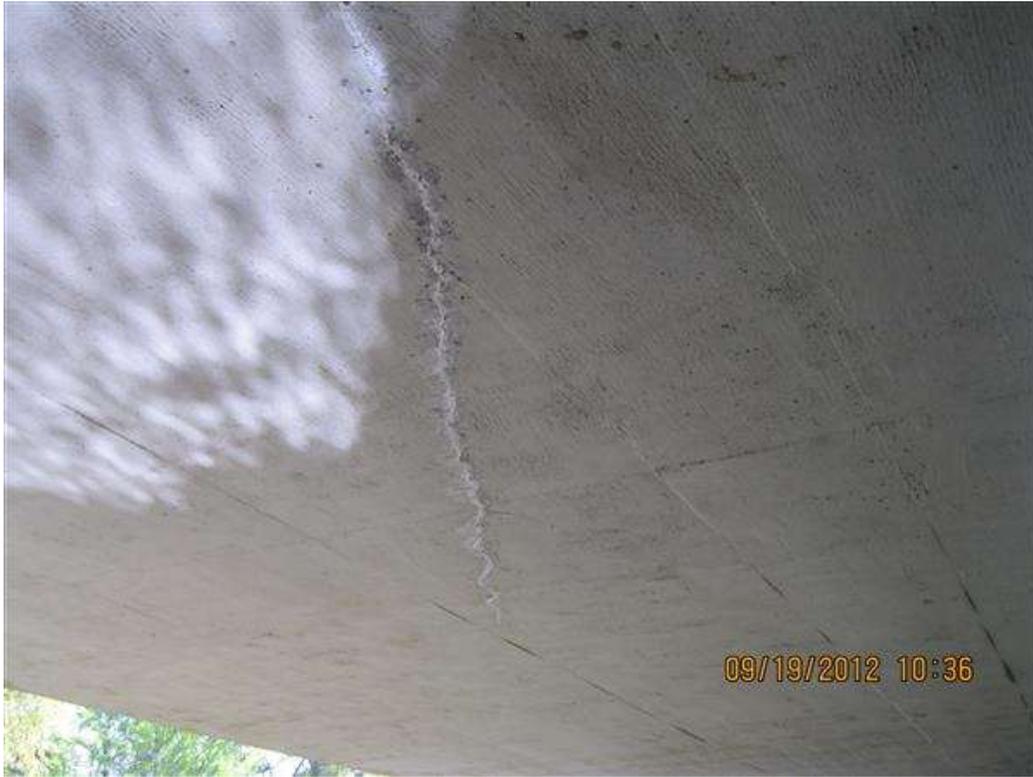
Photo 5 - cracks under deck west side

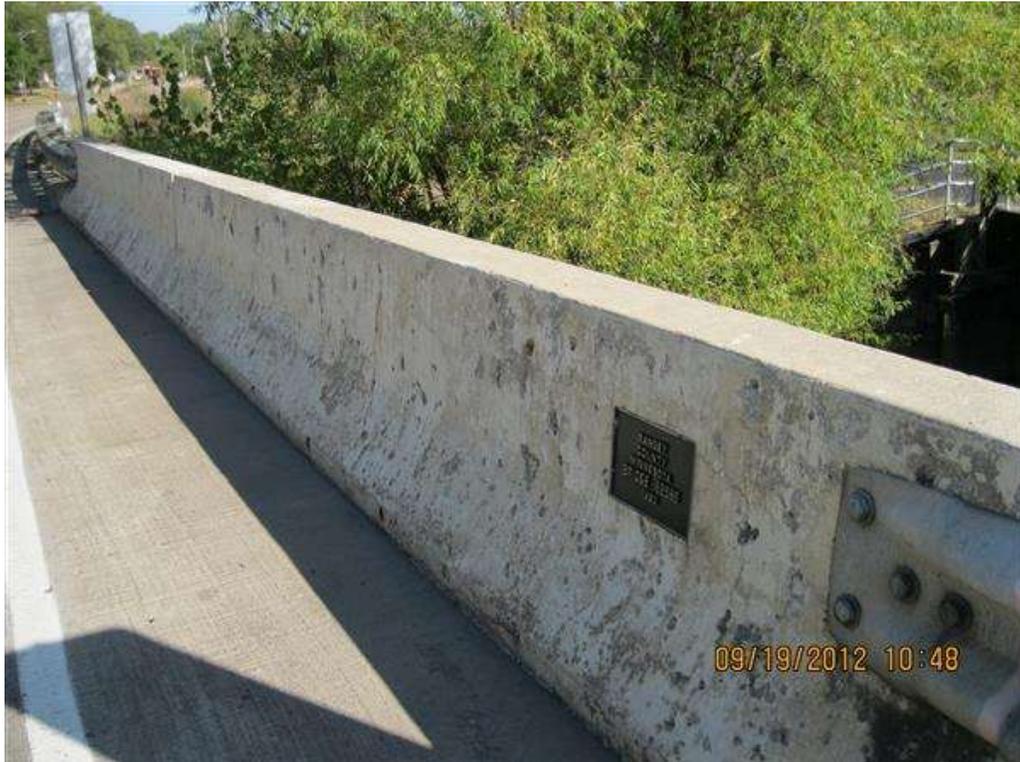
Migrated Values		82 LF	0	82	0	0
	Notes: [2016] The west rail contains 5 vertical cracks with moderate spalls. [2010-2014] The west rail contains 4 vertical cracks with moderate spalls. [2010-2014] The east rail contains vertical cracking with numerous moderate size spalls. No exposed rebar. [2008] There are moderate spalls on the east side concrete railing. [2001-2008] Minor vertical cracks with spalls present.							
800	Critical Deficiencies or Safety Hazards	Routine	09/14/2016	1 EA	1	0	0	0
		Migrated Values		1 EA	1	0	0	0
	Notes: NO CRITICAL FINDINGS OBSERVED DURING THE LAST INSPECTION.							
810	Concrete Decks - Cracking & Sealing	Routine	09/14/2016	300 LF	0	300	0	0
		Migrated Values		300 LF	0	300	0	0
	Notes: [2014-2016] There are 10 longitudinal cracks across the bridge + diagonal cracking at sides. Approximately 10 X L= 300 LF of cracks. [2010-2014] There are numerous minor to moderate cracks in the concrete deck (approximately 250 LF). [2002-2006] Minor cracking.

Photo 6 - east concrete rail 2

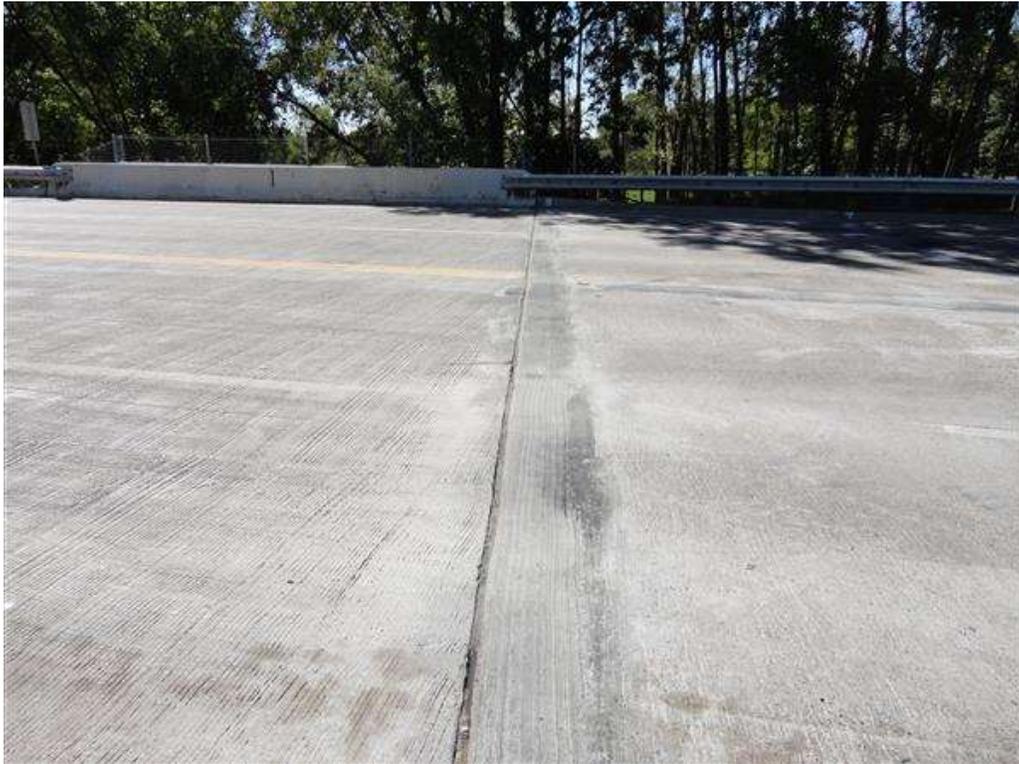
301	Pourable Joint Seal	Routine	09/14/2016	141 LF	0	141	0	0
		Migrated Values		141 LF	0	141	0	0
<p>Notes: [2016] B3 repairs were done on all joints on both approach panels                      [2006-2014] Centerline joints of both approach panels need replacement. No joints in deck.</p>

Photo 12 - B3 repair 2016

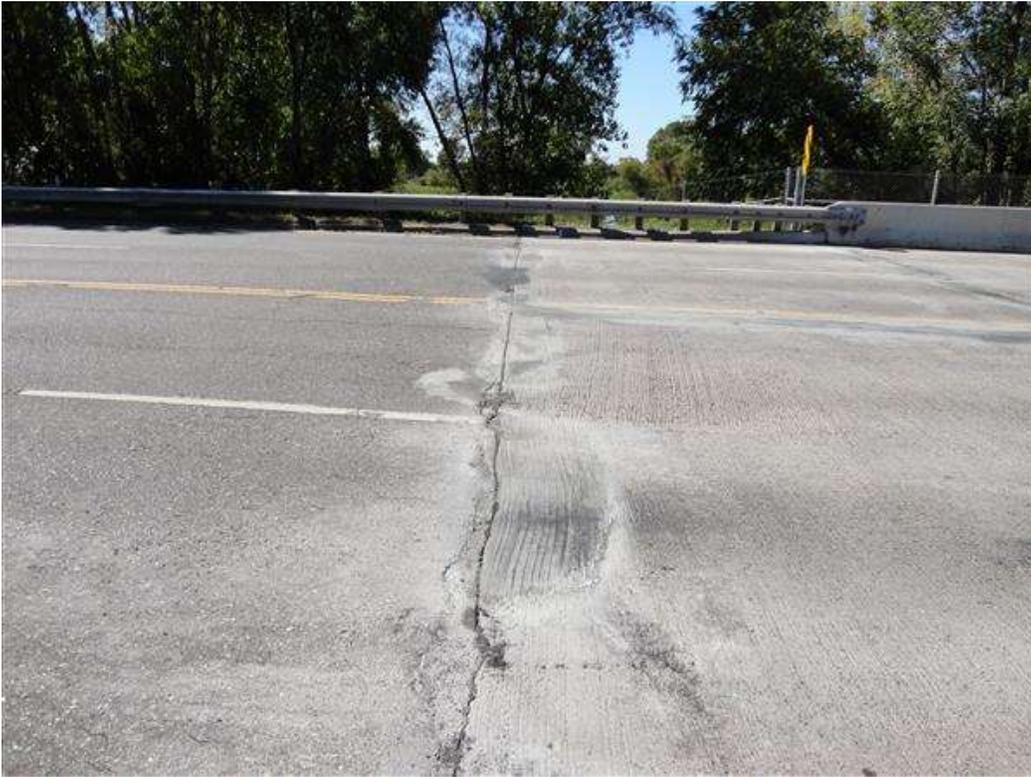
Photo 13 - B3 repair1 2016

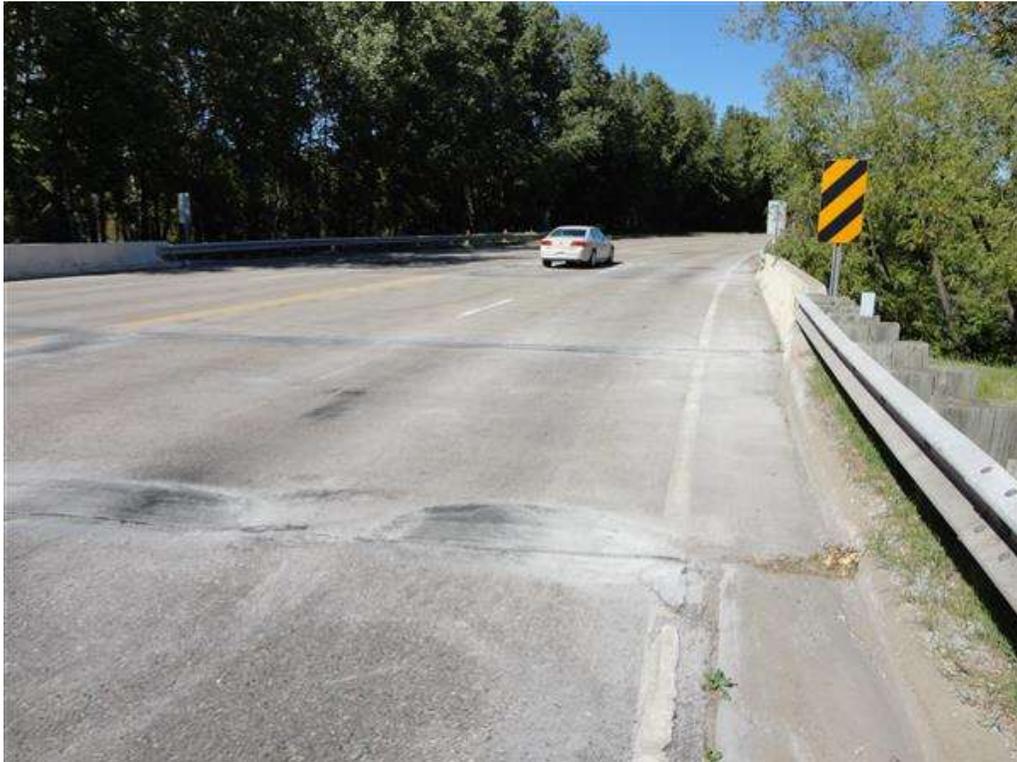
Photo 14 - B3 repair2 2016

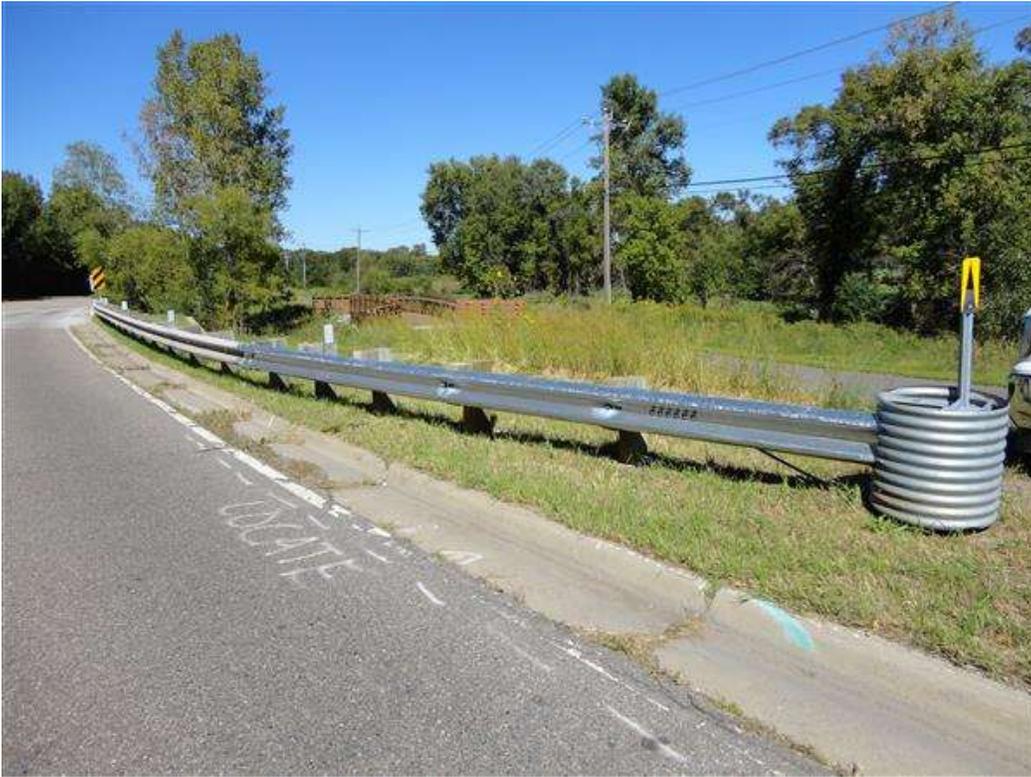
Photo 15 - SE Guardrail 2016

891	Other Bridge Signing	Routine	09/14/2016	1 EA	1	0	0	0
		Migrated Values		1 EA	1	0	0	0
	Notes: [2012-2016] All appropriate signing is present.							
892	Slopes & Slope Protection	Routine	09/14/2016	1 EA	0	1	0	0
		Migrated Values		1 EA	0	1	0	0
	Notes: [2014-2016] Moderate erosion at the NW corner [2014-2016] Rip rap is filled with sediment [2006-2016] There is some movement of riprap south side of Rice Creek. [2012-2016] Riprap is operating as intended. Some settlement both sides. The north side has been grouted. [2012-2016] Also settlement of the concrete wall south side of Rice Creek at the SW corner.							
893	Guardrail	Routine	09/14/2016	1 EA	0	1	0	0
		Migrated Values		1 EA	0	1	0	0
	Notes: [2016] SE end has been replaced [2008-2016] There are moderate damage to the guardrail system. [2006-2016] Guardrail system is in place and functioning properly. [2004] There is collision damage to the SE end of the SE guardrail. Need to repair guardrail.

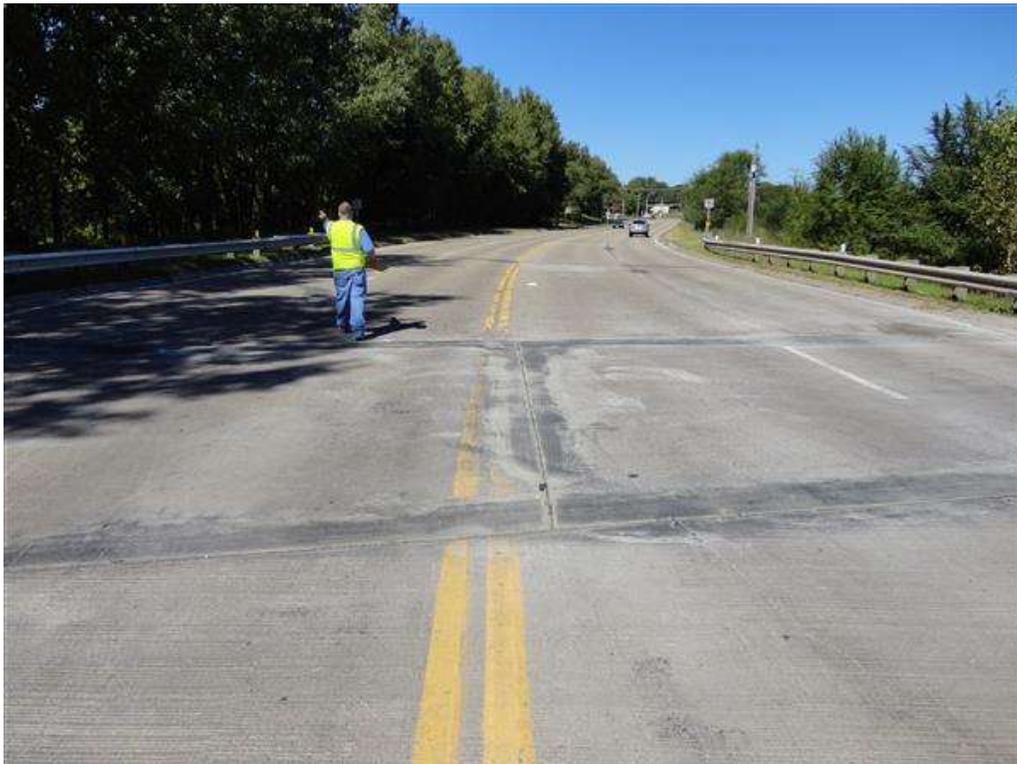
Photo 16 - North approach panel 2016

ELEM NBR	ELEMENT NAME	REPORT TYPE	INSP. DATE	QUANTITY	QTY CS 1	QTY CS 2	QTY CS 3	QTY CS 4
321	Reinforced Concrete Approach Slab	Routine	09/14/2016	2080 SF	0	2080	0	0
		Migrated Values		2080 SF	0	2080	0	0
	Notes: [2016] B3 repairs were done on all joints on both approach panels [2016] there is moderate cracking and spalling on both approach panels. [2016] Migrator assumed an approach slab length of 20FT and used the inventory quantity of 52FT for the width. [2010-2014] Bituminous patches are letting loose. There is significant deterioration of concrete at joints adjacent to deck. [2012-2014] Rehabilitation of the concrete adjacent to deck joints is recommended. [2010] Both slabs have moderate cracking & spalling. [2001-2008] Both slabs have minor cracking & spalling. [2004-2010] There is moderate deterioration of concrete at joints adjacent to deck.							
331	Reinforced Concrete Bridge Railing	Routine	09/14/2016	82 LF	0	82	0	0
