**2016 ROUTINE  
BRIDGE INSPECTION REPORT**

**BRIDGE # 62590  
CSAH 96 over SUCKER CREEK UNSTABLE MA**

**DISTRICT:** Metro                      **COUNTY:** Ramsey                      **CITY/TOWNSHIP:** Vadnais Heights  
**STATE:** Minnesota

**Date of Inspection:** 09/08/2016  
**Equipment Used:** Chain Drag

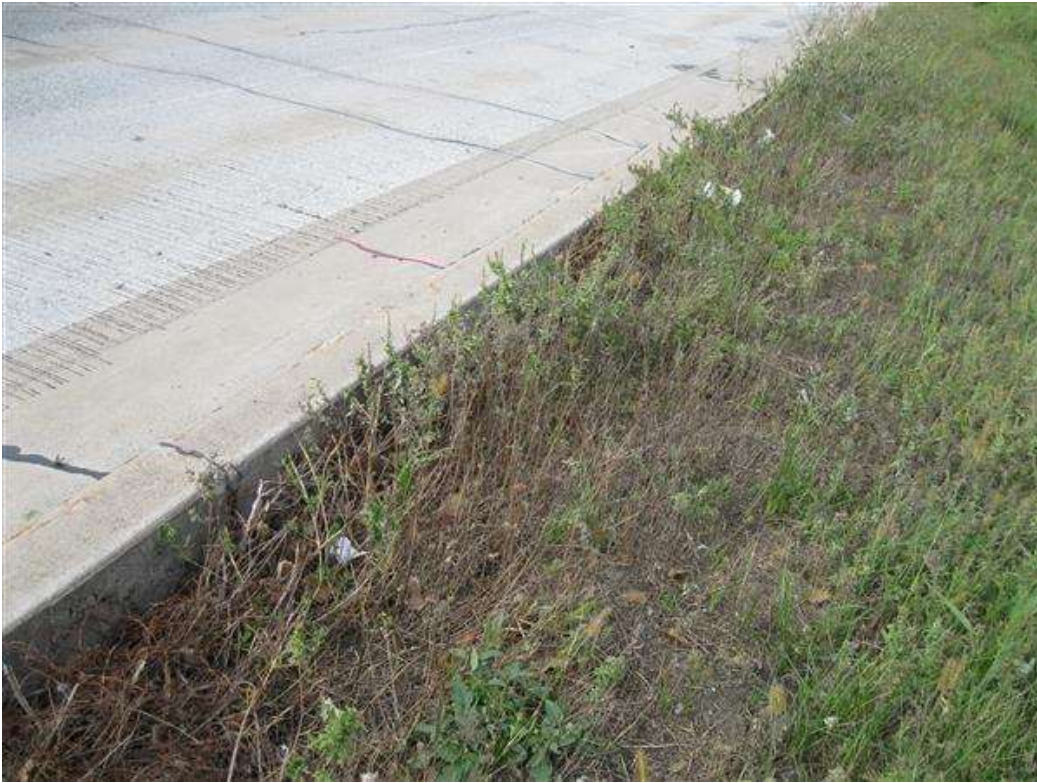
Photo 3 - curb north side-2.JPG

ELEM NBR	ELEMENT NAME	REPORT TYPE	INSP. DATE	QUANTITY	QTY CS 1	QTY CS 2	QTY CS 3	QTY CS 4
	[2006] There is major settlement behind the curb on the north side. Boulevard requires fill. Land Bridge was built in 1999. There is a settlement problem of detached bike path adjacent to the south side of bridge. Bike path was repaired in 2002. There are 2 culverts running perpendicular underneath the land bridge.

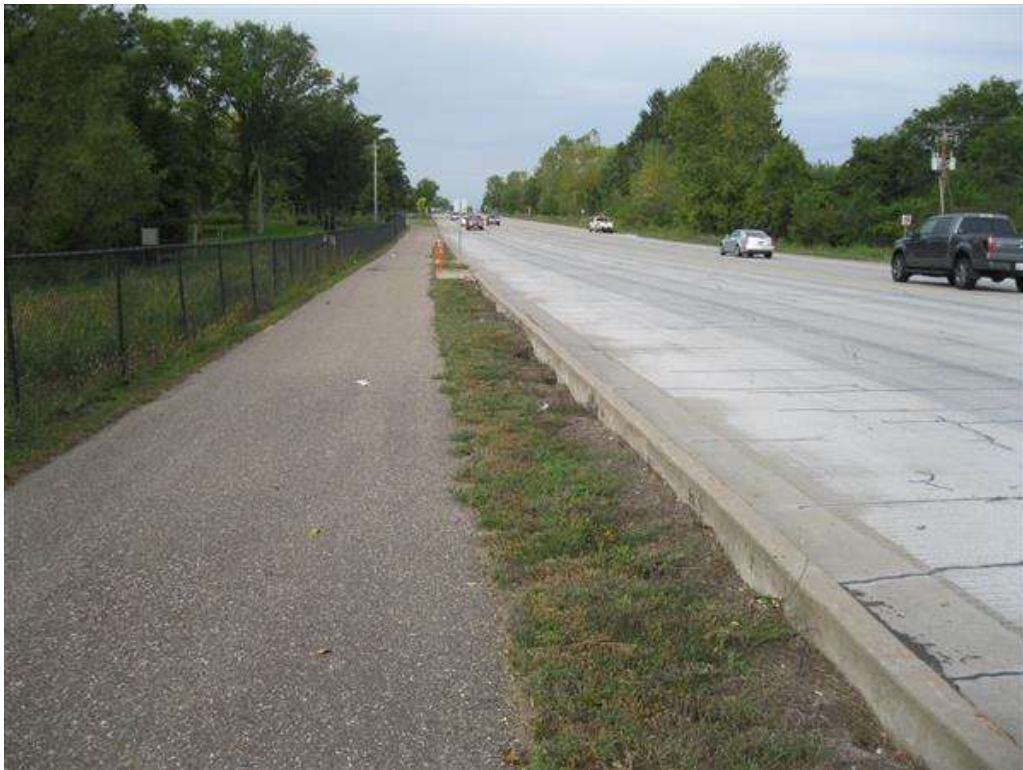
Photo 4 - curb south side.JPG

895	Sidewalk, Curb, & Median	Routine	09/08/2016	1 EA	0	1	0	0
		Migrated Values		1 EA	0	1	0	0
<p>Notes: [2016] 7.0' of damaged curb on SW corner of bridge.                      [2014-2016] Moderate settlement behind north curb, Major settlement behind south curb                      [2014] Curb has been replaced on all 4 corners of bridge                      [2008-2012] There are 2 areas of deterioration of the curb @ SW corner. [2008-2012] There is deterioration of curb located at the 4- LP-4's.                      [2012] Curb OK at the SE corner- has been repaired.                      [2012] There is moderate- major settlement behind the curb on both sides. Need fill behind curb at the NE CB. The settlement is 2' low X 2.5' W X 18' length.</p>								
900	Protected Species	Routine	09/08/2016	1 EA	1	0	0	0
		Migrated Values		1 EA	1	0	0	0
<p>Notes: Use this element to track the presence of protected species living on this structure.                      [2016] No protective species found.</p>

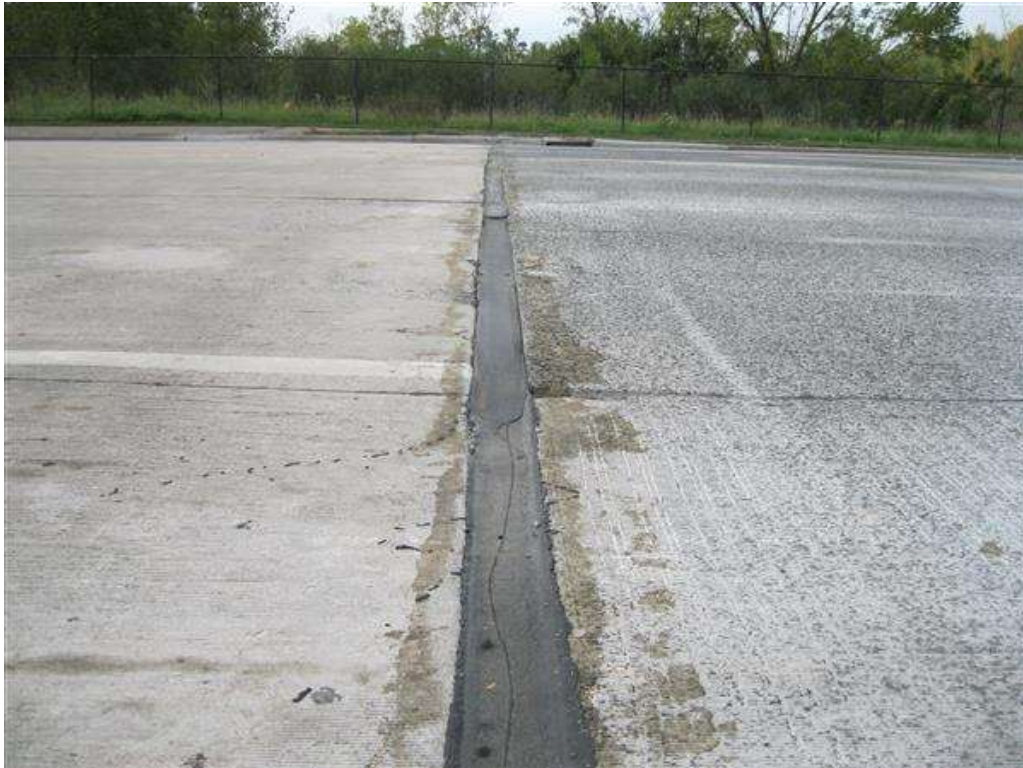
Photo 6 - east E-8 joint.JPG

ELEM NBR	ELEMENT NAME	REPORT TYPE	INSP. DATE	QUANTITY	QTY CS 1	QTY CS 2	QTY CS 3	QTY CS 4
321	Reinforced Concrete Approach Slab	Routine	09/08/2016	4020 SF	0	2010	2010	0
		Migrated Values		4020 SF	0	2010	2010	0
<p>Notes: [2016] 67' x 30' = 2010 SF x 2 = 4020 SF of Approach Slab.                      [2016] Migrator assumed an approach slab length of 20FT and used the inventory quantity of 67FT for the width.                      [2016] East Approach has 0.5' x 1.5', 1' x 1' &amp; 0.5' x 0.5' moderate spalls                      [2016] West Approach has 1.0' x 0.5' &amp; 0.5' x 0.5' moderate spalls.                      [2014] Diamond ground surface for noise &amp; grade difference, sealed cracks in deck &amp; approach panels in 2014                      [2014-2016] 0.5' x 7.0' spall in NW corner                      [2003-2016] There is settlement of concrete pavement at east &amp; west approach slabs resulting in impact on approach panels.                      [2010-2012] The west approach slab has a 30' of moderate longitudinal cracking north side, 20' of minor cracking at centerline of the west approach and a 13' diagonal crack at the SW corner. [2012] The west concrete approach slab also has moderate settlement at the west end.                      [2008-2012] The east approach has a 12' diagonal crack @ SE corner. [2008] There is an 8' area of delamination at the NW corner of the east approach.                      [2006-2012] There is a 3' X 0.5' area of major delamination at the SE corner with some settlement.                      [2002-2012] Both slabs contain minor to moderate cracking. [2003-                      [2003-2012] There is deterioration of Styrofoam expansion joints (E8S joint) at both ends. Hot pour has cohesion failure.</p>
