**2016 ROUTINE
BRIDGE INSPECTION REPORT**

**BRIDGE # 62618
CP RAIL over STREET 69**

Date of Inspection: 09/08/2016

MINNESOTA BRIDGE INSPECTION REPORT

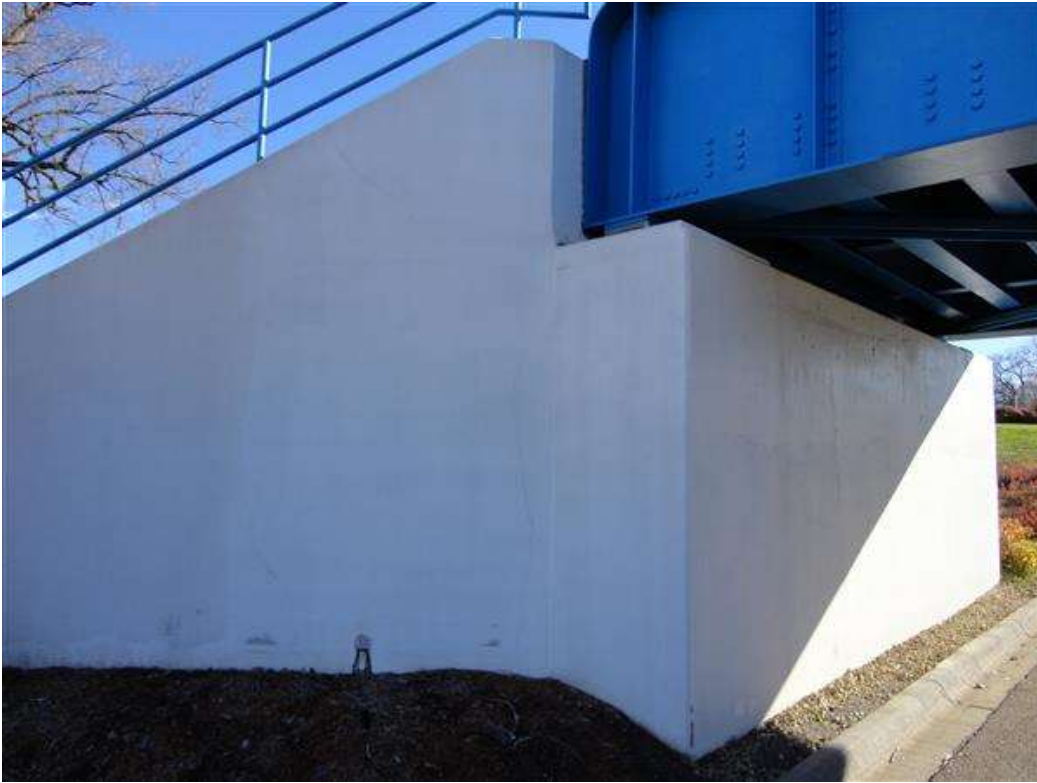
Photo 1 - 62618 NW WW

387	Reinforced Concrete Wingwall	2	Routine	09/08/2016	4 EA	0	4	0	0	N/A
			Routine	09/11/2015	4 EA	0	4	0	0	N/A
Notes: [2013-2014] NW wingwall has a 14' moderate vertical crack, 3 - 5' minor diagonal cracks and a 3' 4' and 5' minor diagonal cracks at the north corner. [2013-2015] NE wingwall has a minor 7' diagonal, 2 3' diagonal, and a 7' vertical cracks. [2012-2015] The SW wingwall has a 12' diagonal crack at wingwall drain + 2- 4' minor diagonal cracks. [2006-2015] The SE wingwall contains minor 6' vertical crack, 3' vertical crack and a 2' diagonal crack. [2013-2014] NW wingwall has 3 5' minor diagonal cracks. [2006-2012] The NE wingwall has a minor 6' diagonal, 3' diagonal, 3' diagonal and a 6' minor vertical crack. [2012-2014] The NW wingwall has a 14' moderate vertical crack, minor cracking at drain and minor horizontal & vertical cracking at the north end.										
401	Steel Ballast Plate Deck (Railroad Bridges)	2	Routine	09/08/2016	1152 SF	1152	0	0	0	0
