**2015 ROUTINE
BRIDGE INSPECTION REPORT**

**BRIDGE # 62623
CSAH 16 over WEST VADNAIS SWAMP**

Date(s) of Inspection: 10/09/2015

Final Report Date: 01/05/2016

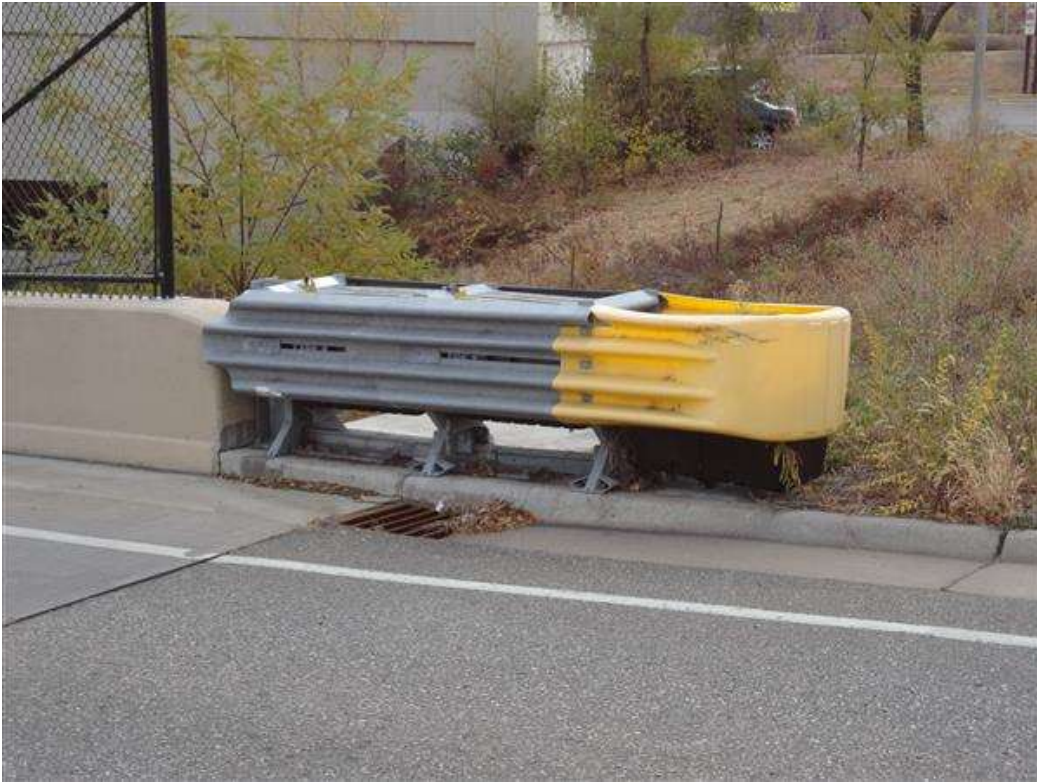
Photo 1 - NW Atten

Notes: [2012-2015] SOME MODERATE SPALLS PRESENT NEAR CRASH ATTENUATOR ON NW WING WALL.
 [2009-2015] NO SIGNIFICANT DETERIORATION PRESENT ON SW, SE & NE WING WALLS.

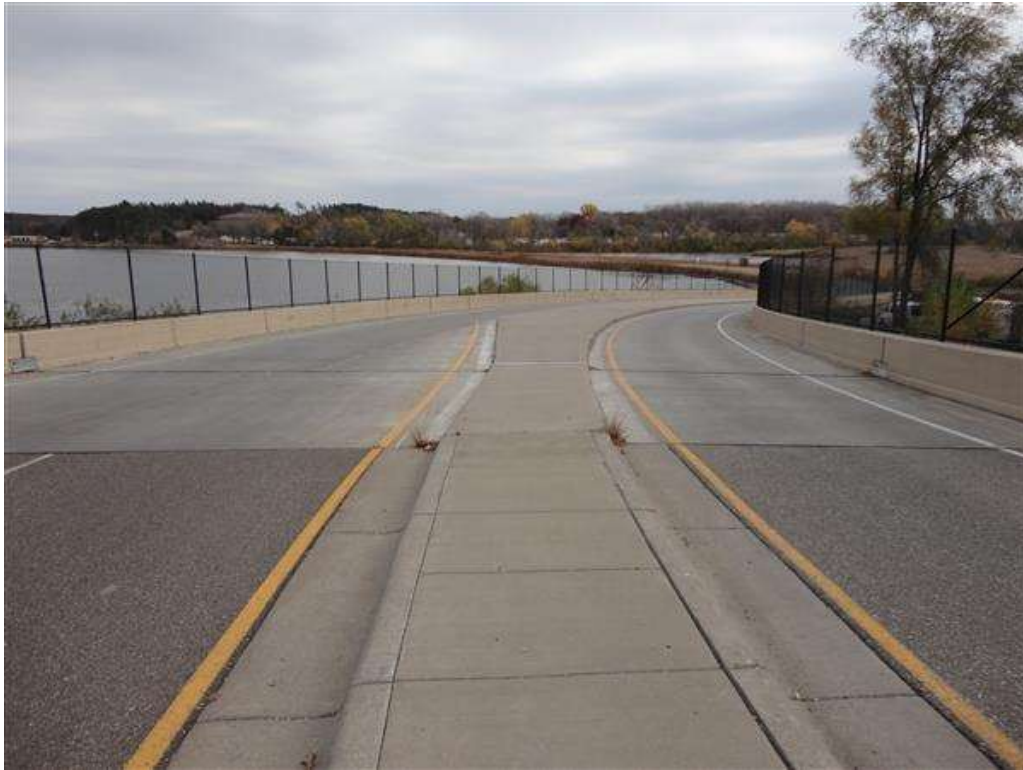
Photo 4 - West Appr

Notes: [2012-2015] THE SOUTH APPROACH SLAB HAS 5- 15" LONGITUDINAL CRACKS AT THE EXPANSION JOINT.
 [2009-2015] THERE IS A MAJOR 6" SPALL AT SW CORNER OF SOUTH APPROACH SLAB.
 [2012-2015] THE NW APPROACH SLAB HAS 23- 15" LONGITUDINAL CRACKS AT THE EXPANSION JOINT. THERE IS MINOR DELAMINATION NEAR THE CB AT THE NW CORNER. [2010-2015] MODERATE SPALLING AT WEST END OF NORTH APPROACH SLAB.

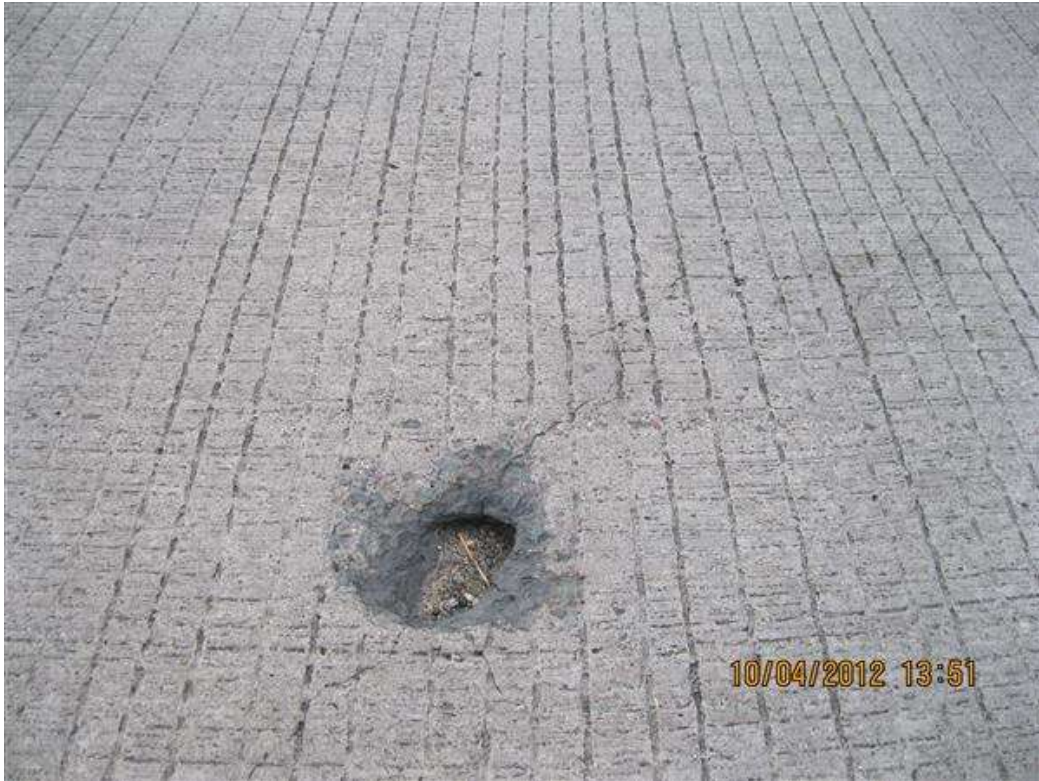
Photo 11 - Overlay South side Pier #1 WB

Notes: [2015] THERE IS SOME OCCASIONAL MINOR TO MODERATE SPALLING THROUGHOUT.
 [2010-2015] THERE IS A 4" SPALL SOUTH SIDE OF PIER #1 WESTBOUND.
 [2009-2015] THERE ARE 50 LF OF MINOR DIAGONAL, LONGITUDINAL & TRANSVERSE CRACKING AT EAST SIDE OF PIER #1.
 [2009-2015] MODERATE SPALL AT EASTBOUND SPAN #1.
 [2009-2014] THERE IS SOME OCCASIONAL MINOR SPALLING THROUGHOUT. [2009-2015] THERE ARE MINOR TRANSVERSE CRACKS EXTENDING INTO THE DECK FROM MEDIAN CRACKS THROUGHOUT. THE 2" 3U17A WEARING COURSE WAS INSTALLED IN 2008.

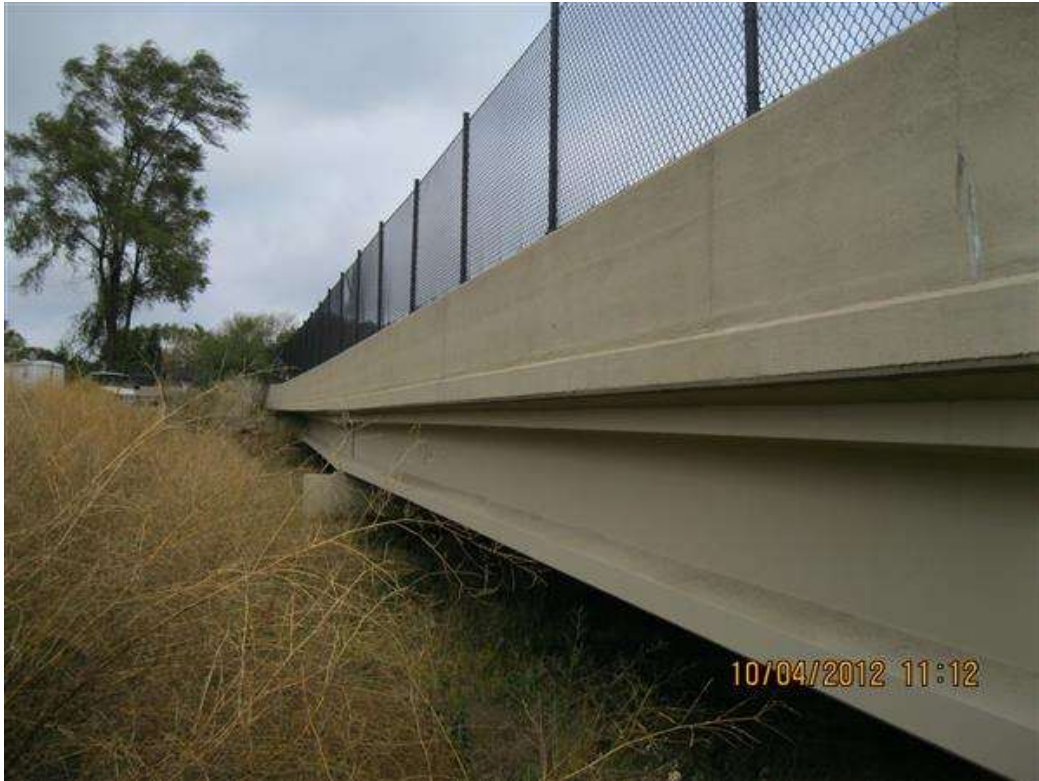
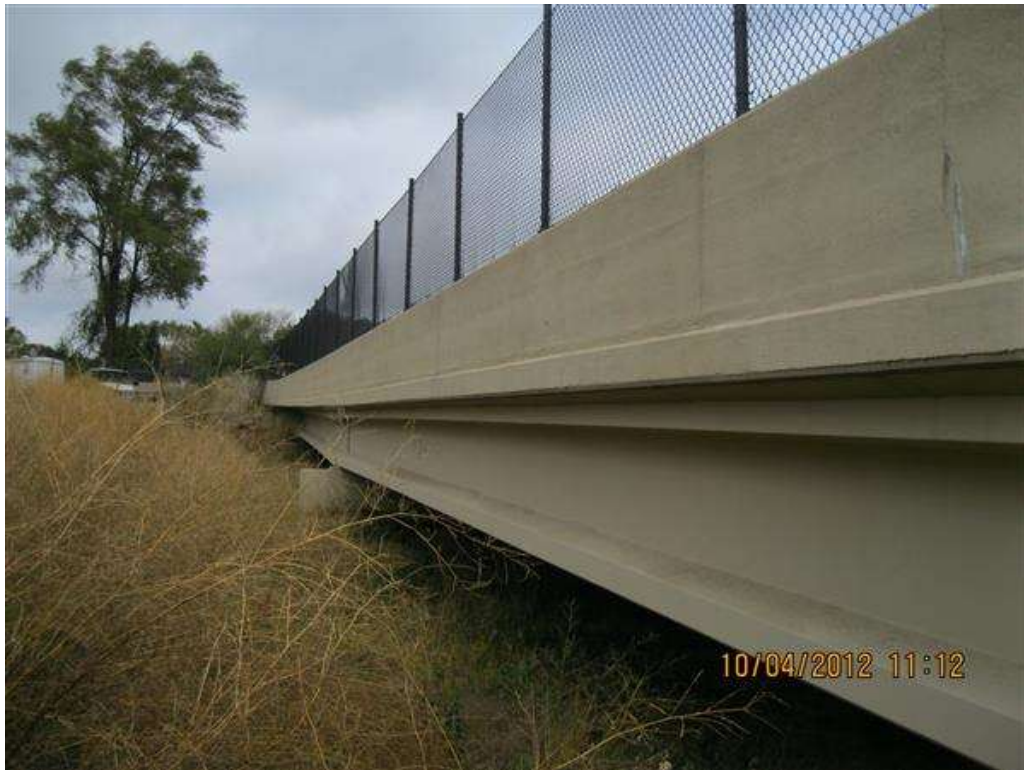
Photo 15 - West Bridge Rail

Notes: [2010-2015] 50 % IN CONDITION STATE 2. THERE IS MINOR TO MODERATE VERTICAL CRACKING W/EFFLORESCENCE BETWEEN JOINTS. THERE ARE NUMEROUS MINOR SPALLS PRESENT BOTH SIDES. BRIDGE RAIL CONSISTS OF TYPE P-4 RAILING WITH SPECIAL SURFACE FINISH #33522.
