**2016 ROUTINE
BRIDGE INSPECTION REPORT**

**BRIDGE # 62J06
LARPEN TEUR AVE over PED PATH**

Date of Inspection: 08/20/2016

Final Report Date: 10/04/2016

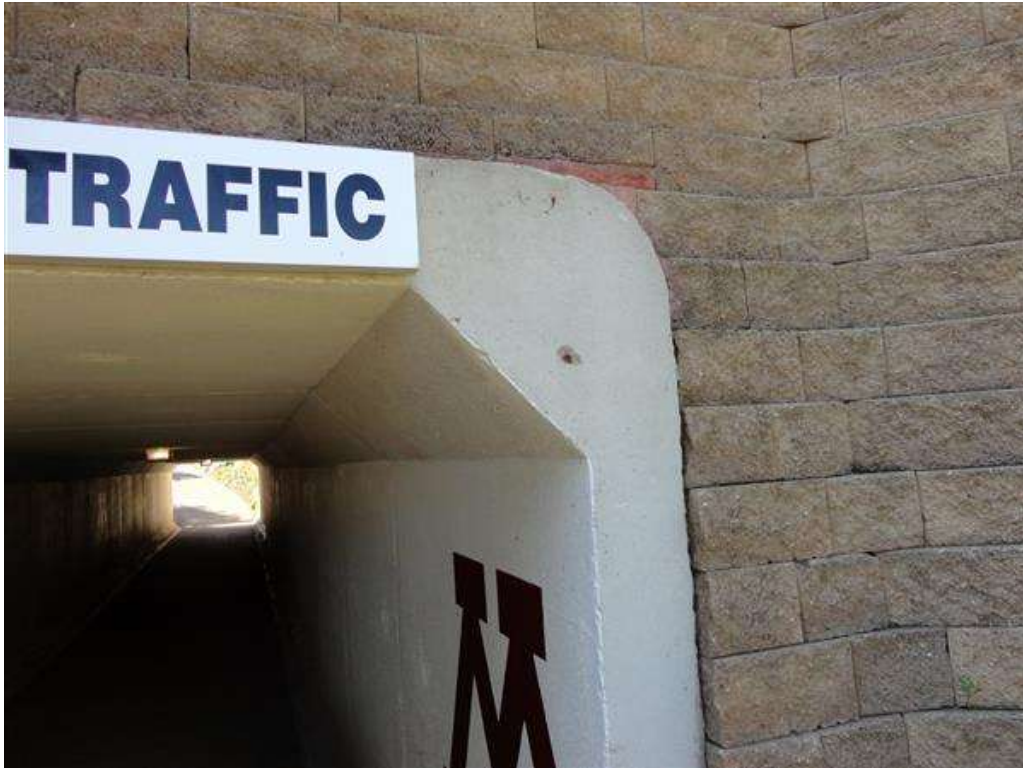
Notes: [2012] Culvert has minor deterioration- condition state 2.
 [2008-2012] There are minor cracks @ joint #2 and #14. Minor spalls are present. Culvert interior was painted by U of M.
 [2012] There are minor- moderate spalls at the NW corner north end of culvert.
 [2003-2012] No movement of culverts. Bottom of culvert has bituminous overlay. [2012] Bituminous overlay is starting to let loose

Photo 4 - SpallInNorthEndTunnel
