**2014 ROUTINE
BRIDGE INSPECTION REPORT**

**BRIDGE # 62J07
CSAH 96 over PED PATH**

Date(s) of Inspection: 10/16/2014

ROUTINE INSP. DATE: 10/16/2014

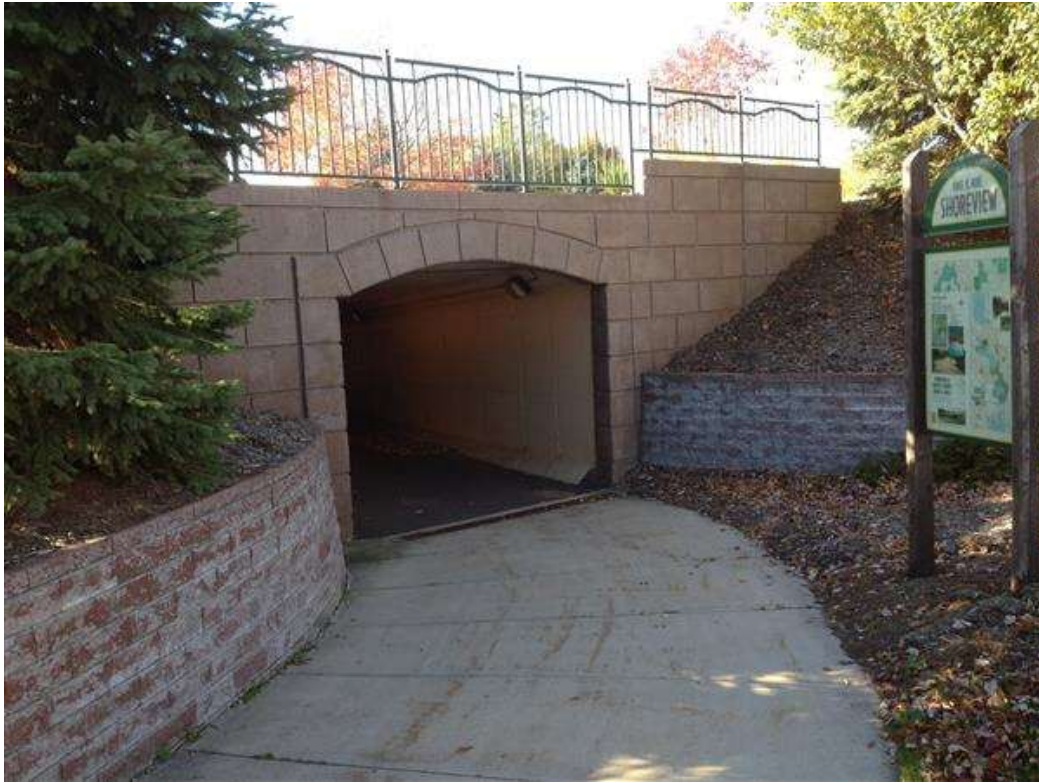
Photo 1 - Elevation View
Looking SW

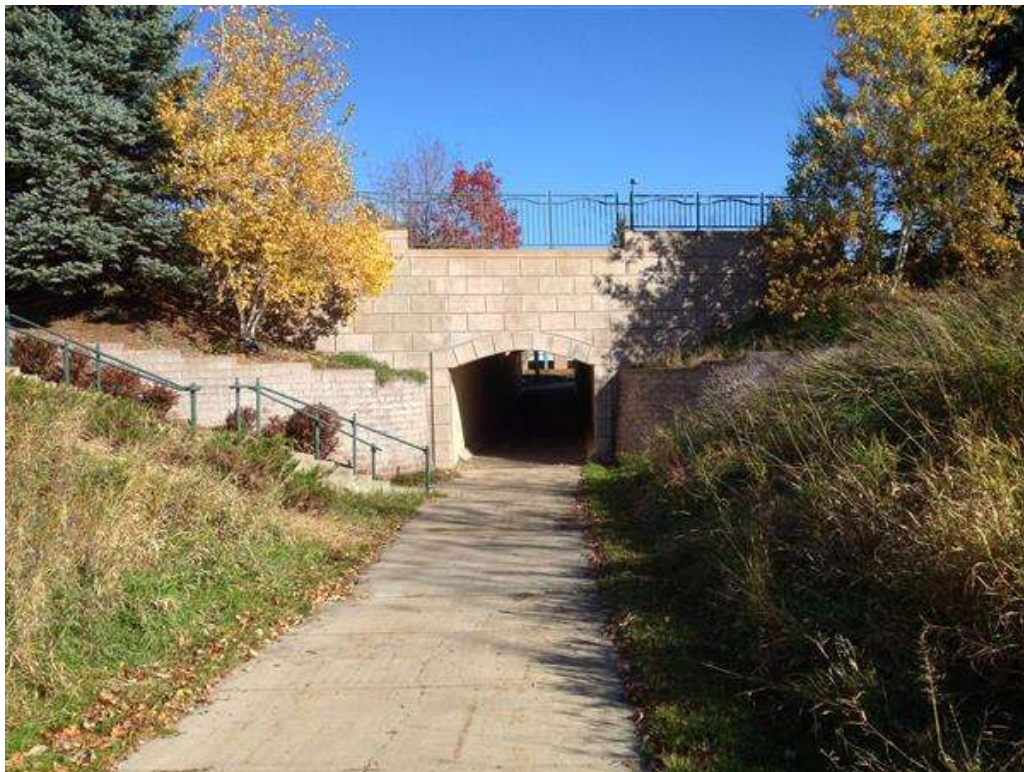
Photo 2 - Elevation View
Looking North

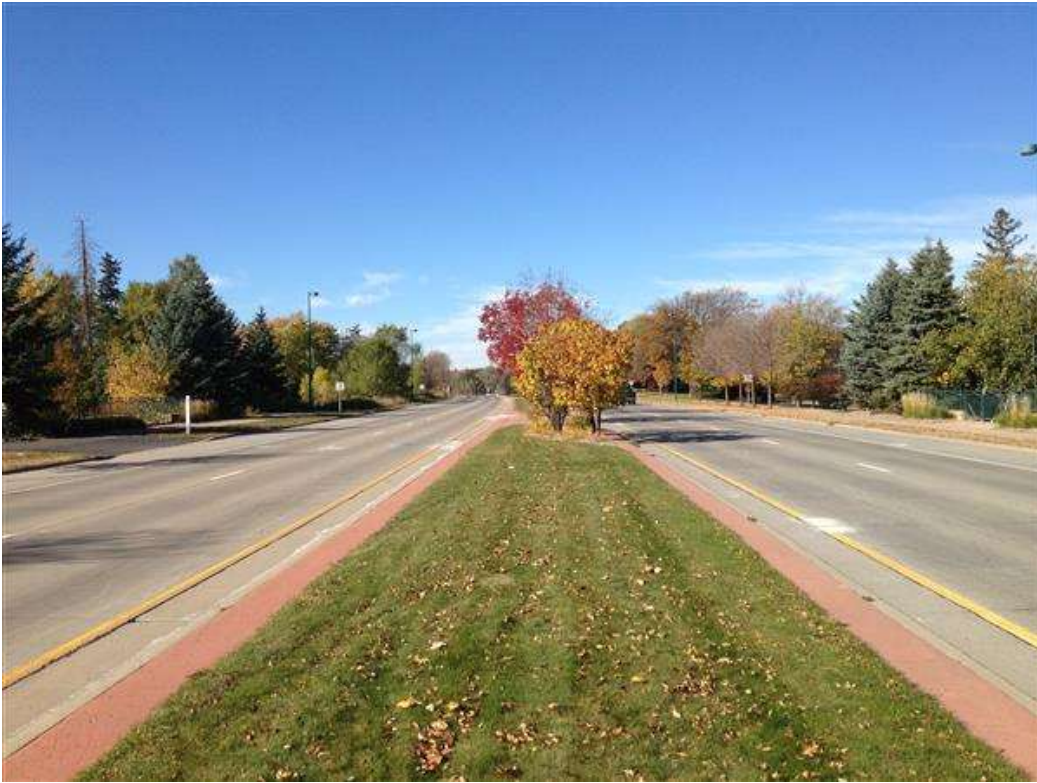
Photo 3 - Alignment View
Looking West

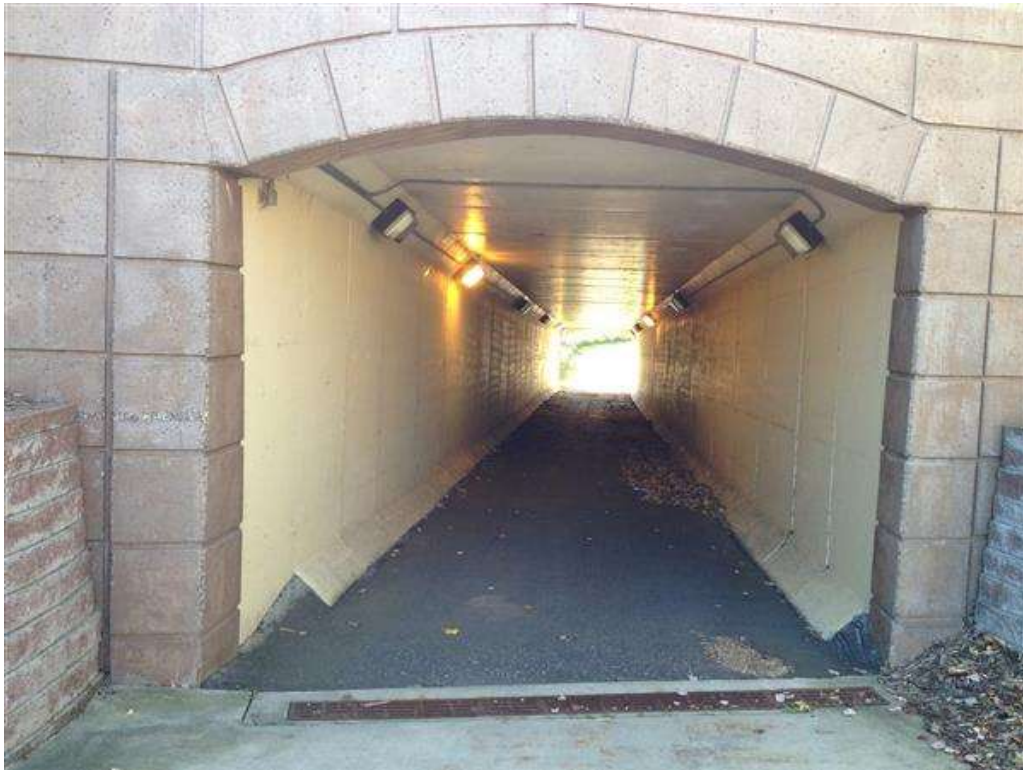
Notes: [2008] Interior culvert painted, joints caulked. Paint cracking at several joints. Asphalt path cracked at two joints.
 [2010] Asphalt cracked across at 6 joints.
 [2014] The paint is cracked at all the joints. The asphalt is cracked between 6 joints. The paint is flaking off 7' of the SW culvert wall due to sun exposure. The culvert sections are sound.

Photo 4 - Culvert
Looking South

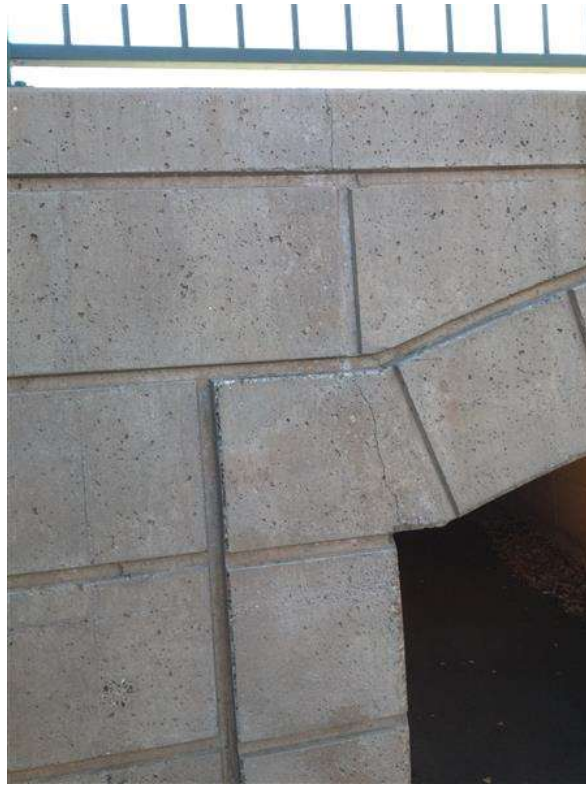
Notes: [2008] Paint sealant peeling in several areas on S end. Both corners on S end have 1½ foot cracks diagonal from culvert corners. N end has 1½ foot crack in NE corner and 1½ foot crack in top curved section. At the top of S headwall, the caulked joints are failing leaving gaps down wall joint.
 [2014] Approx. 50% of the paint on the S face has faded away. The S face has multiple hairline cracks around the arch (a 7' crack at the west corner, a couple of 3' cracks along the west half, a couple of 1.5' cracks along the east half and a 5' crack at the east corner). The N face has a 3.5' (0.04") crack at the east corner and a 2' (0.02") crack west of CL. The caulked joints in the NE, SE and SW have areas where the caulk has separated.

Photo 5 - Crack in east corner of north headwall
Looking South

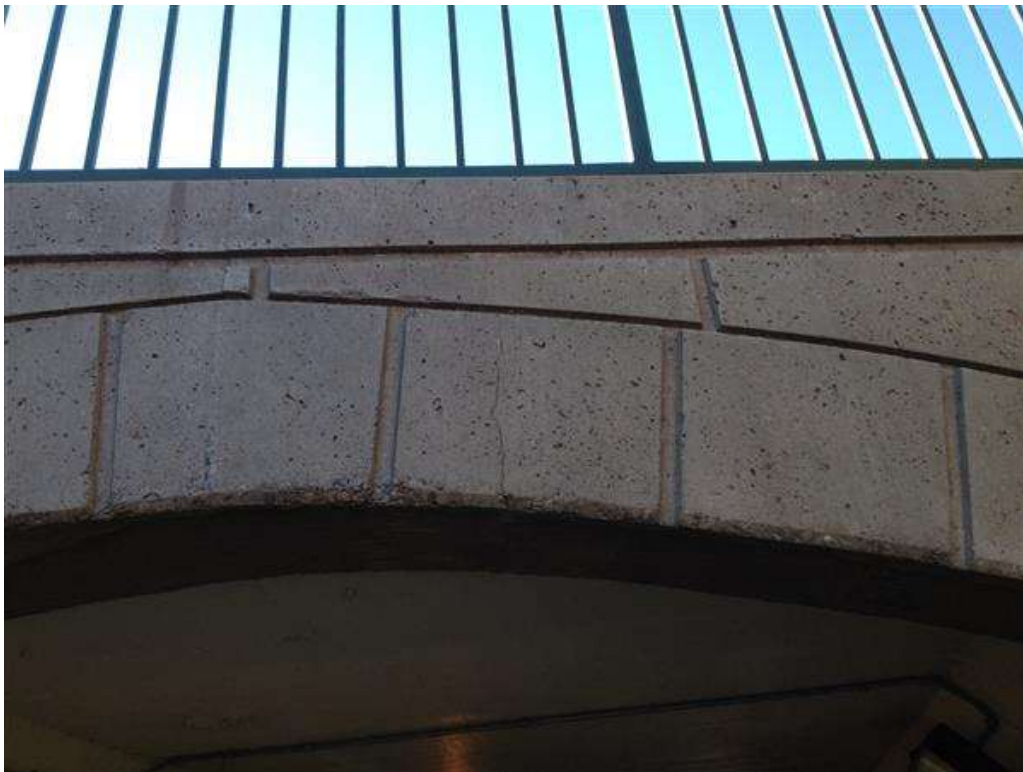
Photo 6 - Crack on west portion of north headwall
Looking South

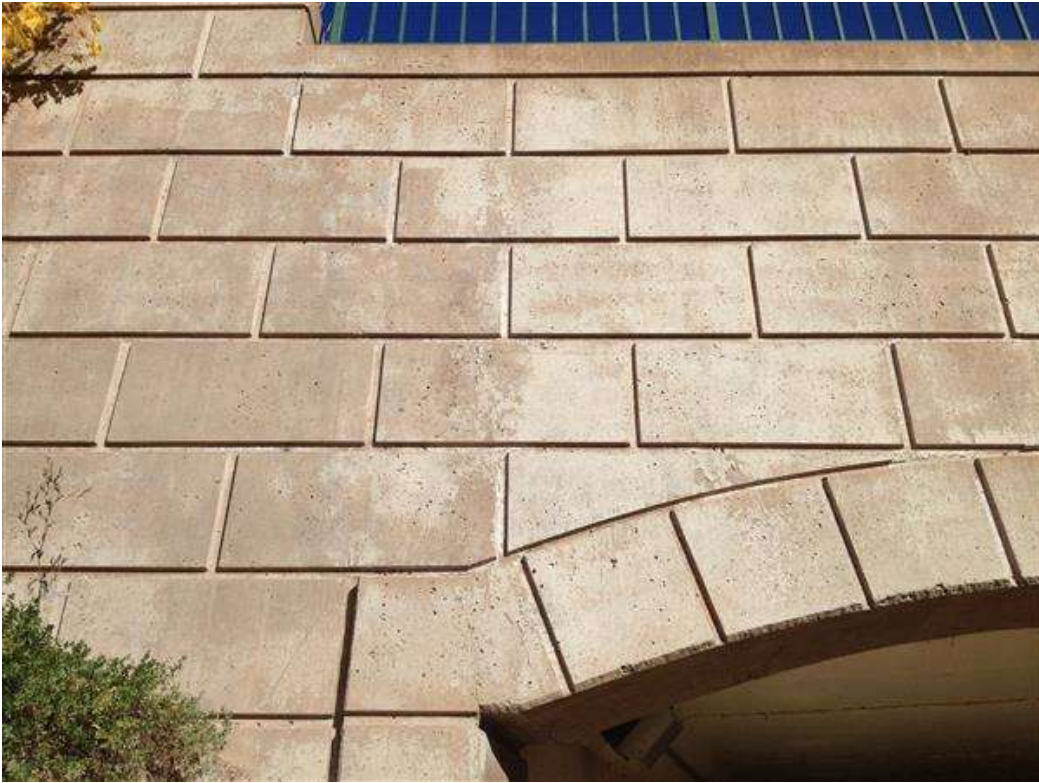
Photo 7 - Hairline crack in west corner of south headwall
Looking North

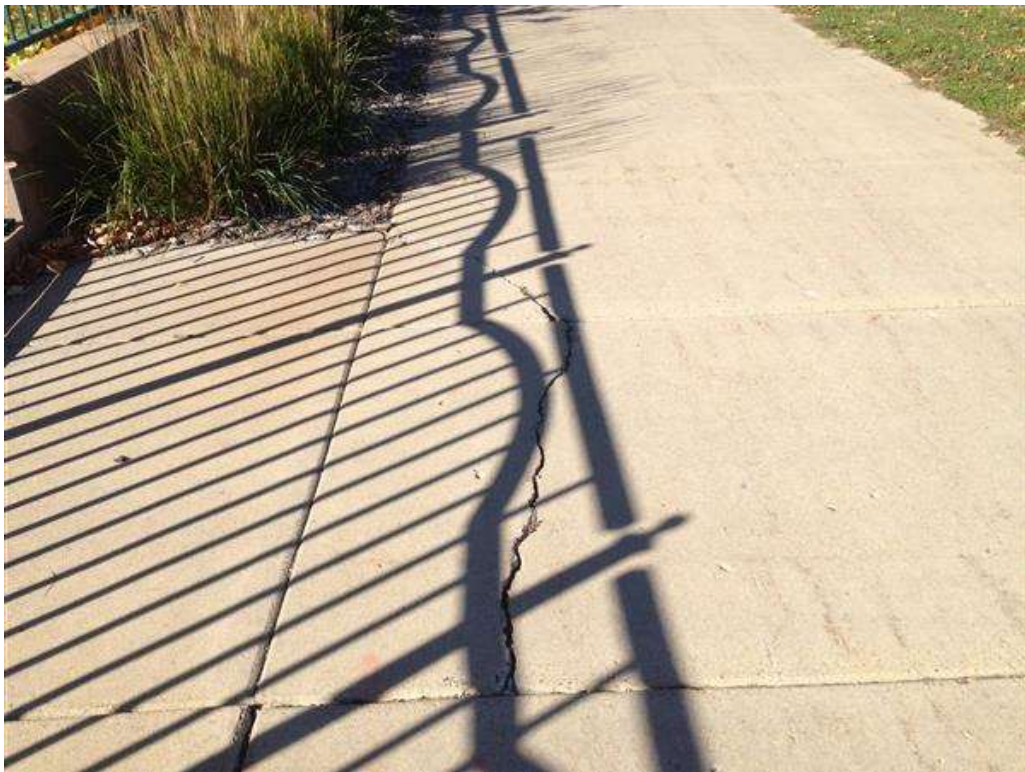
Notes: [2014] The WB lanes have minor cracking but no settlement. The south sidewalk has a 9' (0.25") crack through 2 panels used by pedestrians. The north sidewalk above the NE corner of the culvert has a panel that's tipped 1.5" but it is not in the traveled portion of the walk.

Photo 8 - Crack in south sidewalk
Looking West

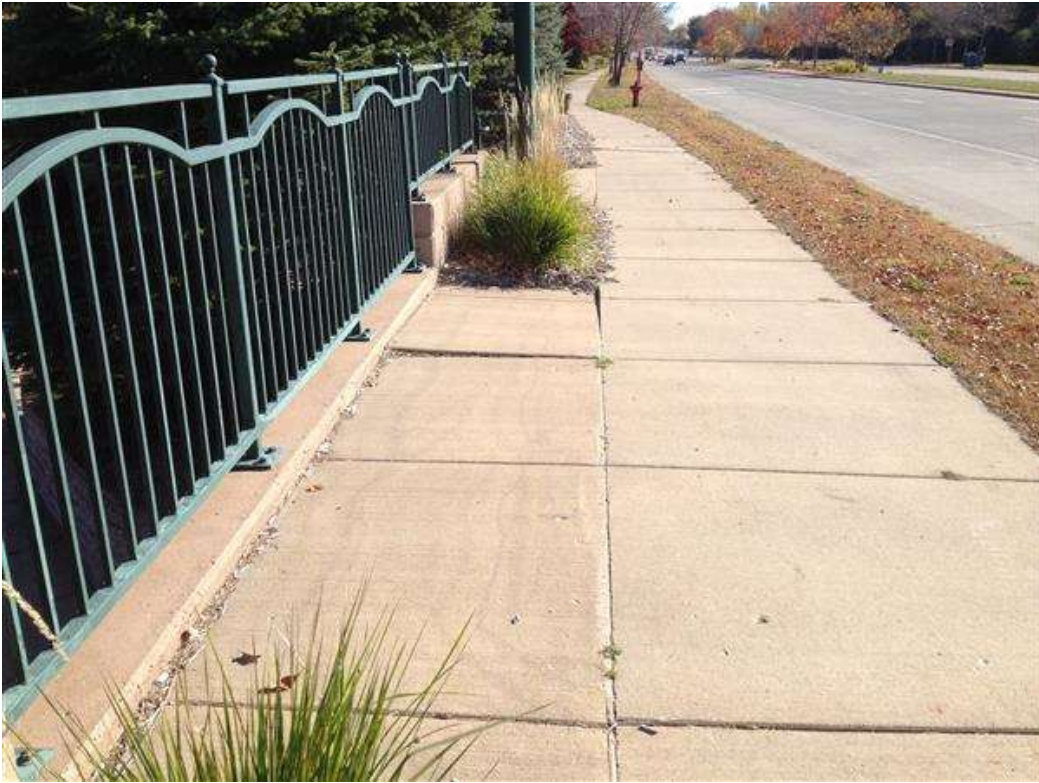
Photo 9 - Tipped panel in north sidewalk
Looking East
