**2015 ROUTINE
BRIDGE INSPECTION REPORT**

**BRIDGE # 90389
CSAH 12(CR F) over SUCKER CREEK**

Date(s) of Inspection: 10/05/2015

**MnDOT Bridge Office
3485 Hadley Avenue North
Oakdale, MN 55128**

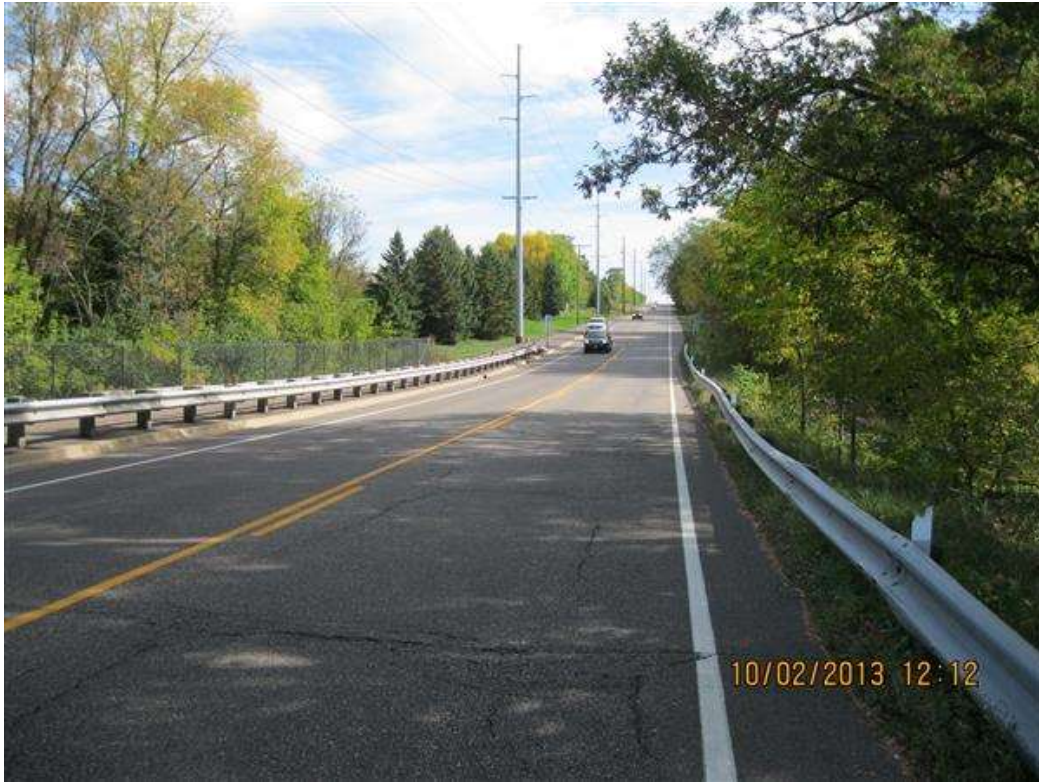
Photo 1 -

1. Looking East.JPG

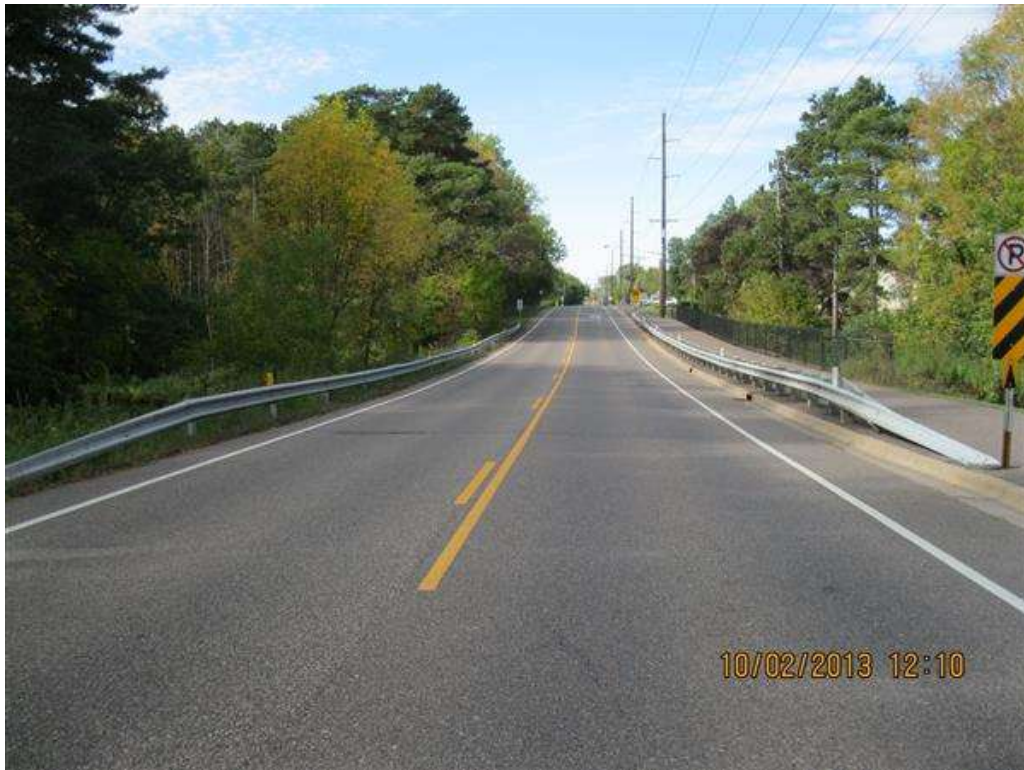
Photo 2 -

2. Looking West.JPG

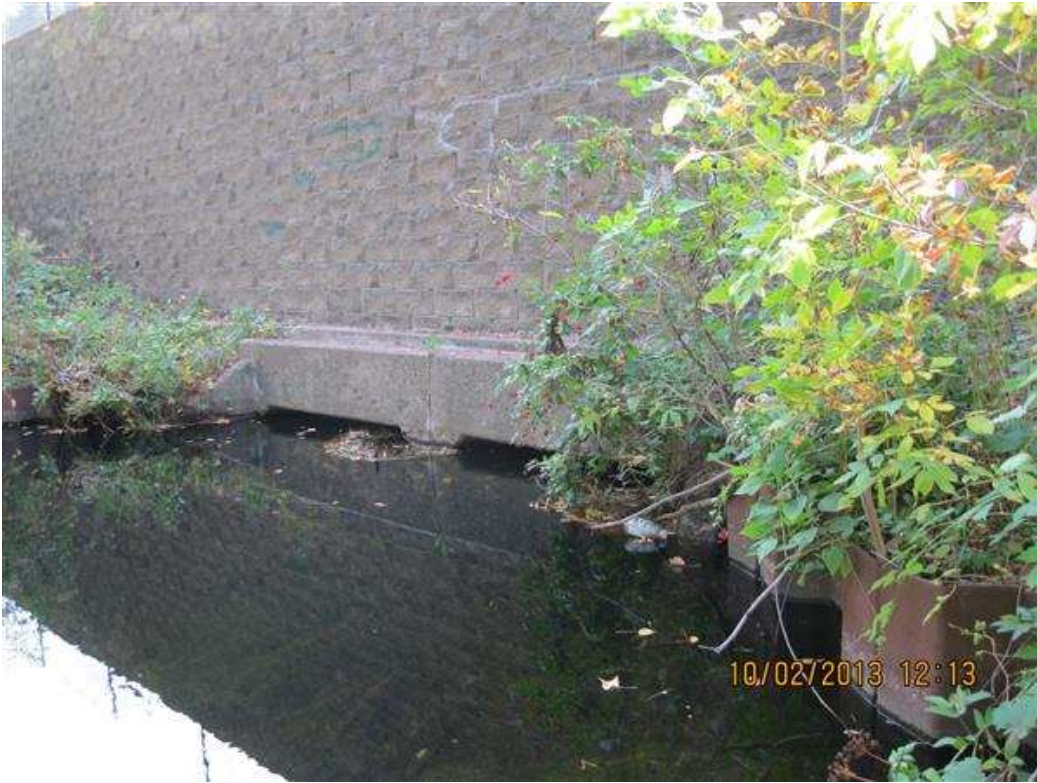
Photo 3 -

3. North End.JPG

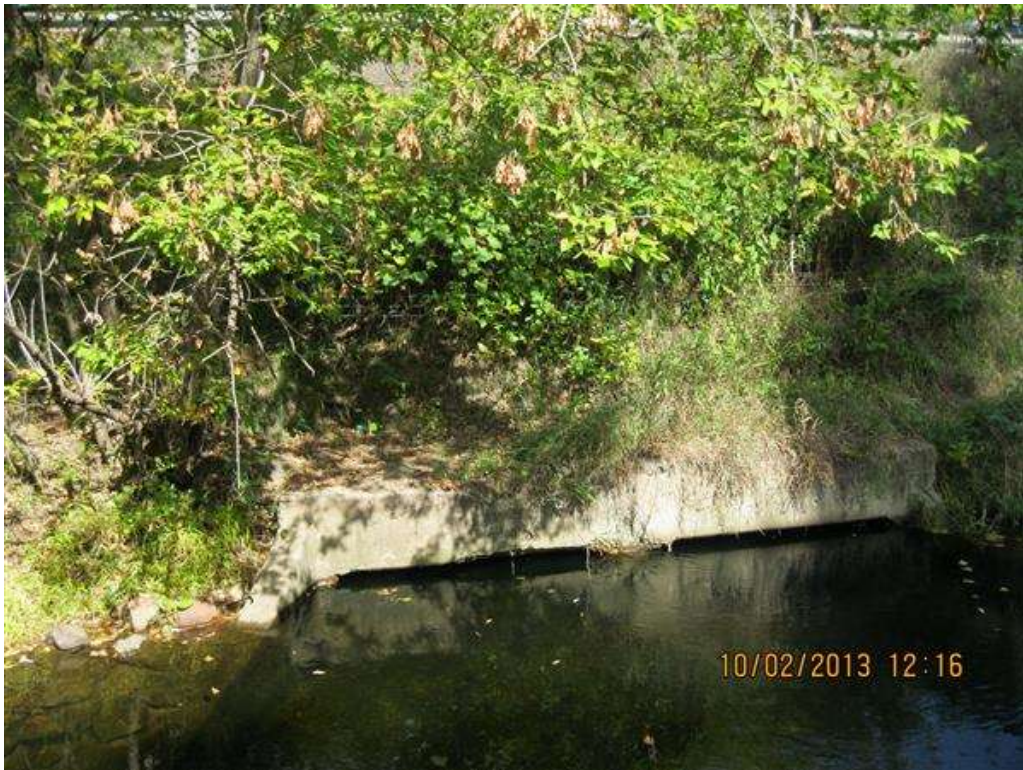
Photo 4 -

4. South End.JPG

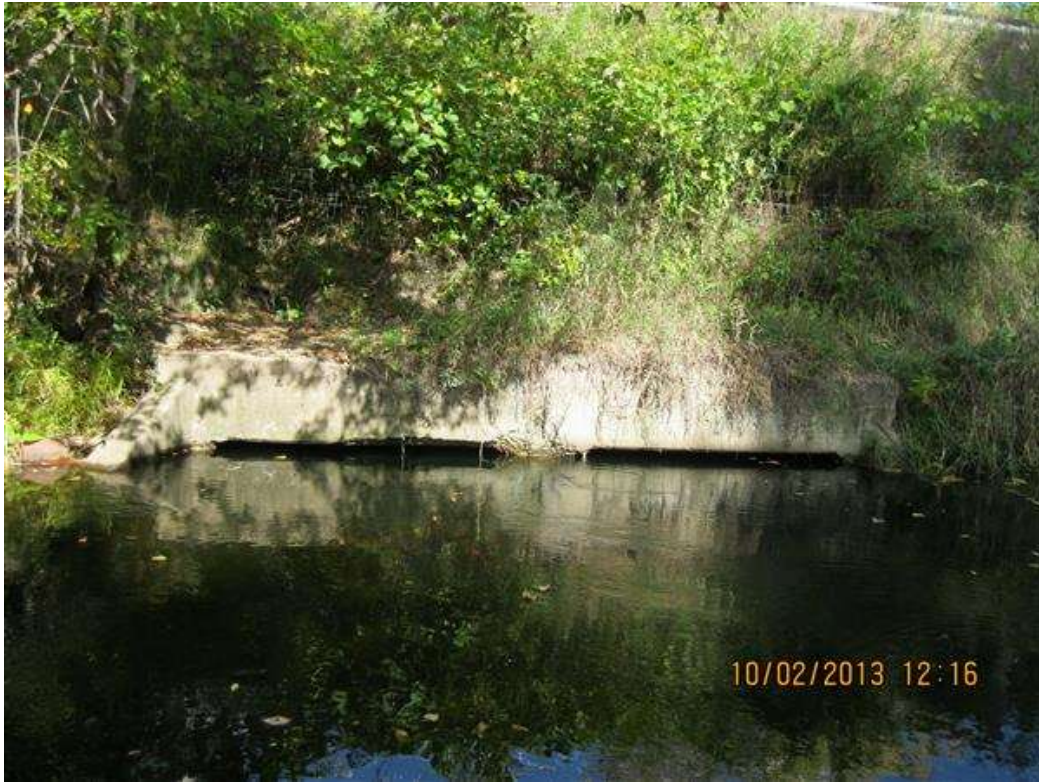
Photo 5 -

5. South End-2.JPG

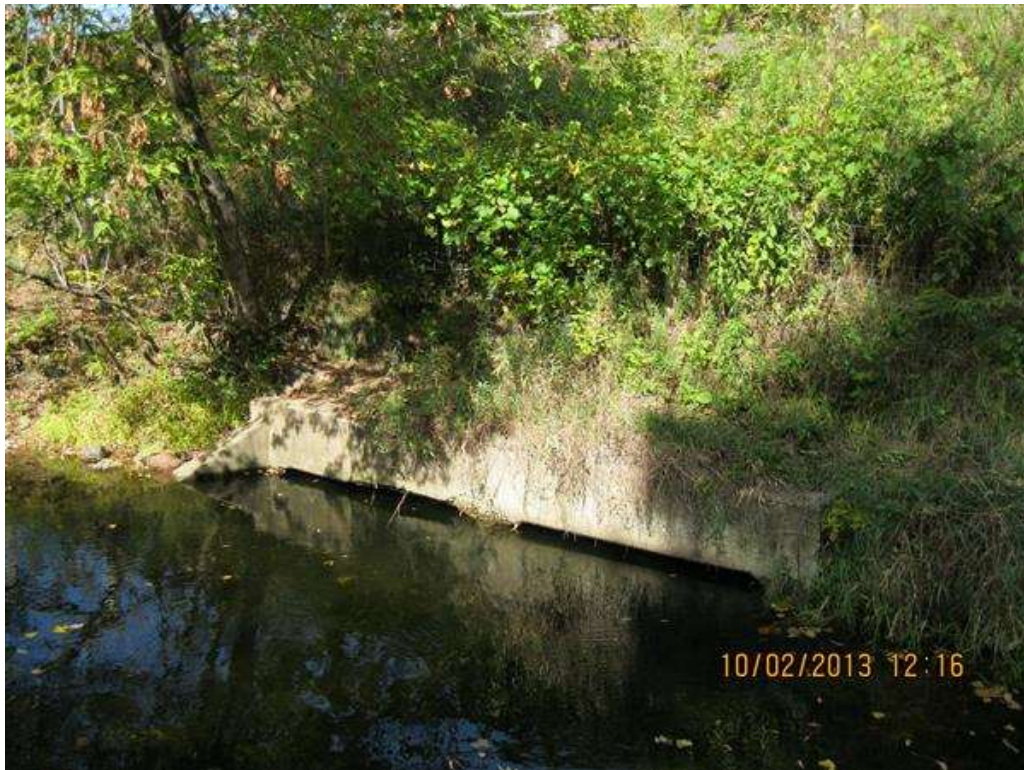
Photo 6 -

6. South End-3.JPG

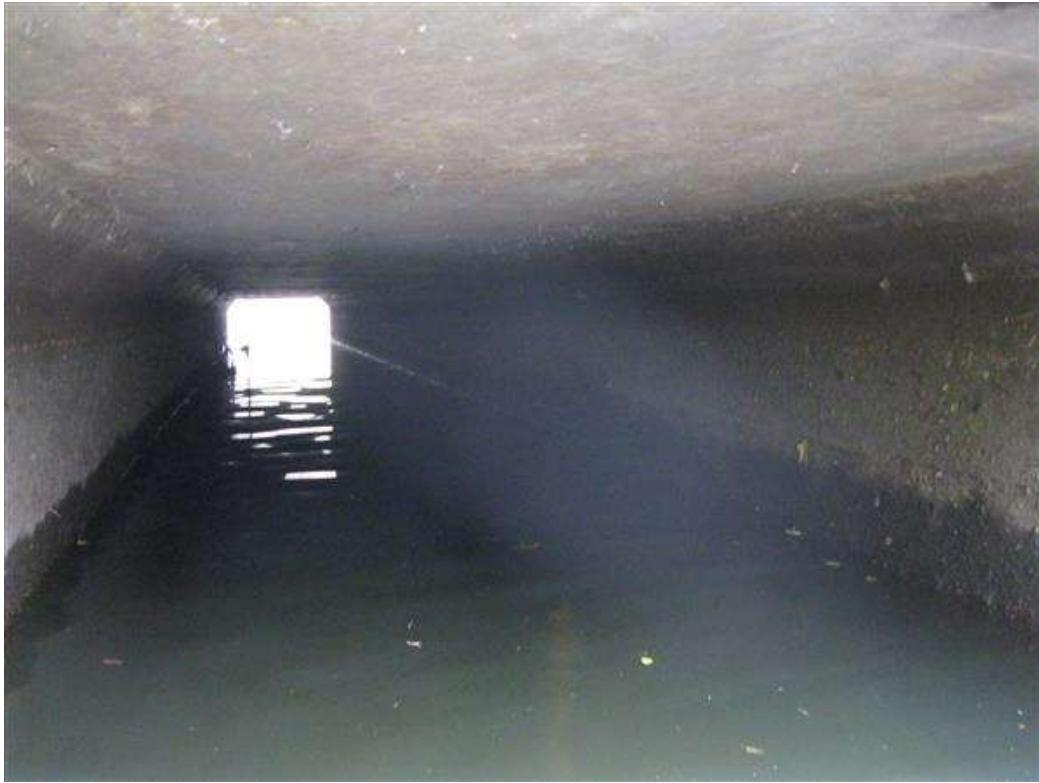
Photo 7 -

7. east culvert.JPG

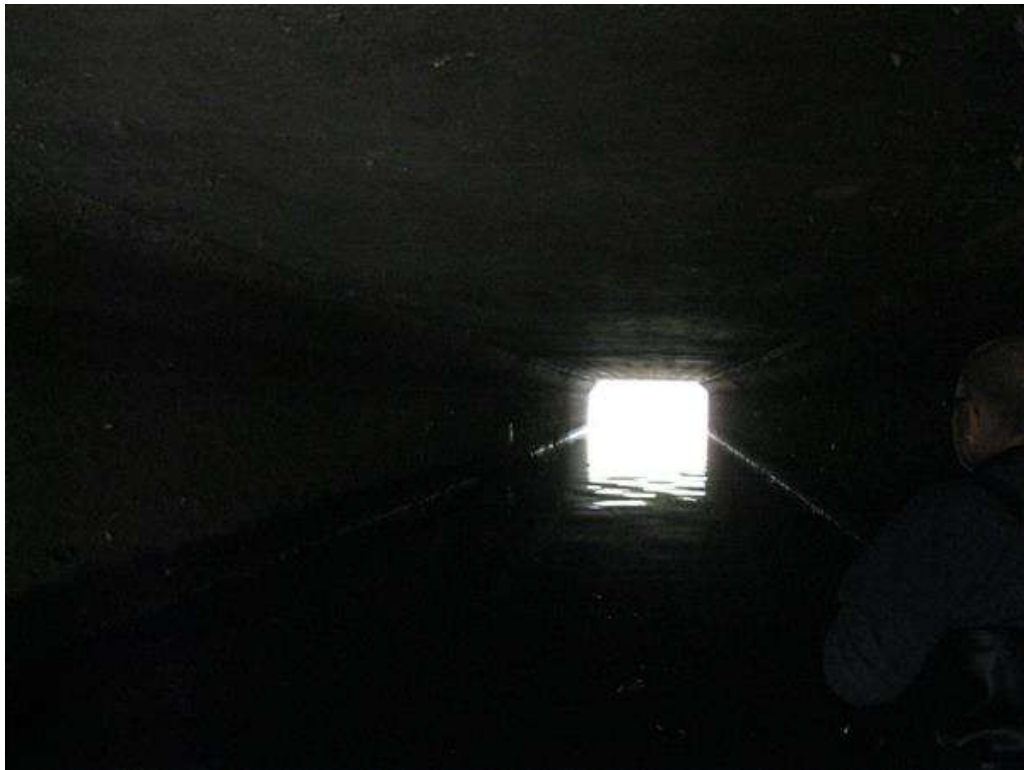
Photo 8 -

8. east culvert-2.JPG

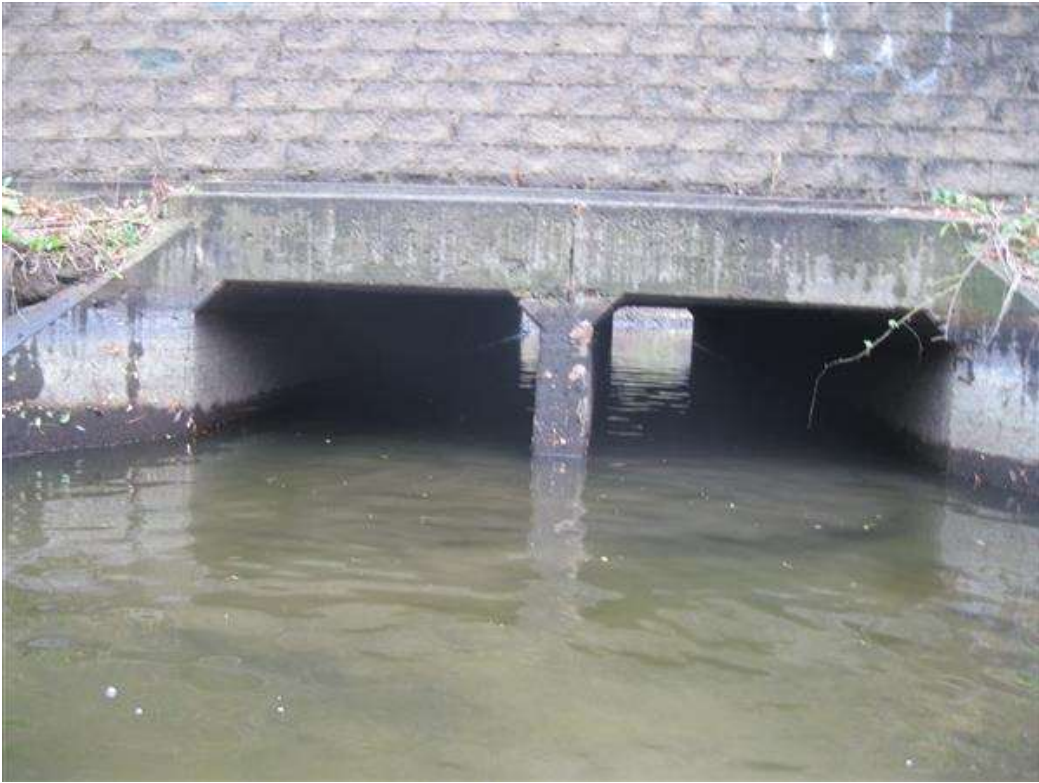
Photo 9 -

9. north end.JPG

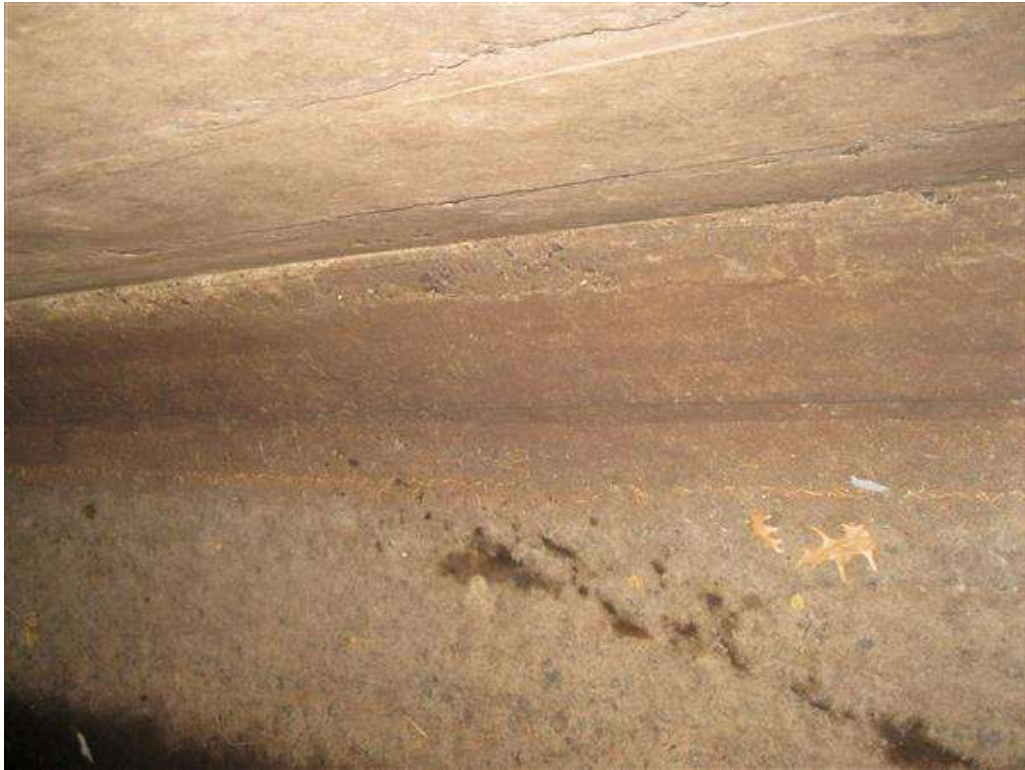
Photo 10 -

Notes: Dan Bodelson & Randy Bussiere walked thru culverts on 11/7/14 - SPWW drained Sucker Creek for repairs to the north. Inside south ends of both culverts have minor spalls & cracks. [2014]
 Can't walk through due to water level and not enough head room to walk through 2005-2013.
 Culvert contains some cracking and leaching with slight separation of joints 2001-2011.

10. spall on south end east culvert.JPG

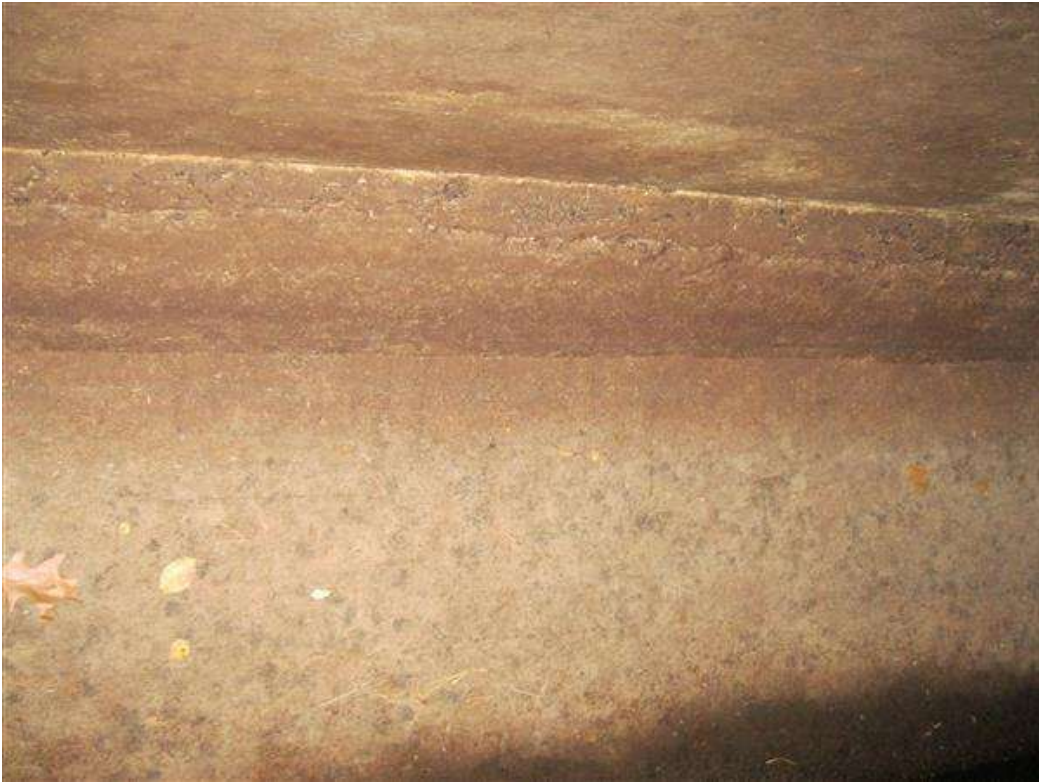
Photo 11 -

11. spall on south end west culvert.JPG

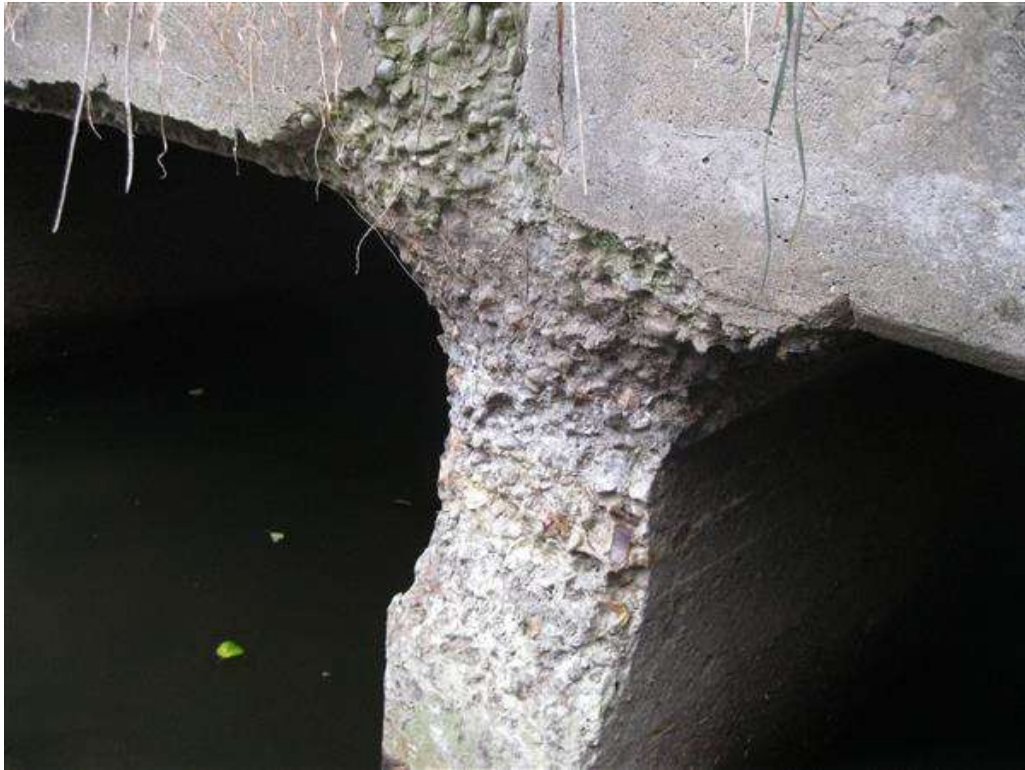
Photo 12 -

Notes: Major delamination @ center divider, SE wing and east 1/2 of south fascia 2007-2015.
 Approximately 5' of the SE wing has deteriorated and no longer in place since 1983.
 North side headwall fascia has minor cracking & spalling with moderate spall @ center of headwall 2009-2015.
 North side in condition 2 and south side in condition 3 2001-2015.

12. spall on south end.JPG

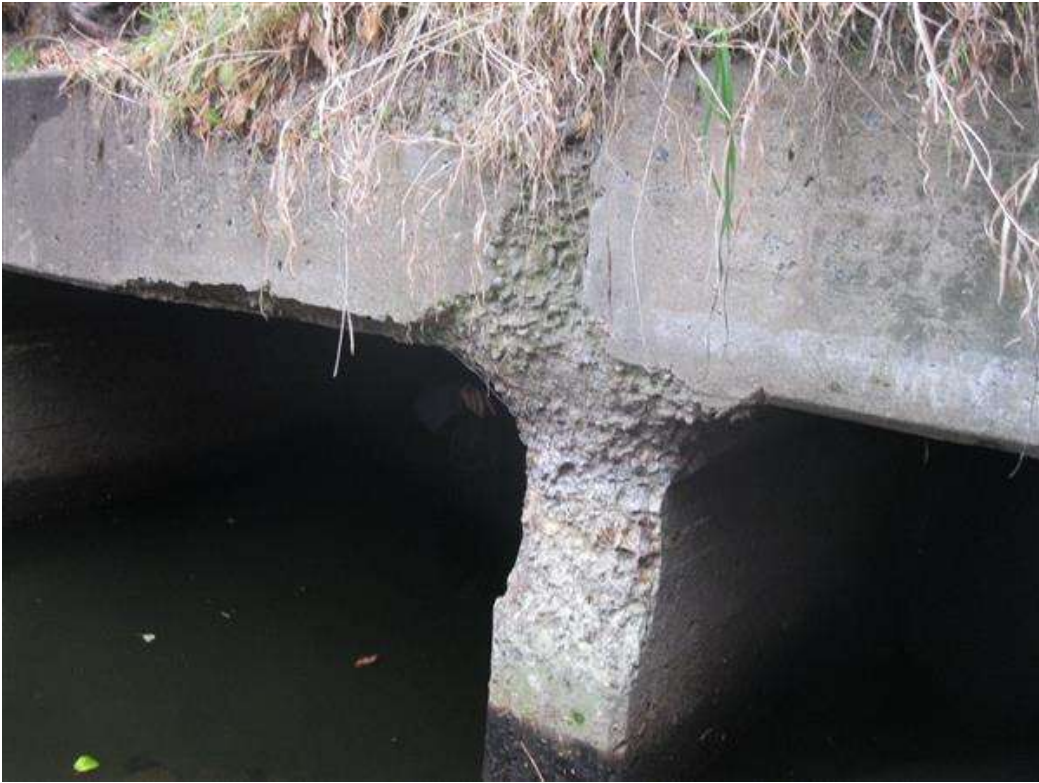
Photo 13 -

13. spall on south end-2.JPG
