**2016 ROUTINE
BRIDGE INSPECTION REPORT**

**BRIDGE # 90411
BNSF RR over CSAH 58(EDGERTON ST)**

Date of Inspection: 11/15/2016

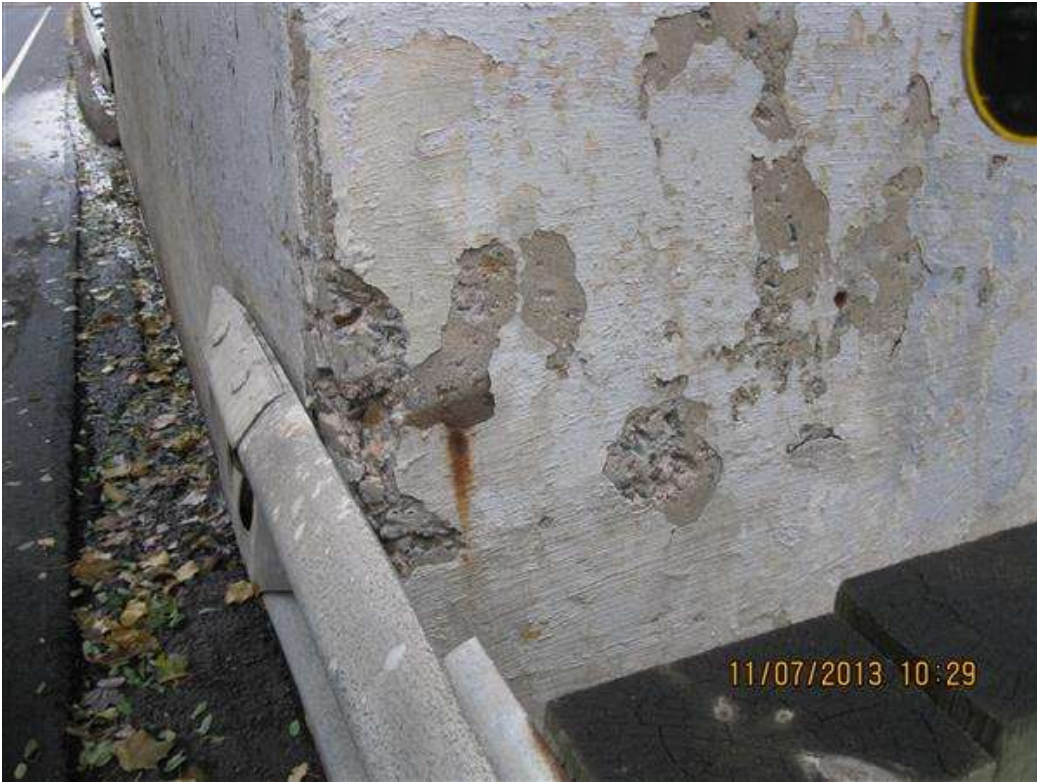
Photo 5 - SW corner of East pier wall 2013

Notes: [2014-2015] There is moderate paint failure on both pier walls.
 [2010-2015] Moderate spalls and cracking are present on both pier walls. There are minor scrapes both sides.
 [2007-2015] There is a scrape on west pier wall at the SE corner. There is minor vertical cracking at mid span of west pier wall.
 [2007-2015] There is some delamination on east pier wall at the SW corner of the east pier wall.
 [2011-2015] Major spall at SW corner of east pier wall.
 [2007-2015] There is a moderate 6' vertical crack mid span west side of east pier wall and minor vertical crack full height mid span of east pier wall back side.
 [1995-2015] Special surface finish on the concrete piers are starting to peel & flake off.
