**2016 ROUTINE
BRIDGE INSPECTION REPORT**

**BRIDGE # 9345
MUN 68 over ISLAND LAKE CHANNEL**

**DISTRICT: Metro COUNTY: Ramsey CITY/TOWNSHIP: Shoreview
STATE: Minnesota**

**Date of Inspection: 08/25/2016
Equipment Used: Life Jacket, Probing Rod**

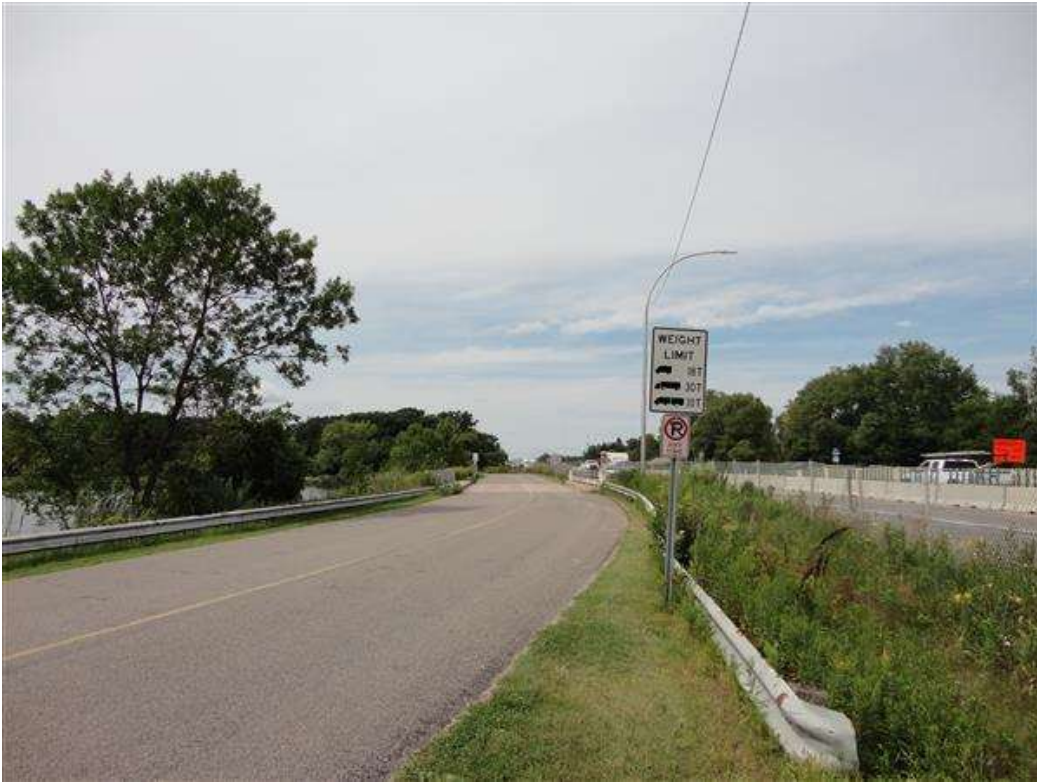
Photo 9 - east load sign 2016

891	Other Bridge Signing	Routine	08/25/2016	1 EA	0	0	1	0
		Migrated Values		1 EA	0	0	1	0
Notes: [2015-2016] load limit signs are in place. [2001-2015] No signing or delineation. 03/31/2015: Load Posting Required: 18T/30T/30T. NBI 41: Status coded 'B - Open, Posting Required'. Agency to notify MnDOT BADMU when signs are installed.
