**2015 ROUTINE
BRIDGE INSPECTION REPORT**

**BRIDGE # 93625
CSAH 58(EDGERTON) over CO DITCH # 16**

Date(s) of Inspection: 10/28/2015

MnDOT BRIDGE INSPECTION REPORT

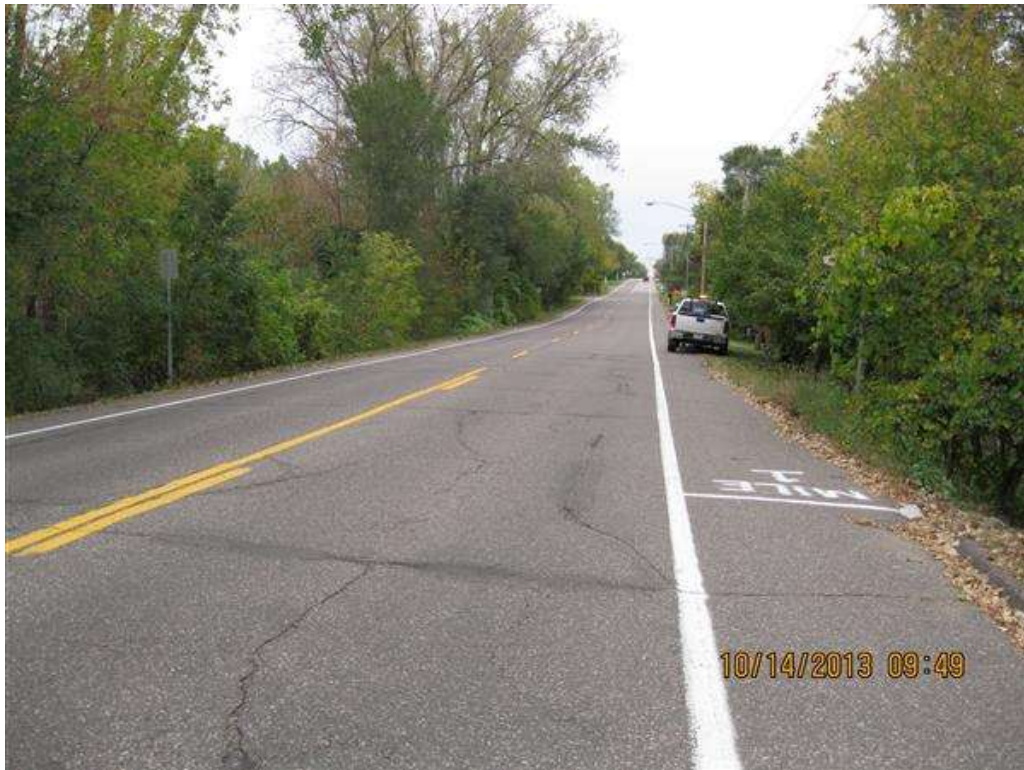
Photo 2 - Roadway north

Notes: Moderate settlement 2001-2015.
