**2015 ROUTINE  
BRIDGE INSPECTION REPORT**

**BRIDGE # 93626  
CSAH 22(KELLER PY) over CO DITCH # 1**

**Date(s) of Inspection: 10/28/2015**

**Final Report Date: 01/05/2016**

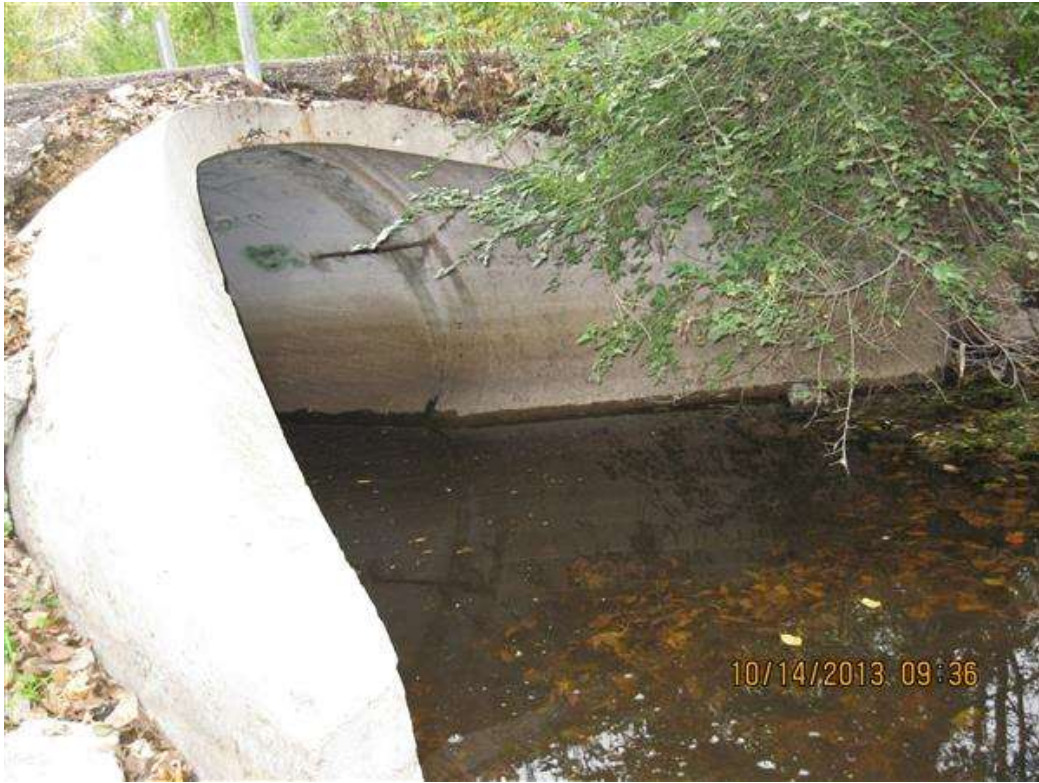
Notes: Moderate slumping @ east end 2005-2015.  
 Minor scour at apron ends 2001-2015.

Requires Monitoring MonitoredNotes: [2015] Minor to moderate erosion on all 4 apron ends.  
[2015] Moderate erosion of rip rap on east end, between culverts.

Photo 1 - east end

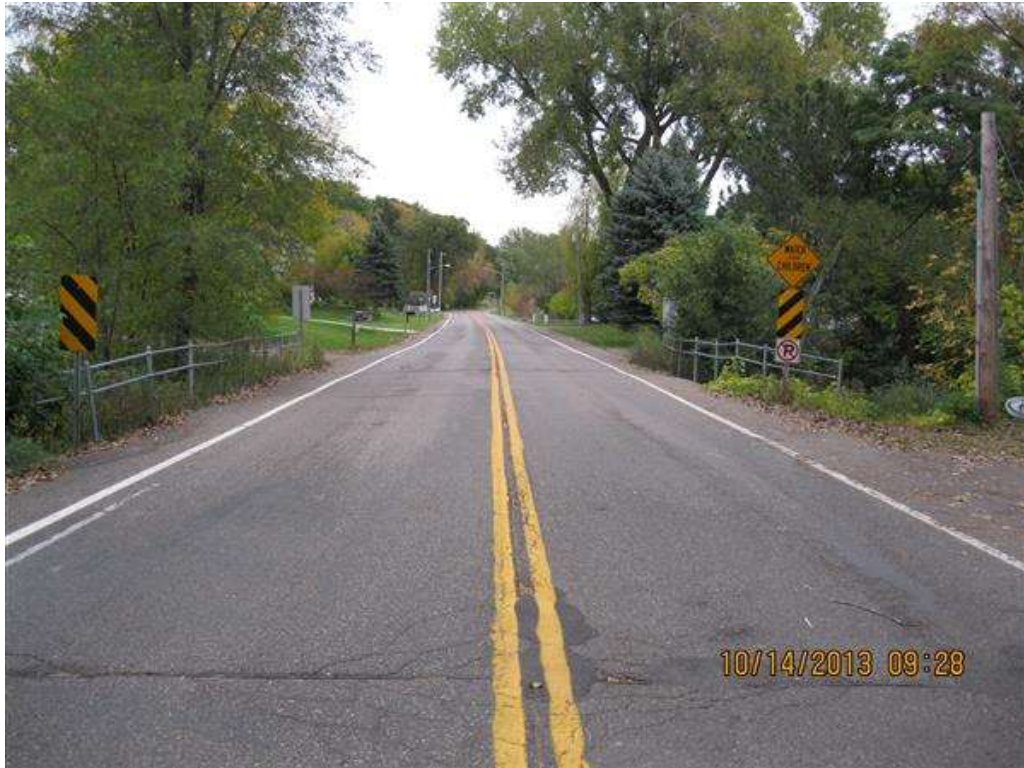
Notes: Moderate cracking and moderate settlement 2011-2015.

Photo 2 - roadway north

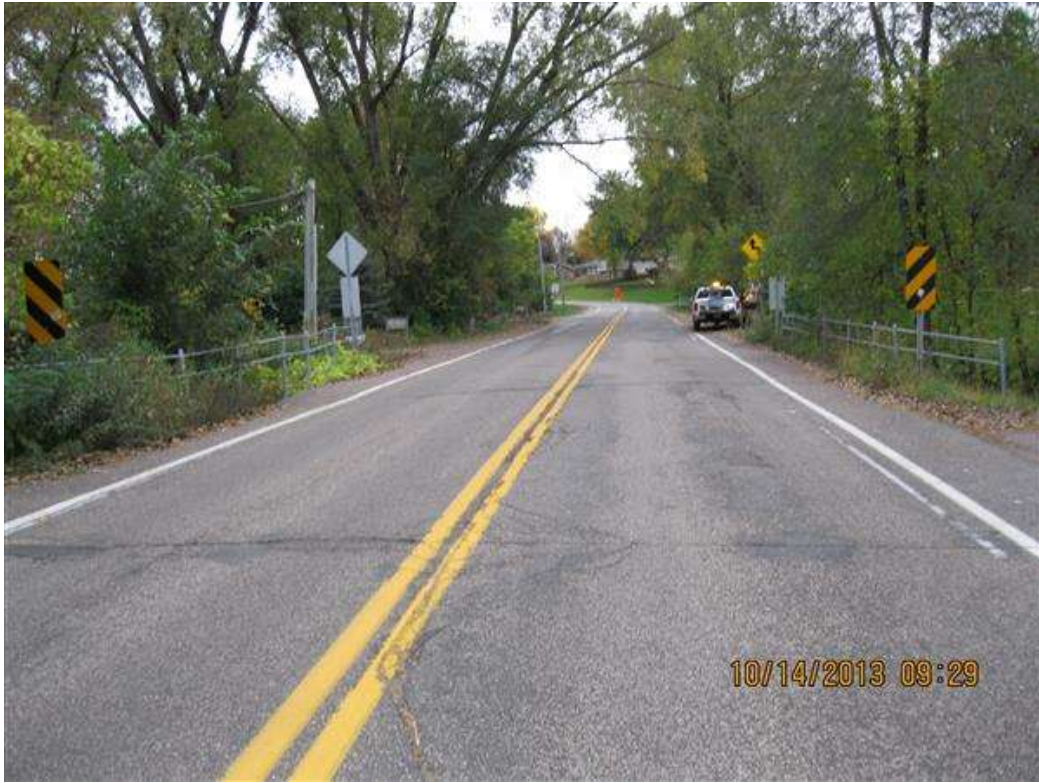
Photo 3 - roadway south

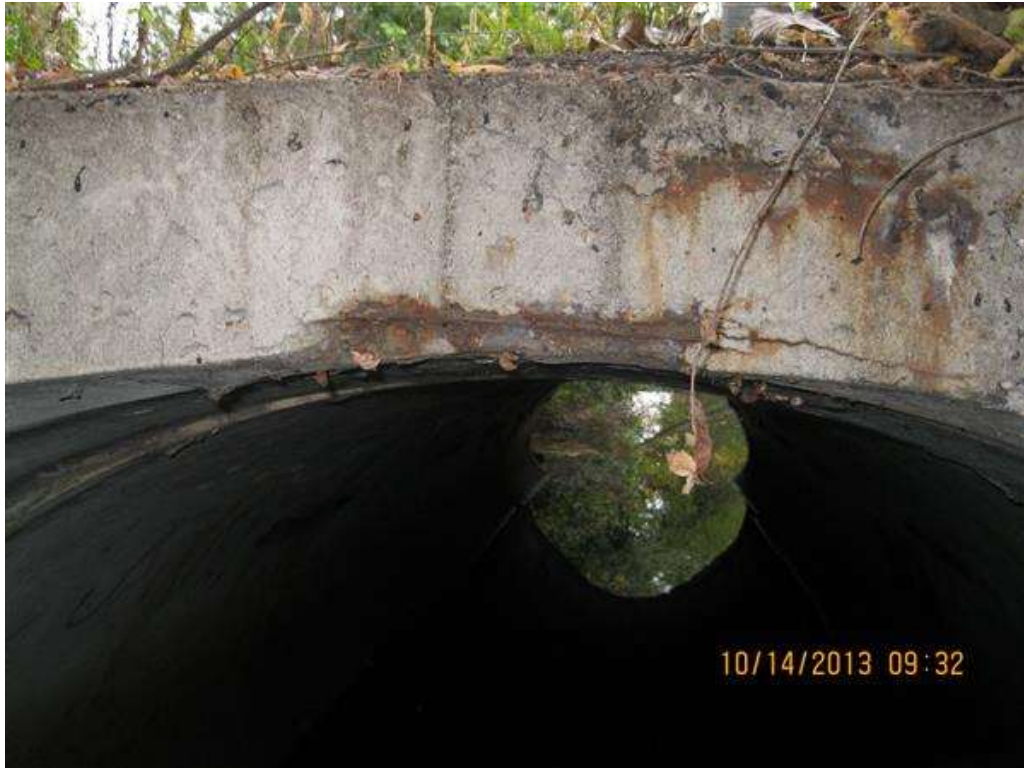
Notes: There is moderate spalling west end apron #1. Culvert #1 has corrosion present both ends 2009-2015.  
 There is a concrete patch at culvert #1 west apron 2007-2009.  
 Culvert #2 north apron headwall @ west end has exposed reinforcing steel.  
 Culvert #2 has some spalling with corrosion @ both aprons 2007-2015.  
 There is vertical cracking at NE apron 2005-2015.  
 Minor cracks and spalls present 2001-2007.  
 There is delamination w/corrosion @ top of aprons #1,#2 & #4 2003-2015.  
 Vines cover the east end of apron #1 2005-2015.

Photo 4 - spall on west end

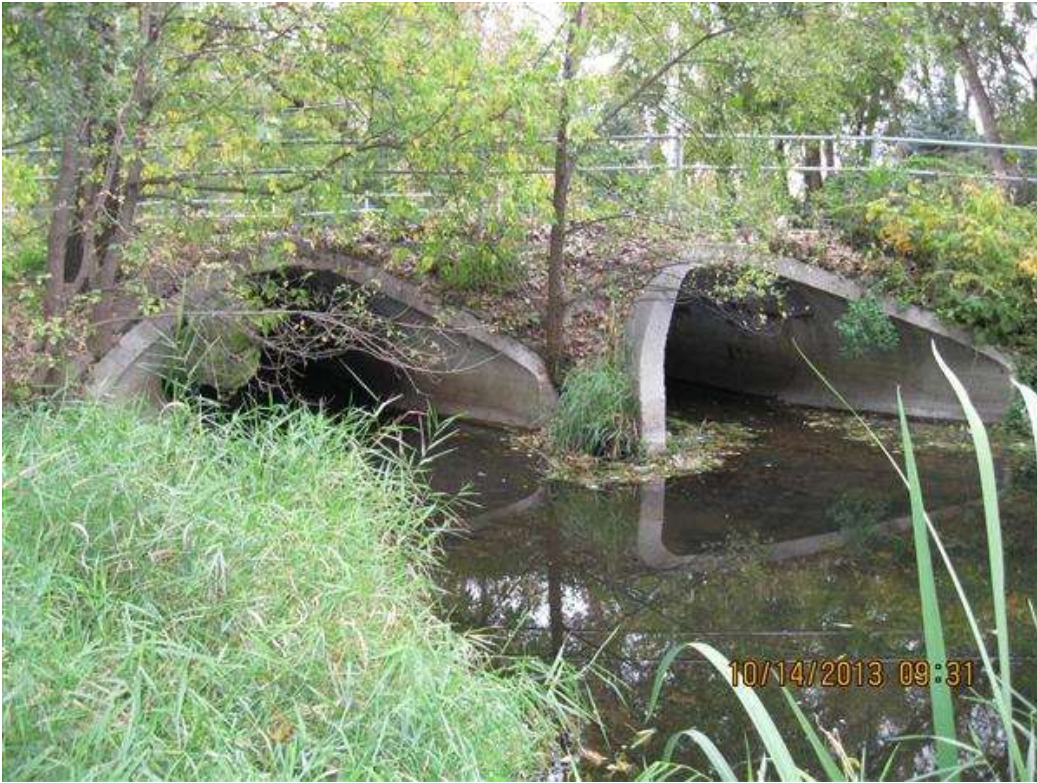
Photo 5 - west end

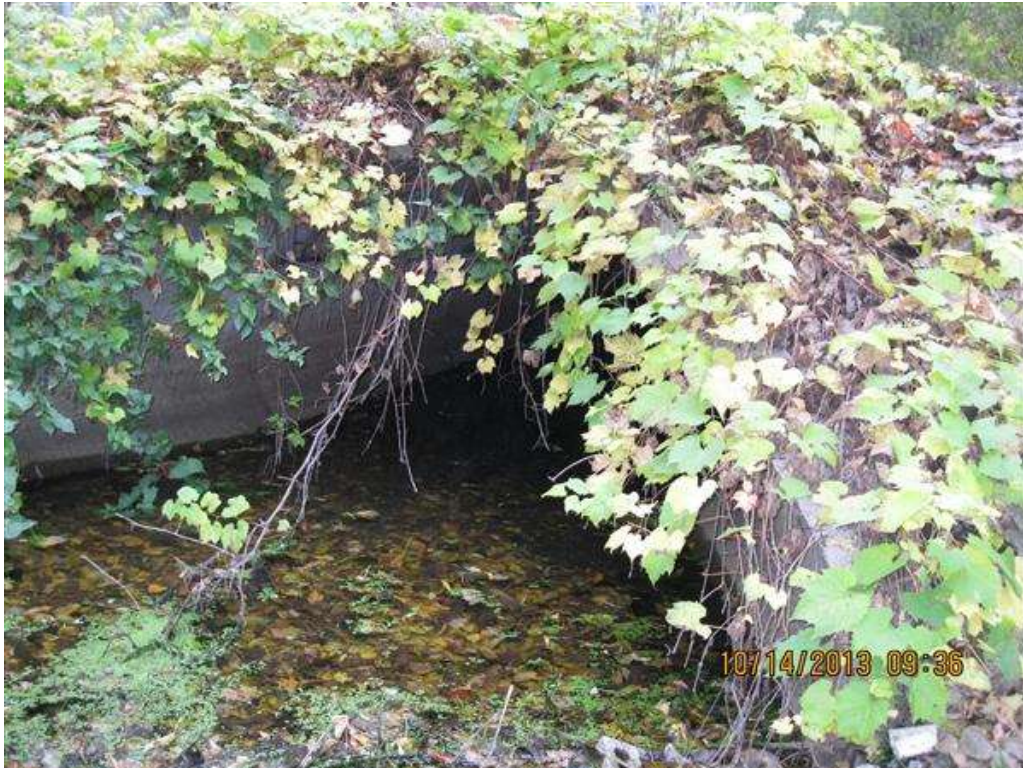
Photo 6 -

6. east end south .JPG
