Subject: ARJD 1, Branch 5 Preliminary Culvert Sizing

## Rice Creek Watershed District ARJD1 Historic Review Memo

Culverts

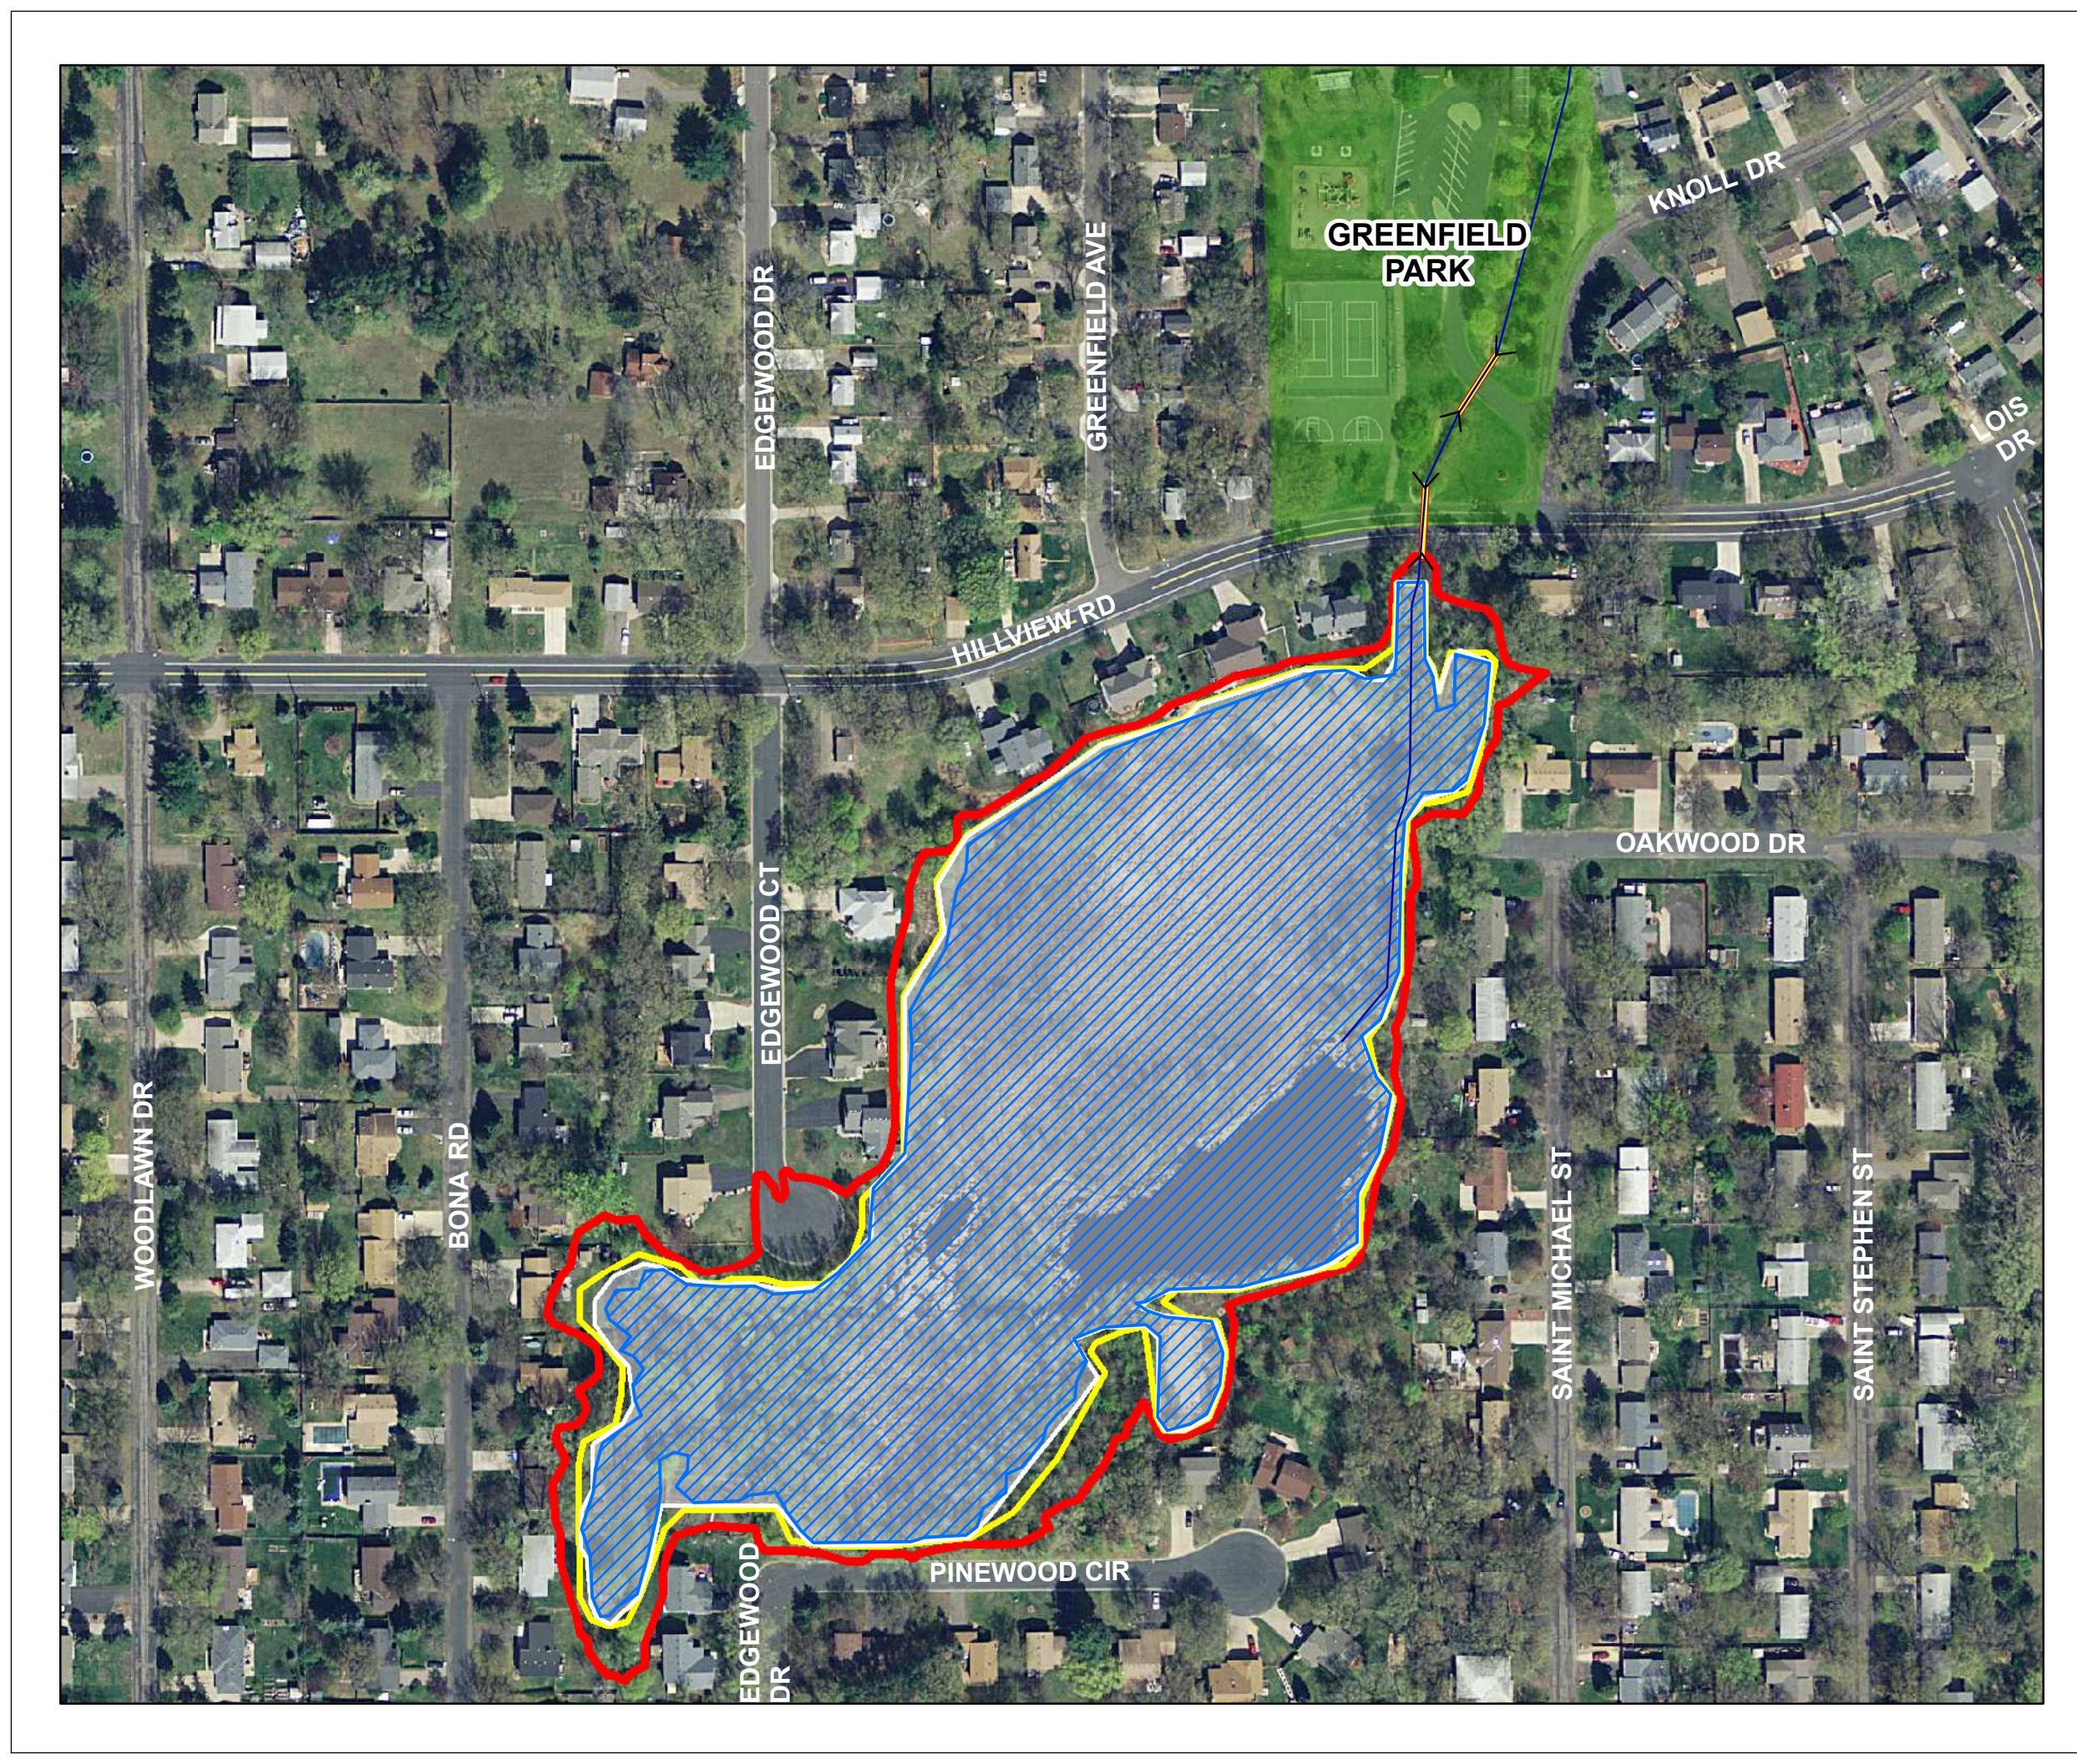
Figure 1: Critical Duration Flood Extents											
Scale: AS SHOWN	Drawn by: SMW	Checked by:	Proje 135	ct No.: 5555-202	Date: 2/21/2013	Sheet: 1 of 1					
		louston		Мар							
		ingineering Ind	C.	P: 763.493.4522 F: 763.493.5572

<u>ARJD 1 Upstream Channel and Pond</u>: Upstream of Hillview Road, the ARJD 1 open channel continues south approximately 300 feet, ending at a 36" CMP culvert (with inverts of 897.70 upstream and 897.61 downstream) which serves as the outlet for an open-water wetland complex. (Note: This wetland is not listed in the MnDNR Public Waters Inventory.) This open water complex, which is nearly entirely within a parcel owned by the state of Minnesota, abuts the backyards of residences along Hillview Road and Edgewood Court. Previous modeling indicates the elevation of the 100-year critical duration flood event (10-day snowmelt) to be at an elevation of 904.1. The flooding at this elevation could potentially inundate several homes adjacent to the wetland complex (see **Figure 1**). Because the flood elevation results directly

The model of the existing conditions within ARJD 1 was modified to simulate a repaired condition in Branch 5 at Hillview Road and the Greenfield Park road, using three scenarios with culverts ranging from 24" to 36" in diameter. The peak elevations of the 100-year, 24-hour rainfall event and the 100-year, 10-day snowmelt event in the upstream wetland and at each end of the Hillview Road and Greenfield Park road culverts were determined for each scenario (see **Table 1**). The critical duration flood elevation for the upstream wetland was then used to map the floodplain under each scenario (see **Figure 1**).

The results indicate that flood elevation and flood extent decrease substantially from existing conditions by restoring the culverts and open channels to 1986 conditions (i.e. Scenario 1: a functioning 24" culvert under both Hillview Road and the Greenfield Park road). Scenario 2 (increasing the culvert sizes to 30") and Scenario 4 (existing Hillview culverts and a 36" Greenfield Park road culvert) further decrease the flood elevation. However, replacing the culverts with larger 36" pipes (Scenario 3) will result in a more substantial decrease in the elevation difference (head loss) across both Hillview Road and the Greenfield Park road. This decrease in head loss will coincide with a decrease in velocities, scour, and downstream erosion. The larger open area of the 36" culverts will decrease the likelihood of clogging which is currently problematic in the existing 24" culvert.

The City of Mounds View's 2013 Street Improvement Project is an opportune time for the District to consider repairing deteriorating components of ARJD 1 Branch 5 because of the pending City project. To decrease flood elevations in the upstream wetland and improve the long-term sustainability of the public drainage system, we recommend replacement of the two 24" RCP culverts under Hillview Road with a single 36" reinforced concrete pipe, with invert elevations of 896.22 upstream and 896.07 downstream. We recommend replacement of the existing culvert under the Greenfield Park road with a single 36" culvert, with invert elevations of 896.0 upstream and 895.8 downstream.

Replacement with 36" culverts will provide the greatest reduction in flooding risk to upstream properties of any of the scenarios analyzed, and will result in the least amount of future maintenance due to clogging, scour, or erosion. We do not recommend further investigation of the feasibility of Scenario 4 (utilizing the existing culverts in Hillview Road) since the investigation will require substantial work (excavation of the adjacent channel, jetting of the culvert, and televising the culvert), the scenario does not decrease the future likelihood of clogging, and the feasibility of re-using the existing culvert is very unlikely.

We further recommend that sediment within the open channel of Branch 5 be removed to a profile matching the pipe invert elevations within Branch 5 (i.e. the 1986 repair profile), prior to or immediately after the installation of the new culverts. This work is critical for minimizing the deposition of sediment in the new culverts. It is estimated that sediment removal would be necessary
