DESCRIPTION OF PROPERTY SURVEYED

Lots 7 through 12, Block 14, MICHEL AND ROBERTSON'S ADD., according to the recorded plat thereof, Ramsey County, Minnesota. Abstract and Torrens Property

St. Louis Park, MN 55416 PLAN, OR REPORT WAS PREPARED BY ME OR UNDER MY DIRECT SUPERVISION AND THAT I AM A DULY LICENSED LAND SURVEYOR UNDER THE LAWS OF THE STATE OF MINNESOTA. DATE 11-6-2020 LICENSE NO. 44565 QA/QC FIELD CREW DO/DT REVIEWED BY RS UPDATED BY VICINITY MAP REVISION SUMMARY DATE DESCRIPTION PROJECT NO.: 20310 ALTA/NSPS LAND TITLE SURVEY

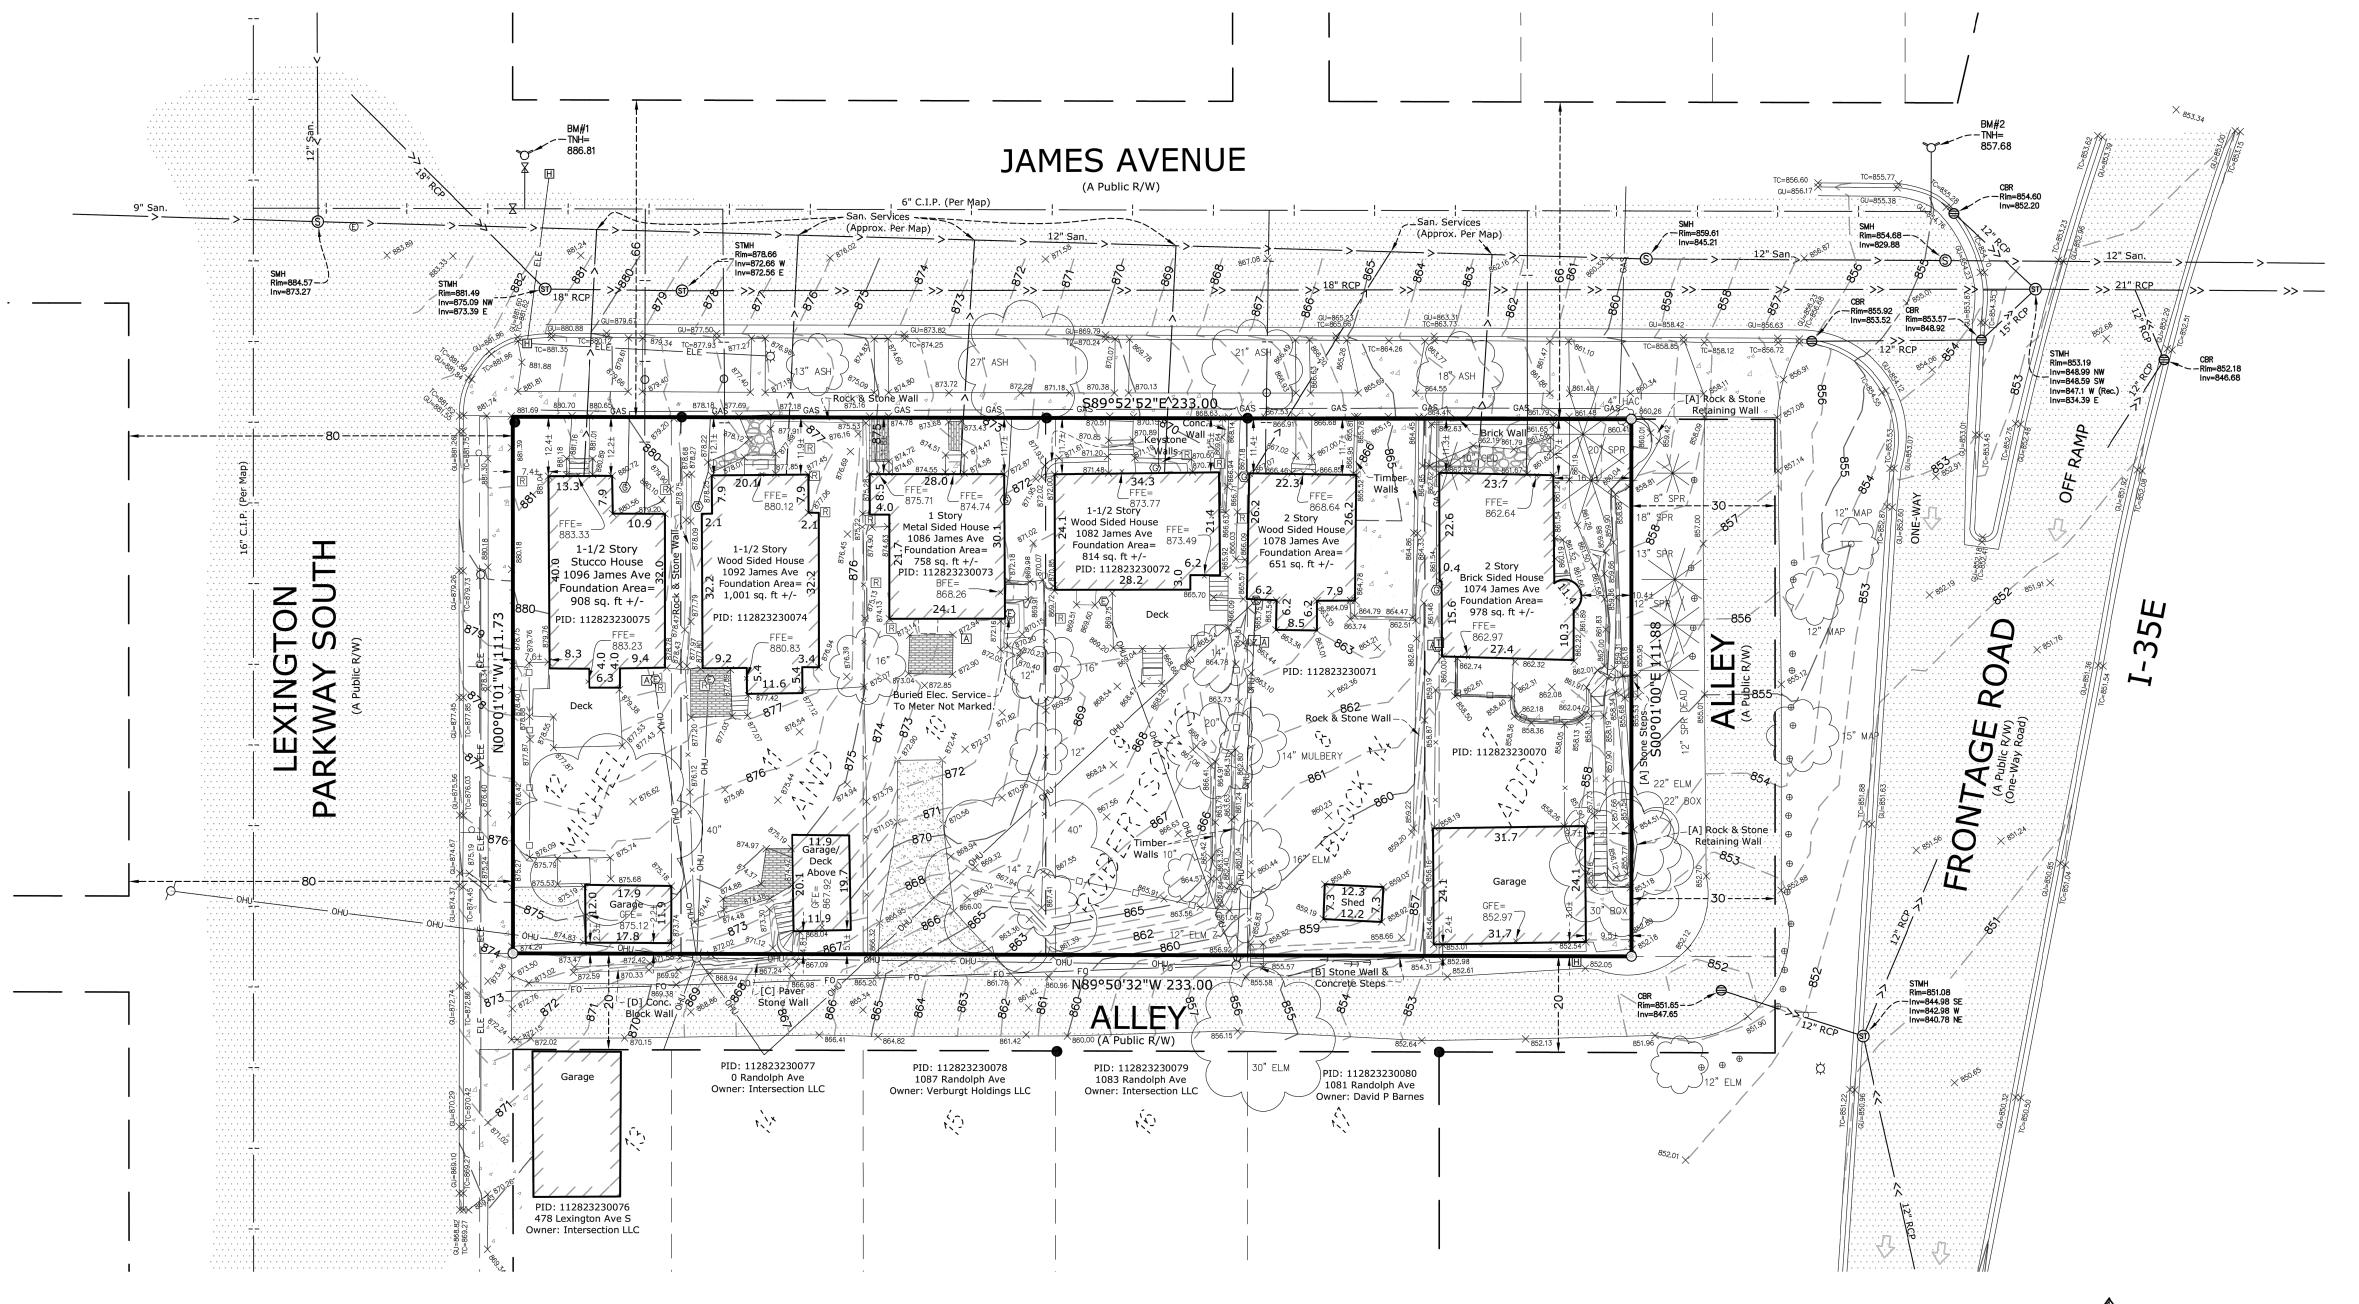
[A]. Rock and stone retaining wall and stone steps appear to encroach onto the Alley right of way as shown hereon along the east line
- of 1074 James Avenue.

[B]. Stone wall and concrete steps appear to encroach onto the Alley right of way as shown hereon along the south line of 1078 James
- [C]. Paver stone wall appears to encroach onto the Alley right of way as shown hereon along the south line of 1092 James Avenue.

[D]. Concrete block wall appears to encroach onto the Alley right of way as shown hereon along the south line of 1096 James Avenue.
