Subject: ARJD 1, Branch 5 Preliminary Culvert Sizing

## Rice Creek Watershed District ARJD1 Historic Review Memo

Culverts

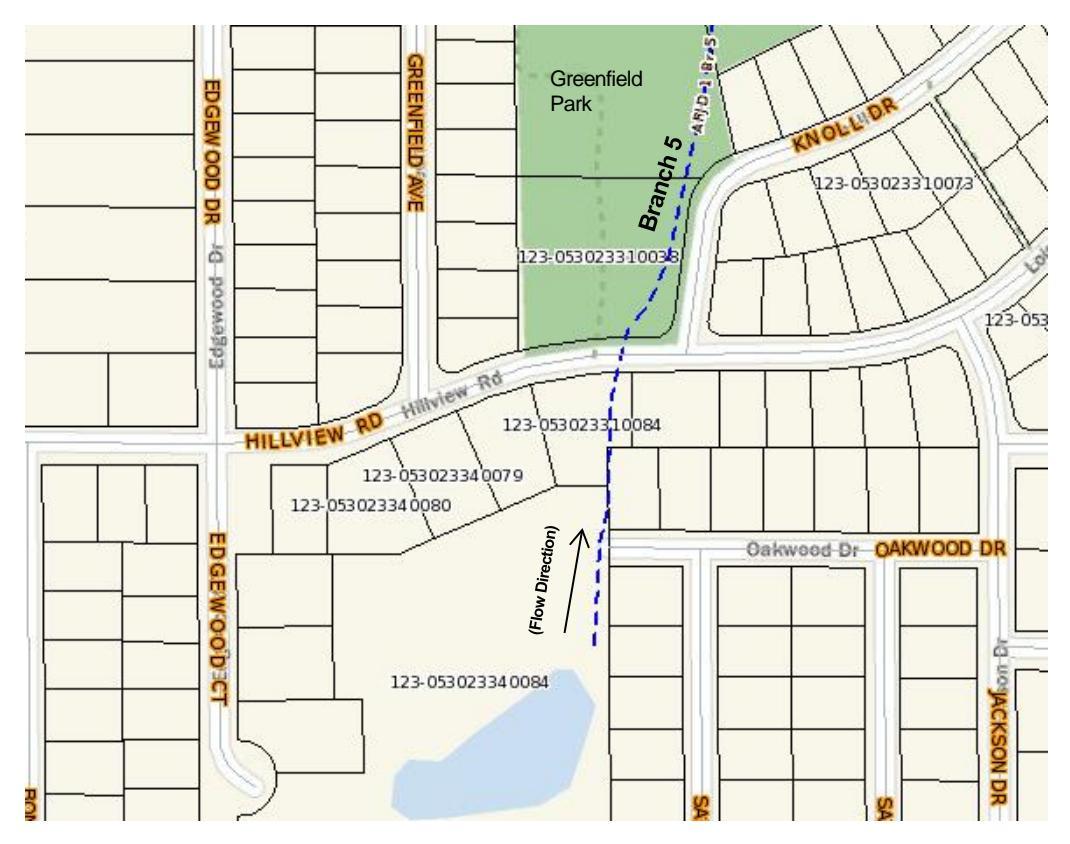
<u>ARJD 1 Upstream Channel and Pond</u>: Upstream of Hillview Road, the ARJD 1 open channel continues south approximately 300 feet, ending at a 36" CMP culvert (with inverts of 897.70 upstream and 897.61 downstream) which serves as the outlet for an open-water wetland complex. (Note: This wetland is not listed in the MnDNR Public Waters Inventory.) This open water complex, which is nearly entirely within a parcel owned by the state of Minnesota, abuts the backyards of residences along Hillview Road and Edgewood Court. Previous modeling indicates the elevation of the 100-year critical duration flood event (10-day snowmelt) to be at an elevation of 904.1. The flooding at this elevation could potentially inundate several homes adjacent to the wetland complex (see **Figure 1**). Because the flood elevation results directly

The model of the existing conditions within ARJD 1 was modified to simulate a repaired condition in Branch 5 at Hillview Road and the Greenfield Park road, using three scenarios with culverts ranging from 24" to 36" in diameter. The peak elevations of the 100-year, 24-hour rainfall event and the 100-year, 10-day snowmelt event in the upstream wetland and at each end of the Hillview Road and Greenfield Park road culverts were determined for each scenario (see **Table 1**). The critical duration flood elevation for the upstream wetland was then used to map the floodplain under each scenario (see **Figure 1**).
